Service Bulletin

Bulletin No.: PIT5274

Subject: Roof Beacon Lighting Harness Location

Models: 2015 Chevrolet Silverado

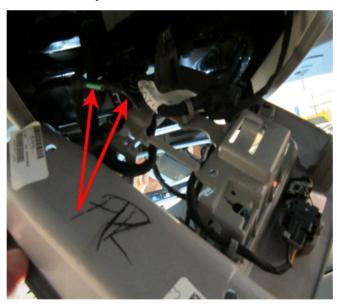
3794424

There are two wires located directly above the overhead roof console. Remove the complete overhead roof console and the wires are taped to the harness, as shown below.

Note: The roof beacon relay is located directly above the overhead roof console.
