SB-10055906-5572

SERVICE BULLETIN

2014 ALTIMA; HYDRAULIC ELECTRIC POWER STEERING SERVICE INFORMATION

APPLIED VEHICLE: 2014 Altima (L33)

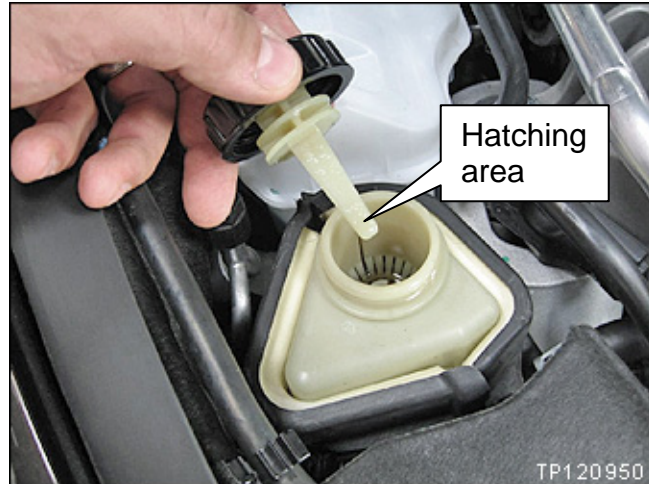
Figure 1

Power Steering Fluid

Check the fluid level of the Hydraulic Electric Power Steering (H-EPS) system.

- Check fluid level with the ignition OFF and fluid temperature between 0 – 30°C (32 – 86°F).
- Power steering fluid level should be within the hatching area of the indicator on the power steering reservoir tank cap.
- If fluid is needed, use only genuine NISSAN E-PSF or equivalent.

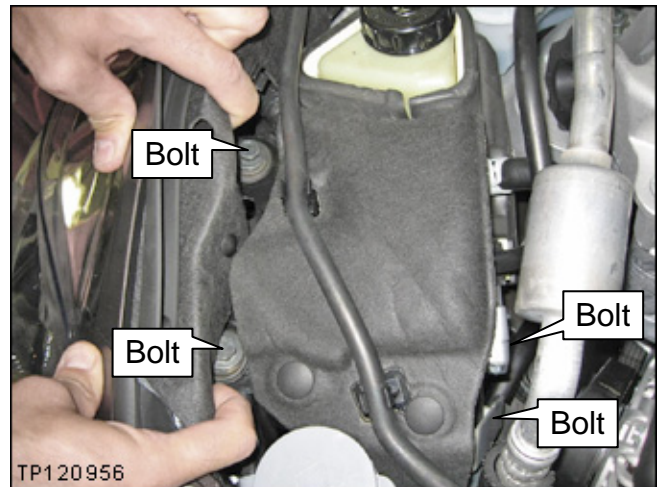
Figure 3

Pump Mounting Isolator

Make sure there is no binding on the H-EPS pump mounting isolator as follows:

- a. Loosen the four (4) H-EPS pump mounting bolts.
- b. Move the H-EPS pump a small amount from side to side.
- c. Tighten the mounting bolts.

Mounting bolts torque:

13.5 N•m (1.4 kg-m, **10 ft-lb**)

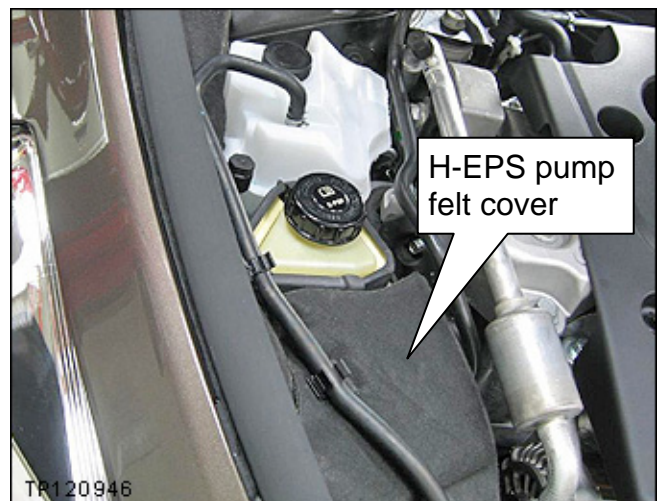
Figure 4

Pump Felt Cover

Make sure the H-EPS pump felt cover is installed correctly.

- Install the felt cover correctly
- or
- If damaged, replace the felt cover
- or
- If missing, install a felt cover.

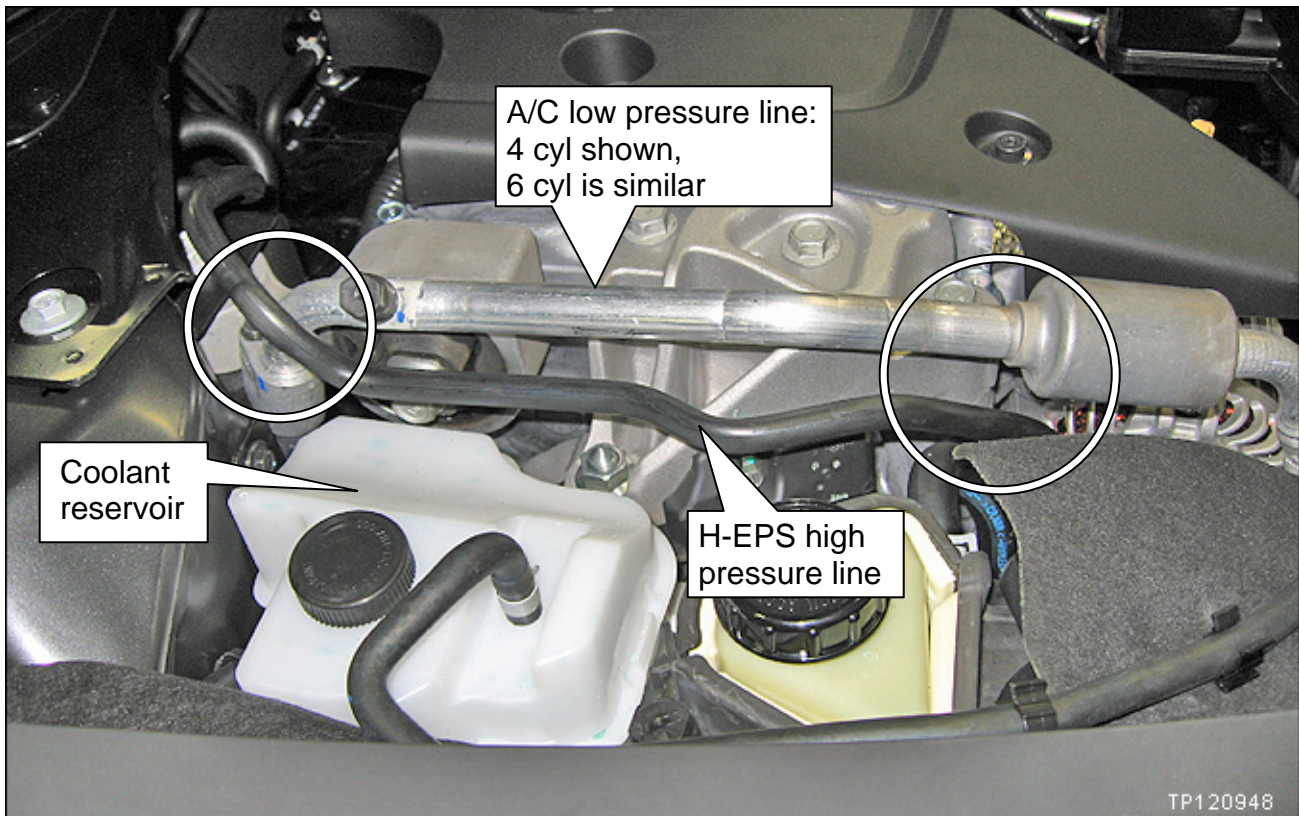
Figure 5

H-EPS High Pressure Line

Check the H-EPS high pressure line and the A/C low pressure line. Make sure they are **not** touching each other (see Figure 5).

Check the H-EPS high pressure line and coolant reservoir. Make sure they are **not** touching each other (see Figure 5).

- a. Check the two locations circled in Figure 5.
- b. If the lines are touching, reposition the lines so they are **not** touching.

If touching:

- a. Make sure the coolant reservoir is mounted correctly; its locator boss must be seated in the mounting hole.
- b. If needed, reposition the H-EPS line so it is **not** touching the reservoir.

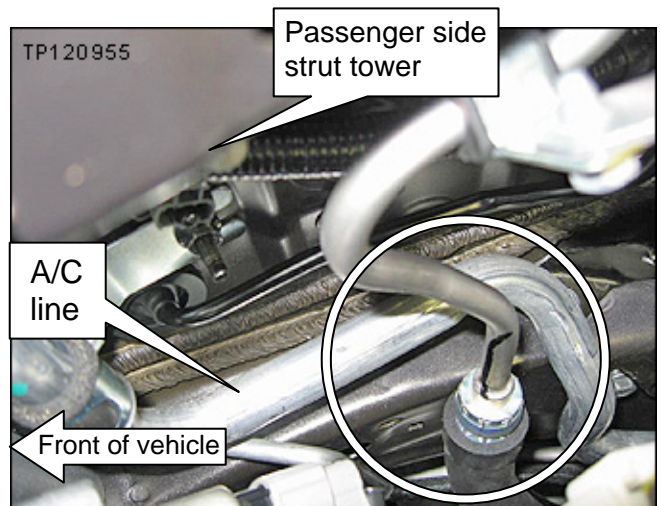
Make sure the H-EPS high pressure line is not touching the A/C line or vehicle body.

NOTE: The view in Figure 8 is downward from the inboard side of the passenger side strut tower.

- a. Check the area circled in Figure 10.
- b. If needed, reposition the lines so they are **not** touching.
- c. If needed, reposition the H-EPS line so it is **not** touching the vehicle body.

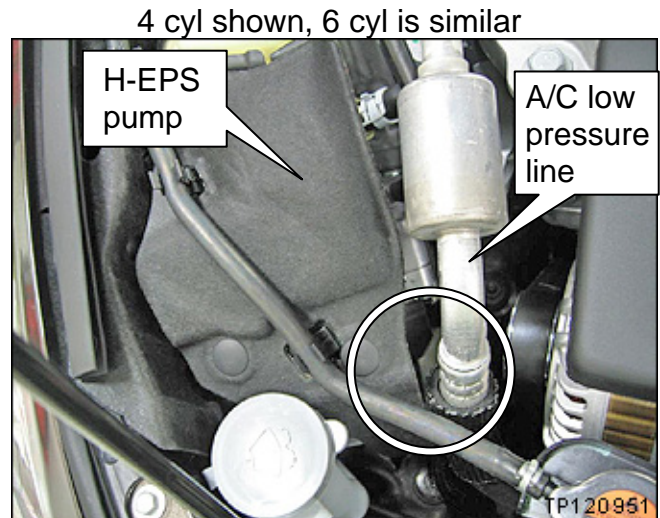
Figure 11

H-EPS Pump

Make sure the A/C low pressure line is **not** touching the H-EPS pump.

- Check the location circled in Figure 8.
- If needed, reposition the A/C low pressure line so it is **not** touching the H-EPS pump.

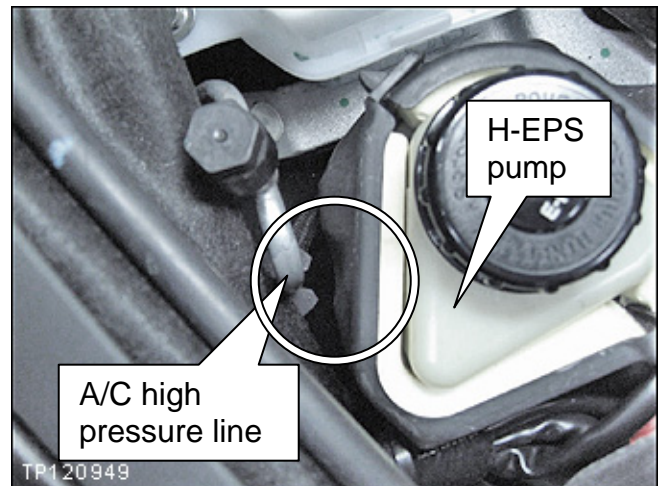
Figure 12

Make sure the A/C high pressure line is **not** touching the H-EPS pump.

- Check the location circled in Figure 9.
- Wiggle the H-EPS pump and observe the A/C high pressure line. If it moves, it is touching.
- If needed, reposition the A/C high pressure line so it is **not** touching the H-EPS pump.

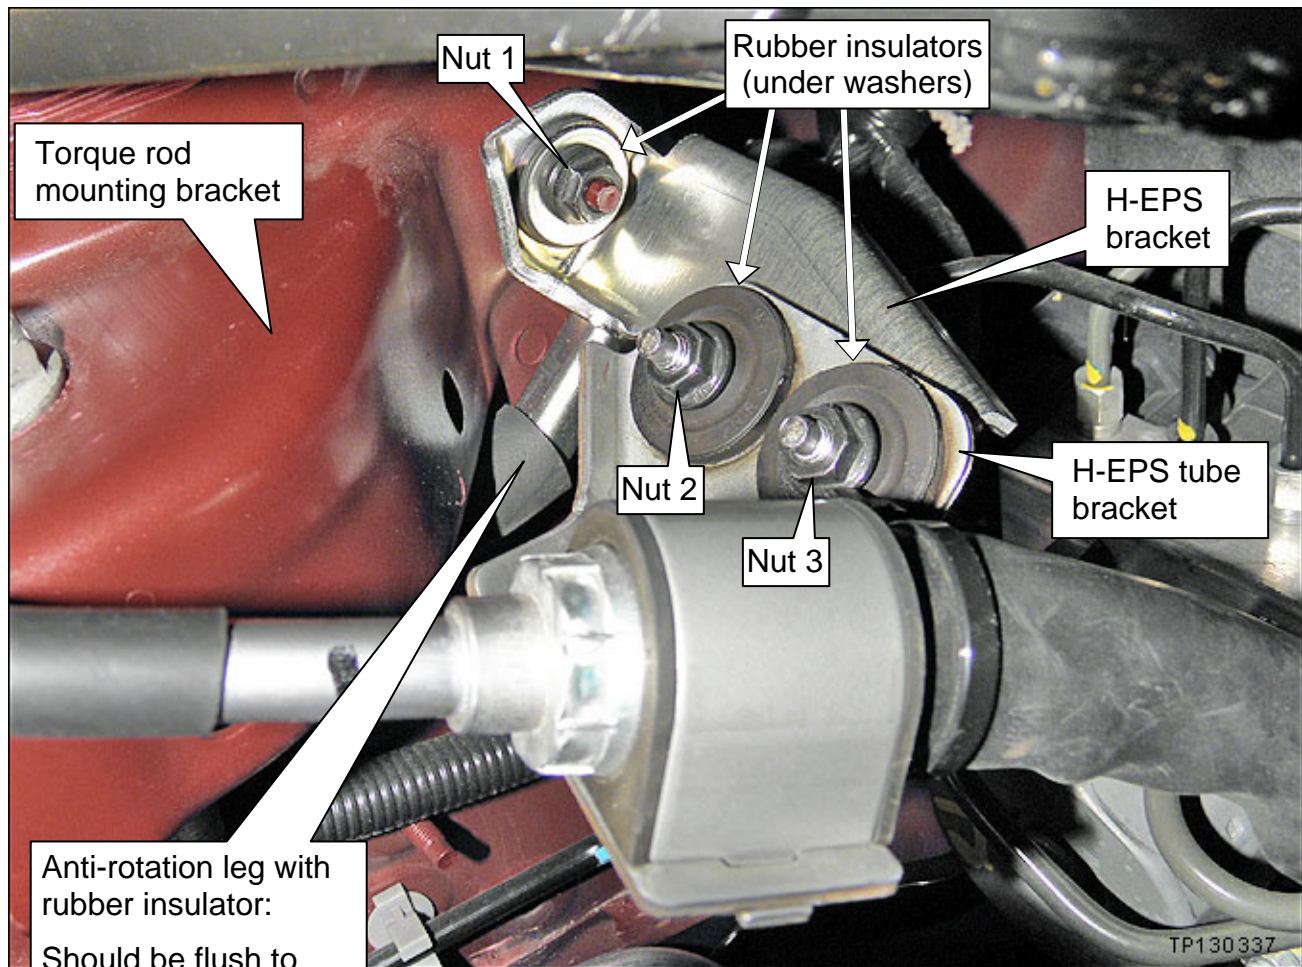
Figure 20

6 Cylinder Models: H-EPS Bracket

Check torque of all three (3) H-EPS bracket nuts:

Nut 1 torque: 8 N•m (0.81 kg-m, **5.9 ft-lb, 71 in-lb**)

Nuts 2 & 3 torque: 4.9 N•m (0.49 kg-m, **3.6 ft-lb, 43 in-lb**)

Make sure the H-EPS bracket and the H-EPS tube bracket are not touching (see Figure 20).

Make sure the H-EPS bracket's anti-rotation leg is flush to the bottom of the torque rod mounting bracket (see Figure 20).

- Make sure there is a gap between the brackets, all the way around.
- Make sure the rubber insulators are seated properly.
- If needed, reposition the brackets so they are not touching.

- Check the position the H-EPS bracket, make sure its anti-rotation leg is flush to bottom of the torque rod mounting bracket.
