# SB-10056027-5192

ROADSTER 2013 Brake Light Stays On - Battery Drainage (ST\_000051492\_TST61Y013S10\_en)

**Summary:**  
BLS has received reports concerning the brake light staying on when the brake pedal is resting on the bump stop. This will cause battery drainage.

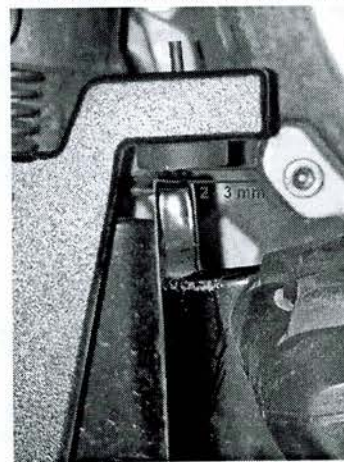
Normal distance between the bump stop and the brake pedal when the brake light turns OFF is 2 - 3 mm (0.08" - 0.12").

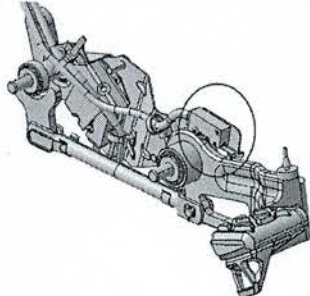
The BLS position changes with the new plate, the lever now rests on the brake pedal, refer to this illustration for proper position.

This requires the replacement of the brake light switch (P10003412) and possibly the support plate depending on the production date of the unit. Follow this chart to know what to replace:
