# SB-10056218-3357

Subject: **Special Service Campaign - 14R1**  
Certain 2012 through 2014 Toyota Prius V Vehicles Equipped with Non-Toyota Seat Heater

**Gulf States Toyota, Inc.**  
**GST SSC - 14R1**  
**2012-2014 Prius V Seat Heater**  
**P/N 00012-J1448-21 Power Harness Update**  
**Technical Instructions**

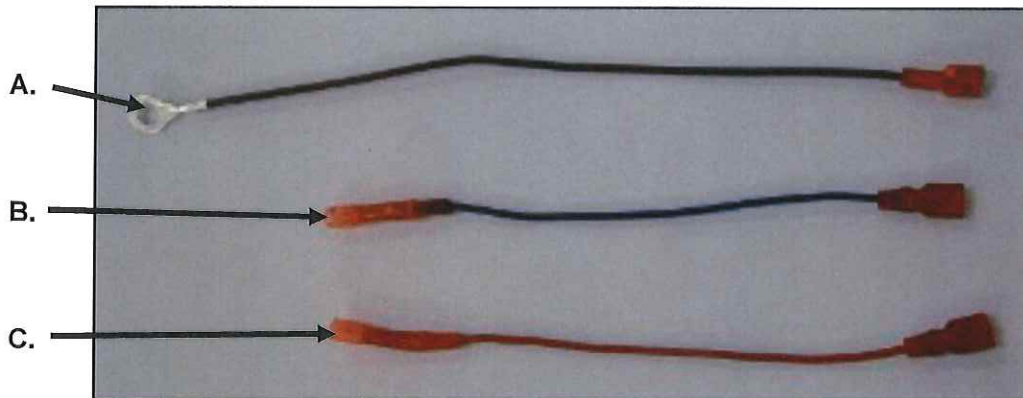
1. The update kit should include the following parts ...
  - A. (1) System Ground Extension (BROWN) Wire.
  - B. (1) Passenger Front Seat Power Extension (BLUE) Wire.
  - C. (1) Driver's Seat Power Extension (RED) Wire.
  - D. (3) 6" Long Cable Ties (not shown in diagram).

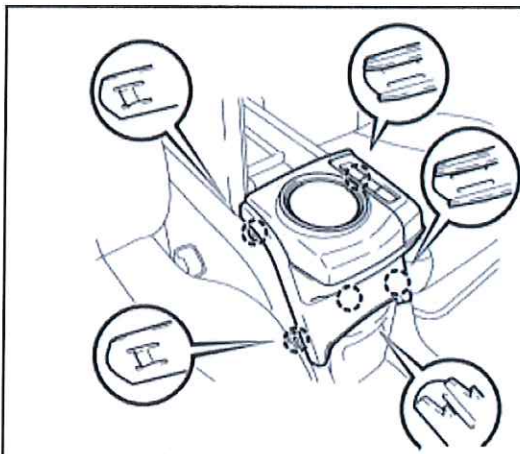
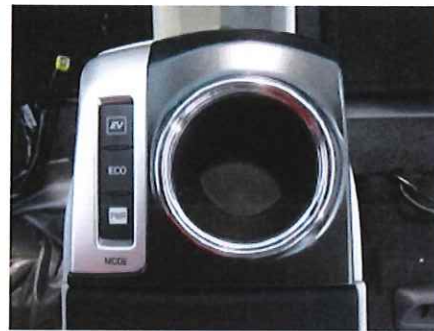
Figure 3a.

3. To remove the Upper Console Panel, carefully disengage the 5 claws, then unplug the connector and place the panel aside where it cannot be damaged.

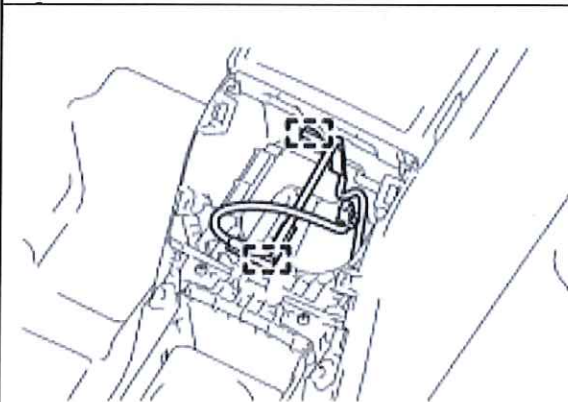
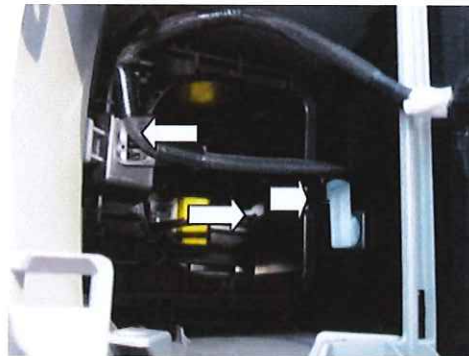
Figure 4a.

4. Disengage (3) harness clamps from the console box.

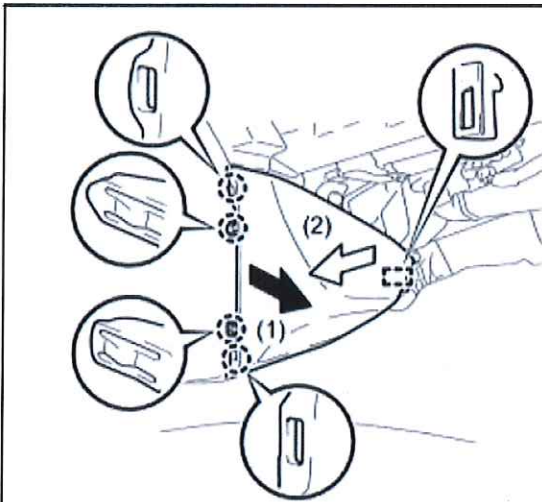
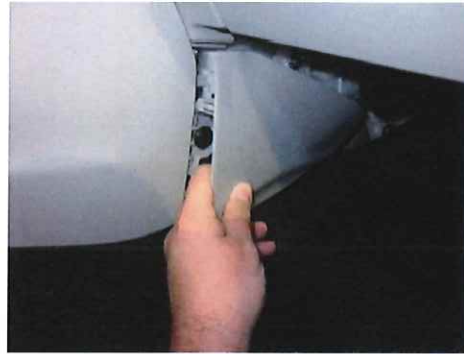
Figure 5a.

5. Carefully remove the Right Front center floor carpet cover panel and set it aside where it cannot be damaged.

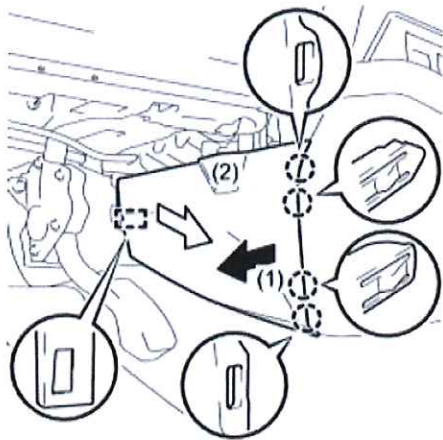
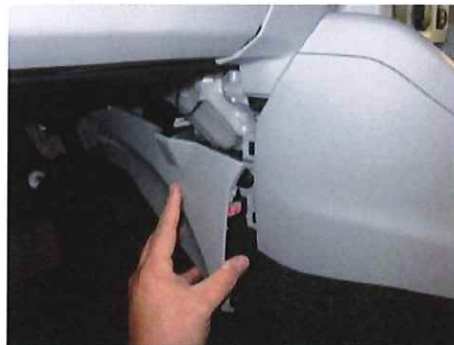
Figure 6a.

6. Carefully remove the Left Front center floor carpet cover panel and set it aside where it cannot be damaged.

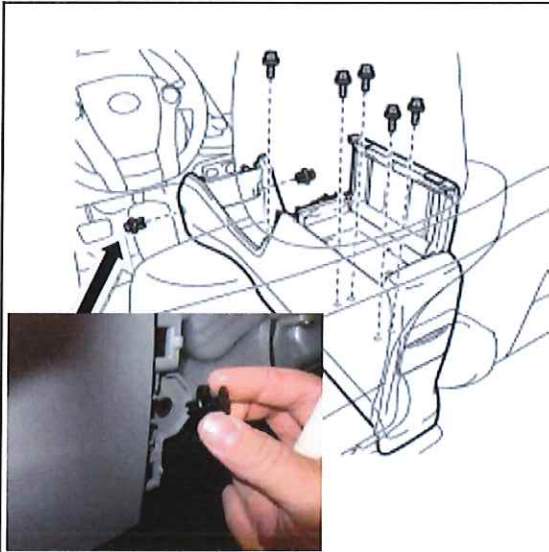
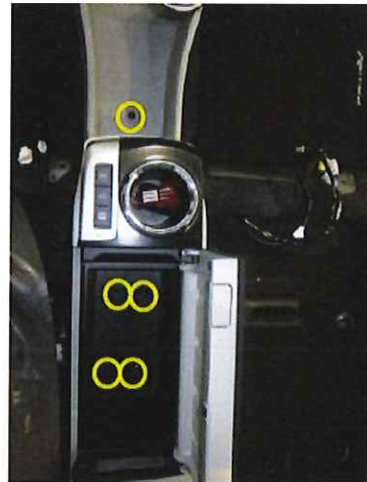
Figure 7a.

7. Remove the (5) 10mm bolts from the center console, then remove the clip from each front corner, and remove the console and set it aside where it cannot be damaged.

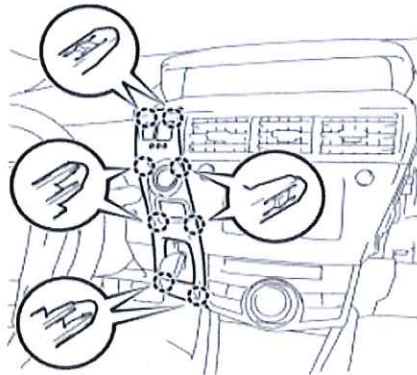
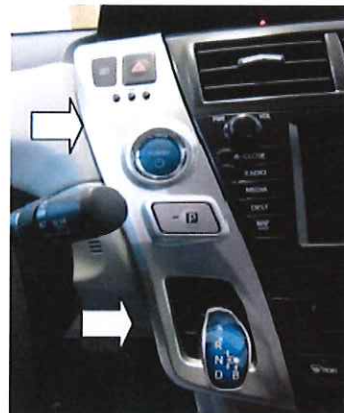
Figure 8a.

8. Disengage the (8) claws, disconnect the connectors, then remove the integration control panel and set it aside where it cannot be damaged.

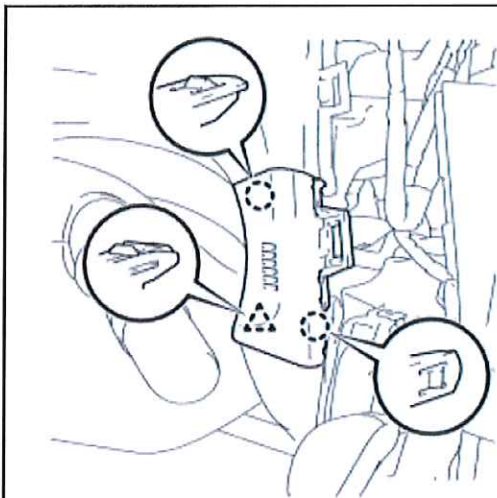
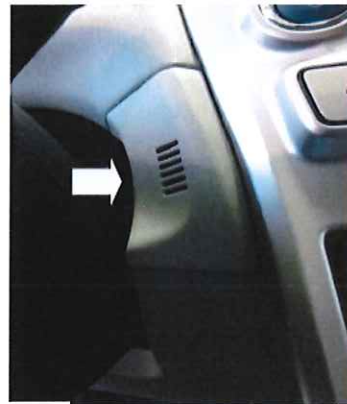
Figure 9a.

9. Disengage the (2) claws and the clip, then remove the upper instrument panel finish panel and set it aside where it cannot be damaged.

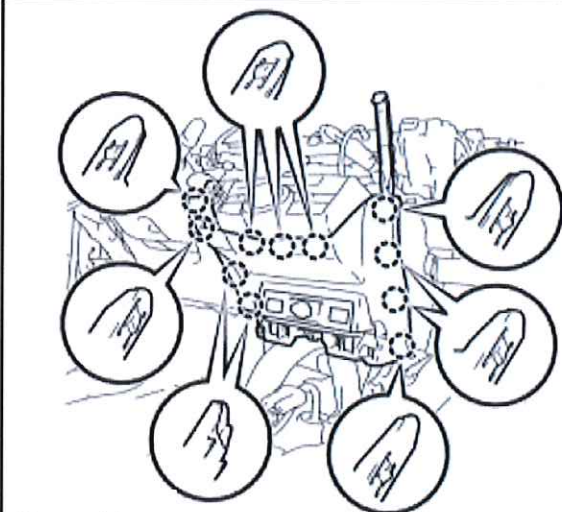
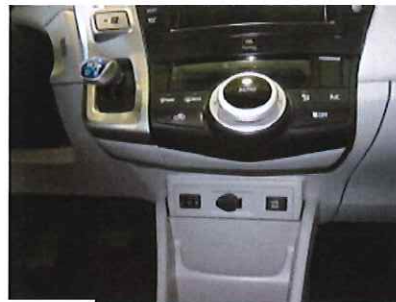
Figure 10a.

10. Disengage the (11) claws and a single clamp, disconnect the connectors, then remove the lower instrument finish panel sub-assembly and set it aside where it cannot be damaged.

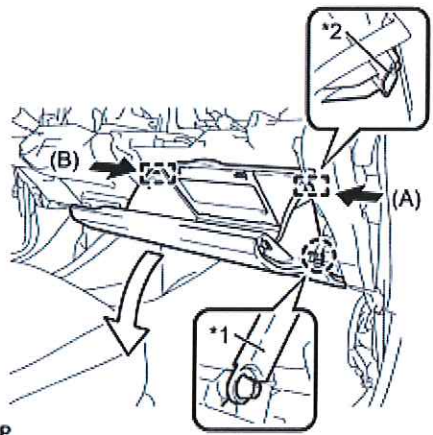
Figure 11

11. Open the glove compartment door, disengage the claw and release the glove compartment door stopper sub-assembly. Then slightly bend stoppers (A & B) in the direction of the arrows shown and pull the glove compartment door assembly until the stoppers are released.

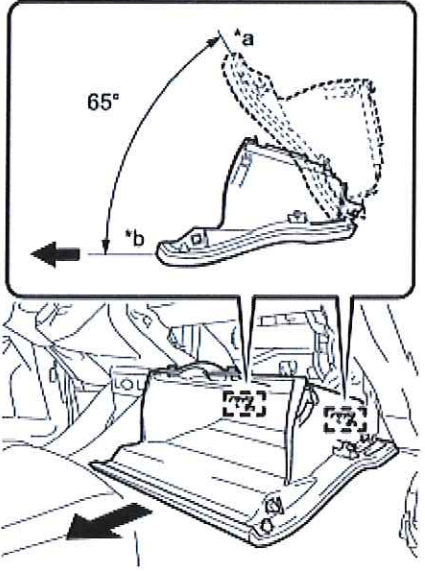
Figure 12

12. Open the glove compartment door assembly to approximately 65 degrees, then carefully pull it horizontally in the direction of the arrow to disengage the (2) hinges. Set it aside where it cannot be damaged.

NOTE: Use care and pull horizontally so the hinges will not be damaged.

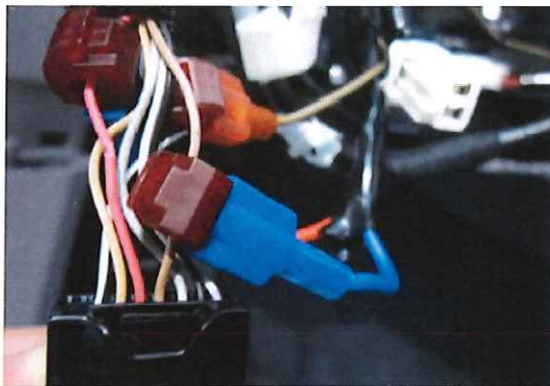
Figure 13

13. Locate connector L26 in the lower center console opening. This is an 8 pin black connector which will have (3) wires from the Seat Heater connected to it.

Seat Heater Wire Color	OEM Wire Color	Connector L26 Pin Number
BR	W-B	2
R	R	4
L	BR	5

L26 ( 8 Pin Black Connector)

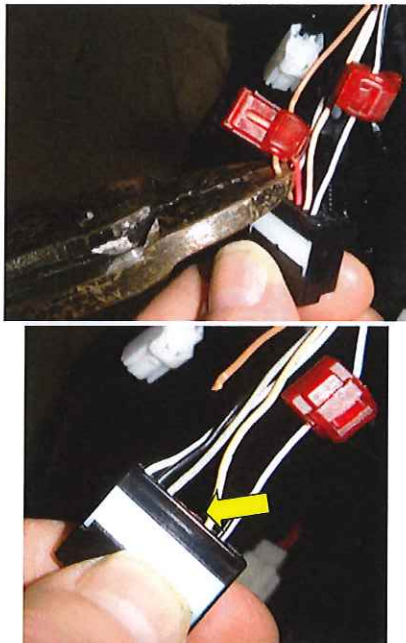
Figure 14

14. Unplug the (3) Seat Heater Wires from the T-Tap terminals at the back of connector L26. Then, cut the T-Tap terminals off the RED and the BROWN OEM wires, cutting the OE wire at both sides of the T-Tap. **BE SURE TO CUT THE RED AND BROWN WIRES AS CLOSE TO CONNECTOR L26 AS POSSIBLE, AS INDICATED BY THE YELLOW ARROW BELOW LEFT.**

NOTE: The 3rd T-Tap should remain connected to the OEM WHITE/BLACK striped wire.

**IMPORTANT !!!** Save the (2) T-Taps that were cut from the harness. These parts **MUST BE** returned to the PDC when the LIO Warranty claim is filed. Claims will not be paid and VINs will not be cleared until the (2) parts with wire are received at the Parts Distribution Center.

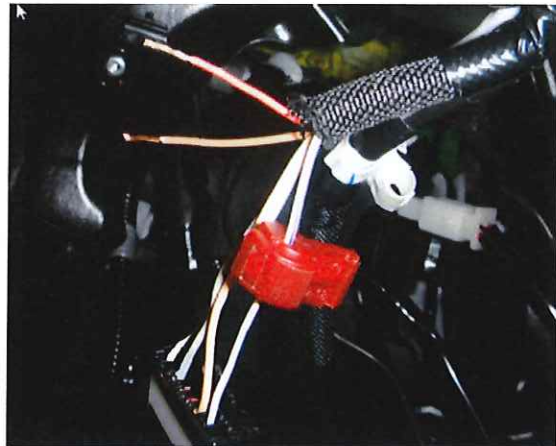
Figure 15

15. Carefully strip back 3/8" of insulation from the OEM Red and Brown wires, at the harness side of the wire.

**IMPORTANT !** This is a 22 AWG wire. Be sure to use the correct wire stripping tool, and be sure that no copper wire strands are removed from the wire during the stripping process.

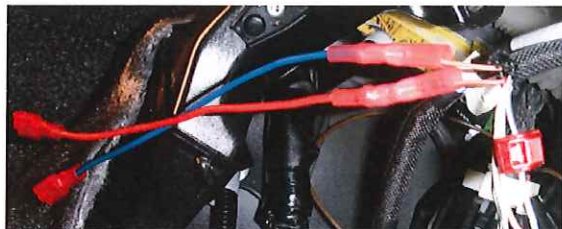
Figure 16

16. Using 3M crimp tool TH-440 or equivalent, crimp the Passenger Front Seat Power Extension (BLUE) Wire included in this kit to the OEM BROWN wire previously inserted into Connector L26, Pin 5.

Crimp the Driver's Seat Power Extension (RED) Wire included in this kit to the OEM RED wire previously inserted into Connector L26, Pin 4.

**IMPORTANT !** After crimping each wire, apply 11 lbs of pull force to ensure the crimp is secure.

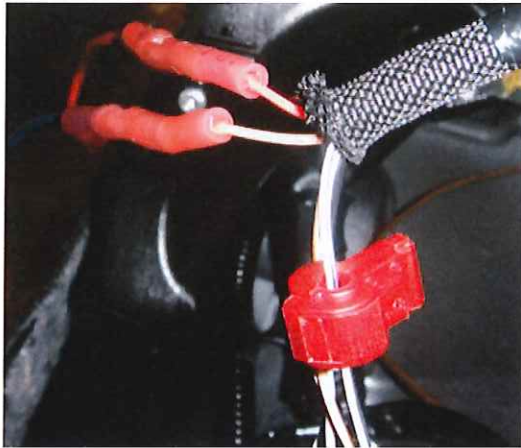
Figure 17

17. Using a concentrated heat source or heat gun at **MEDIUM** setting, shrink the insulation at the crimped end of the butt splice down over the OEM wire insulation.

**IMPORTANT !** Be sure to protect all finish panels and parts including OEM connectors from the heat source. Use extreme care and demonstrate patience when shrinking the tubing.

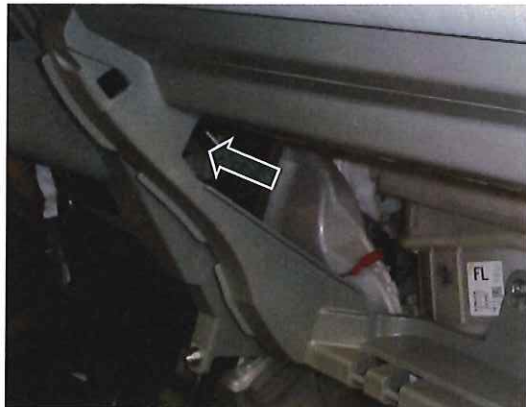
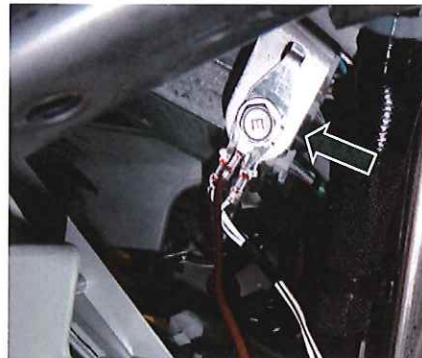
Figure 18

18. Locate the factory ground location L2 behind the upper left corner of the glove box opening. Using a 10mm socket, connect the ring terminal on the System Ground Extension (BROWN) Wire included in this kit to factory ground location L2 and torque to factory specification.

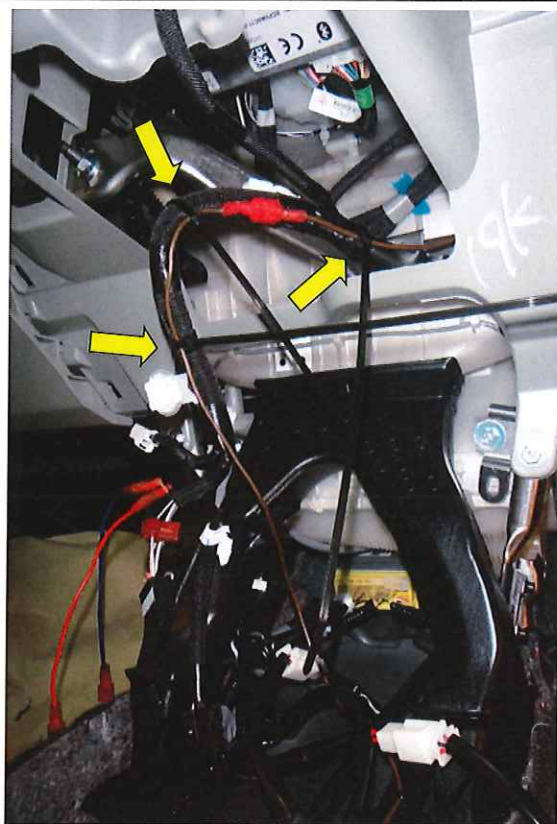
Figure 19

19. Route the insulated female terminal end of the BROWN extension wire into the center console area, and plug it into the male insulated terminal on the end of the BROWN wire from the seat heater harness.

Plug the insulated female terminal end of the RED extension wire into the male insulated terminal on the end of the RED wire from the seat heater harness.

Plug the insulated female terminal end of the BLUE extension wire into the male insulated terminal on the end of the BLUE wire from the seat heater harness.

Install the (3) wire ties as shown at the three yellow arrows. Be sure to trim the excess wire tie extension prior to re-assembly.
