**DART: Rear Bulkhead Seal**

**Issue:** Rear bulkhead seal

**Reason / cause:** Apply fire resistant calk and foam at bulkhead corners to improve resistant against moisture intrusion.

Work instruction number: L3/FSV-224  
L4/QUA-003

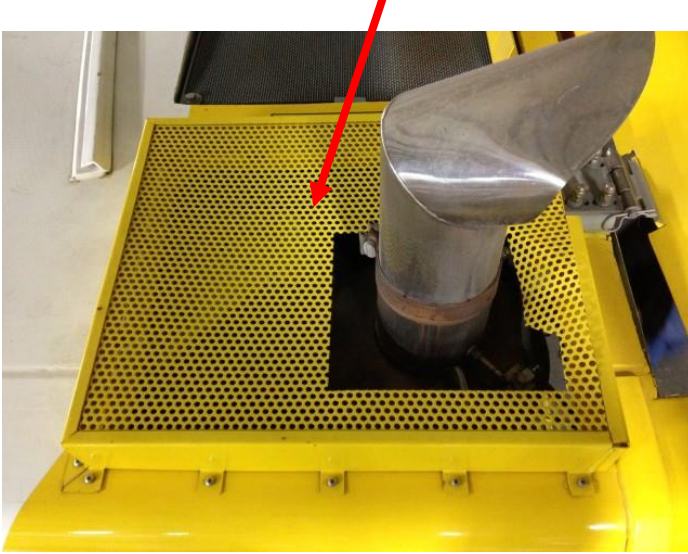
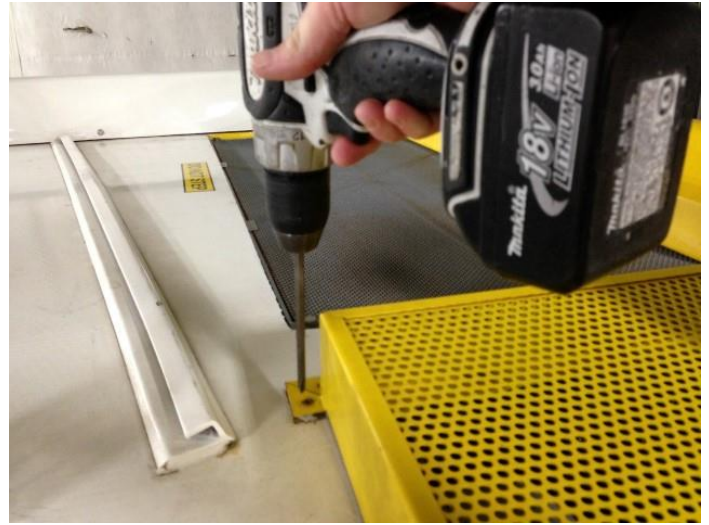
1. Park the bus on a flat surface and apply the parking brake.
2. Turn off main battery disconnect switch(es).
3. Remove closeout grill from around the exhaust pipe.

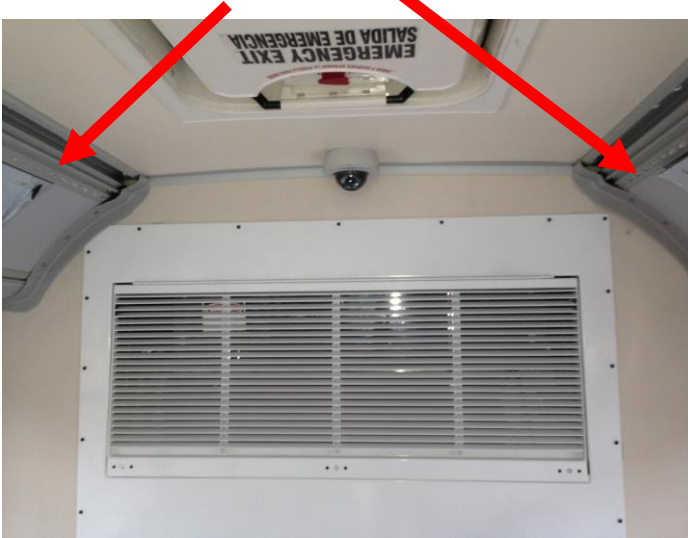
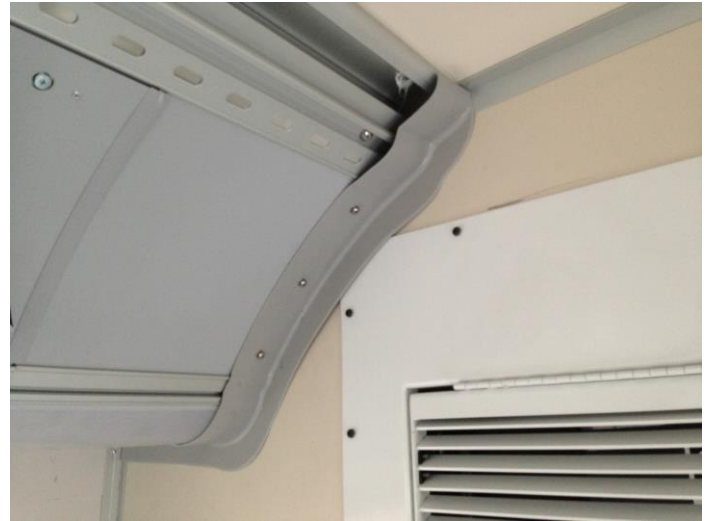
Remove street side and curb side light panel sections in front of the rear bulkhead. See NABI Maintenance Manual section 7C-6 and 14F1-F9 for details.

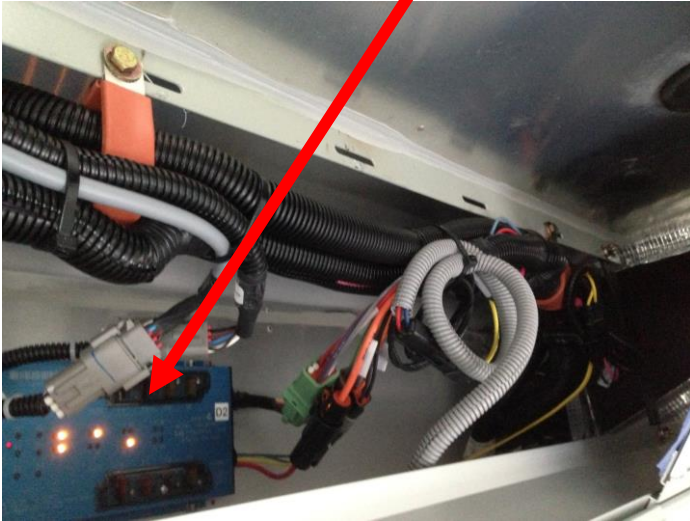
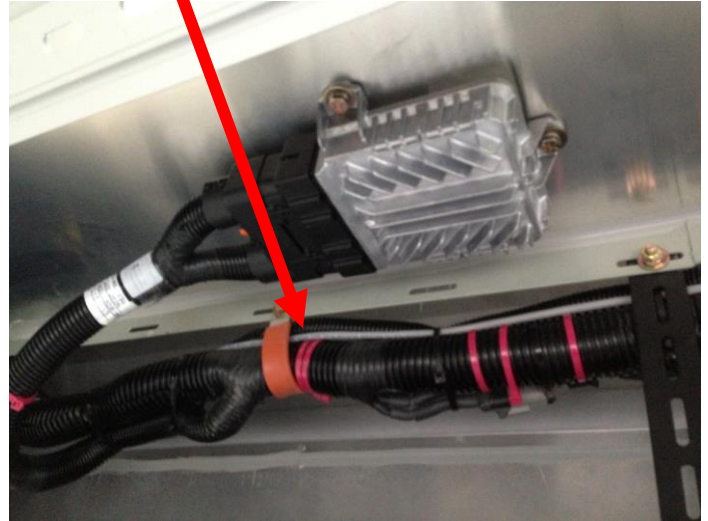
6. Remove components (IO modules, speakers, etc.) installed to the inner aluminum panels.

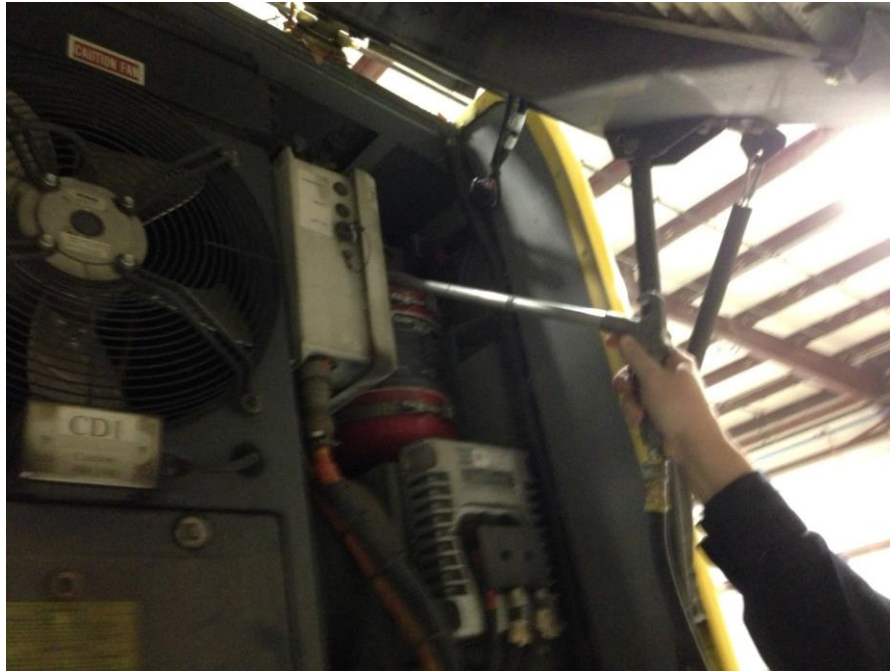
9. At the attic compartment, use compressed shop air to blow debris out from between the frame tubes and roof corner panel. ***Wear safety goggles and respirator!***

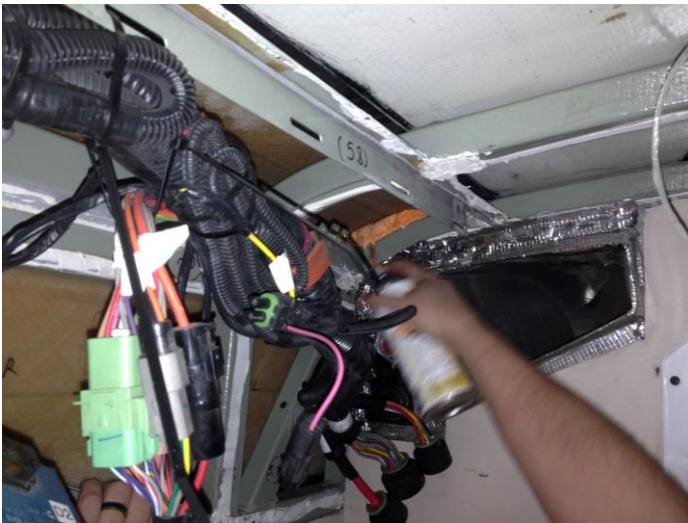
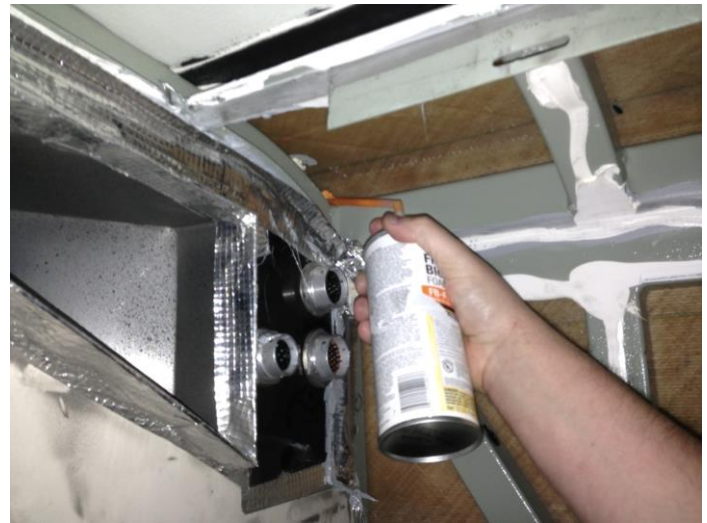
Curb side and street side:  
apply foam between the  
horizontal-longitudinal  
tubes and the roof corner.

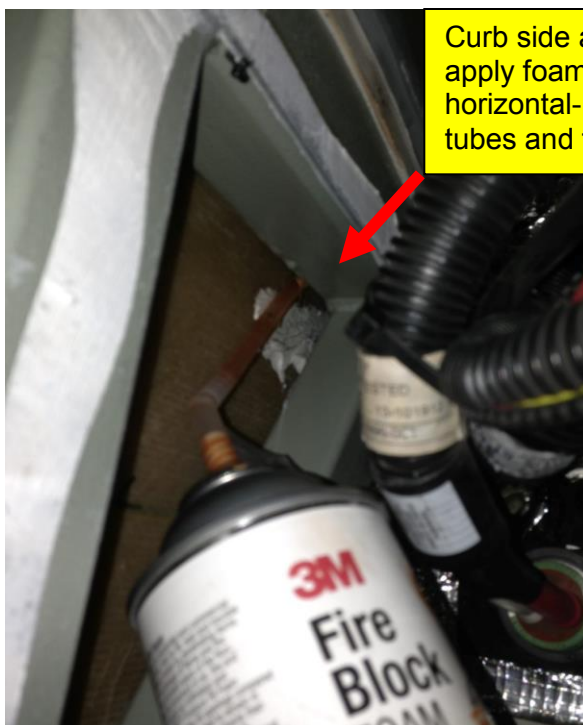
Horizontal-  
longitudinal tube

Roof corner

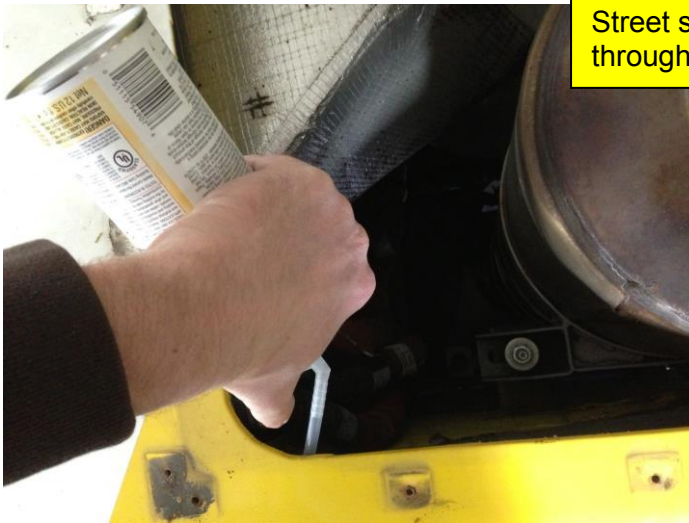
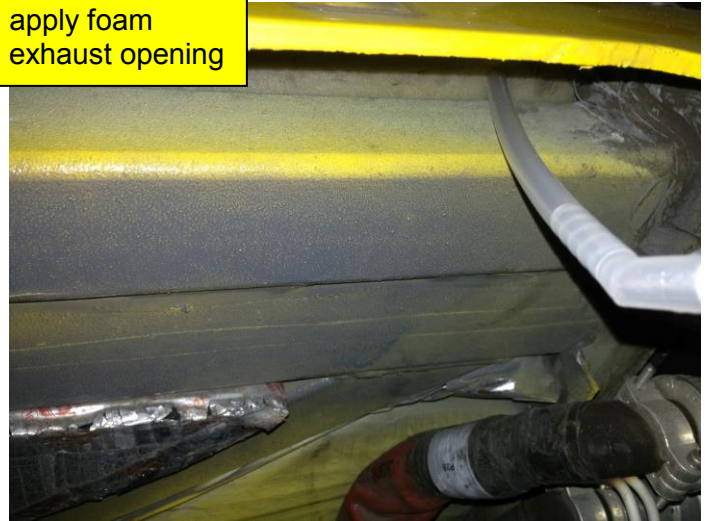
Street side: apply foam through the exhaust opening

12. Spray 3M Fire Block Foam behind the frame tubes (both curb and street sides) at the attic compartment. Orient the nozzle toward the bulkhead and move toward the back of the bus while continuously spraying the foam. The goal is to fill up the gap between the side of the upper horizontal tube and the roof corner. Do not overspray the foam. The foam is expanding 200% so wait couple seconds before applying more foam.

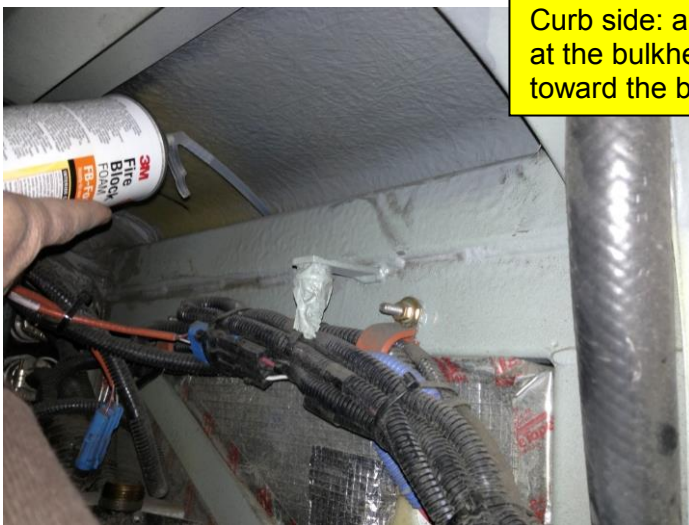
Curb side: apply foam starting at the bulkhead and moving toward the back of the bus

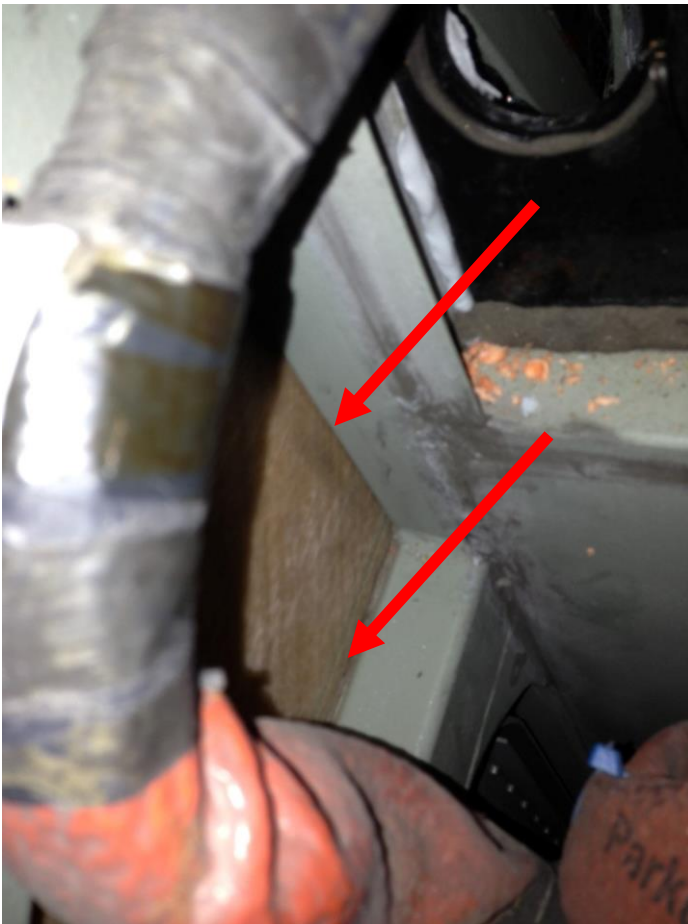
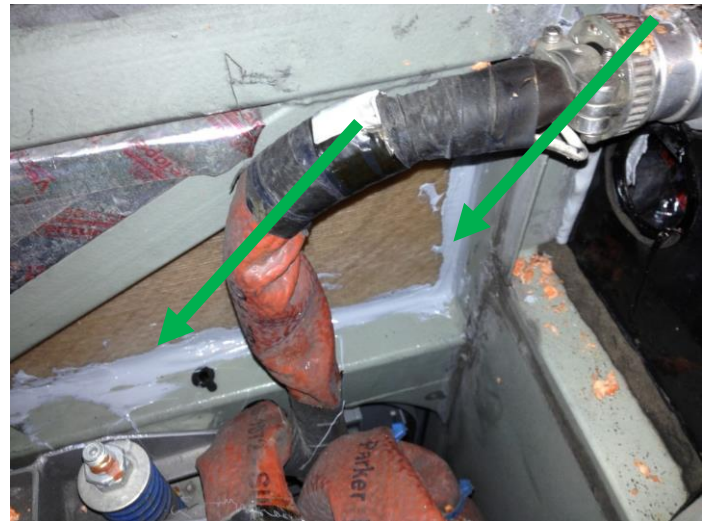
14. On the street side remove insulation from the side wall that is right beside the muffler.
15. Remove harnesses.
16. Wipe structure and inner surface of the roof corner by rag soaked with acetone (location marked by red arrows below).
17. Apply 3M 2000+ fire barrier seal between the roof corner and the structure (marked by green arrows on the picture below).

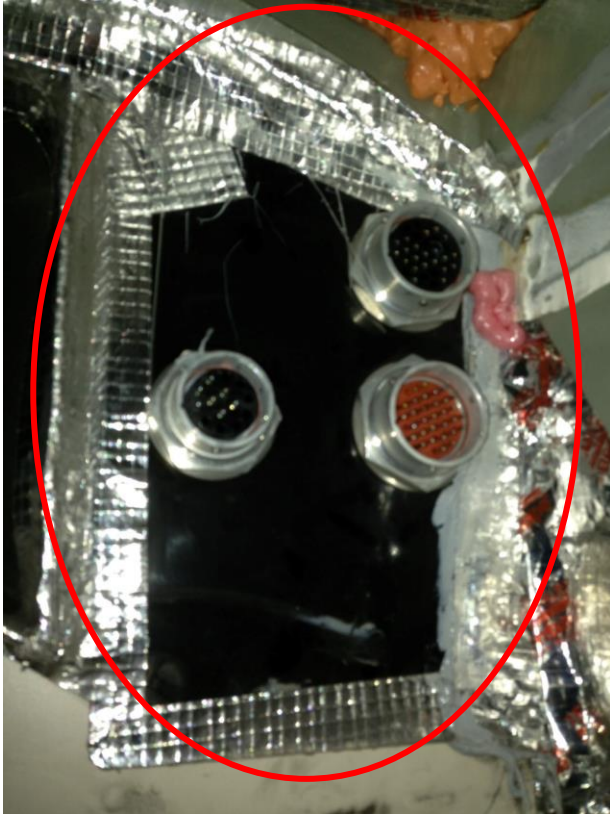
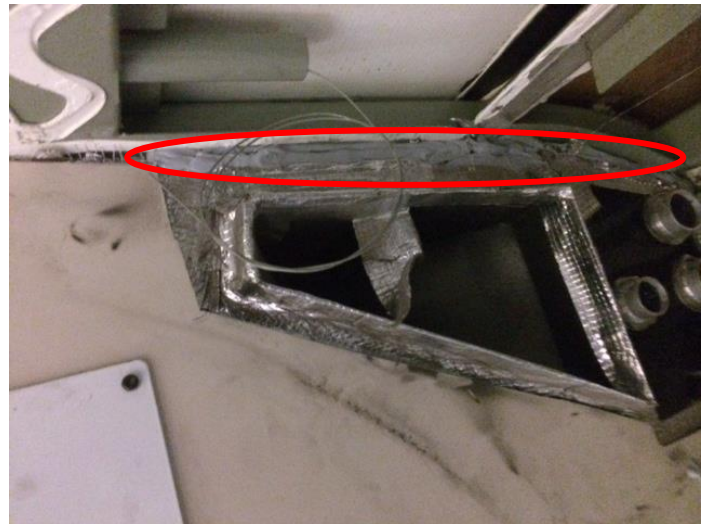
19. Inspect bulkhead area at the street side inside of the bus as pictures show below. If seal is compromised then follow instructions written below.

20. Degrease bulkhead around the area that needs to be sealed by using rag soaked with acetone.

21. Apply 3M Fire Barrier 2000+ seal to the cleaned area. Follow instruction written on the cartridge.

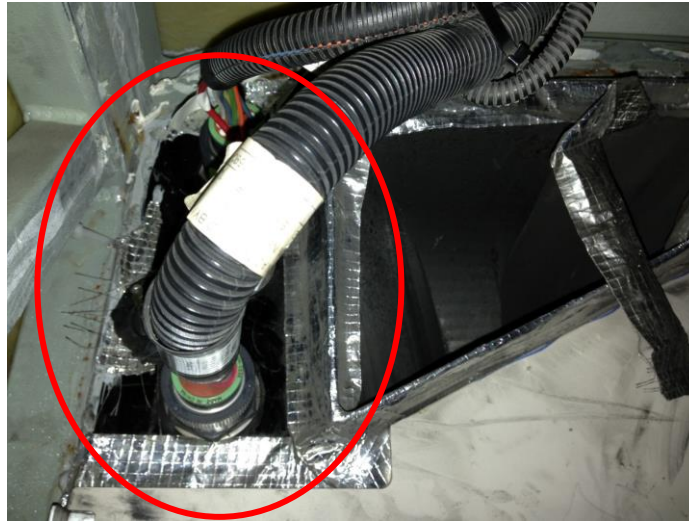
22. Inspect bulkhead area at the curb side inside the bus as picture shows below. If seal is compromised then follow instructions written below.

23. If required, disconnect the three electrical connectors at the bulkhead to gain better access to the bulkhead area that needs to be sealed.
24. Clean bulkhead around the area that needs to be sealed by using rag soaked with acetone.
25. Apply 3M Fire Barrier 2000+ seal to the cleaned area. Follow instruction written on the cartridge.

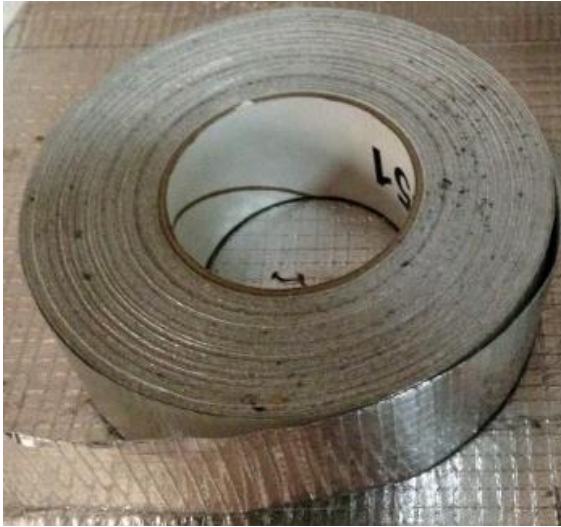
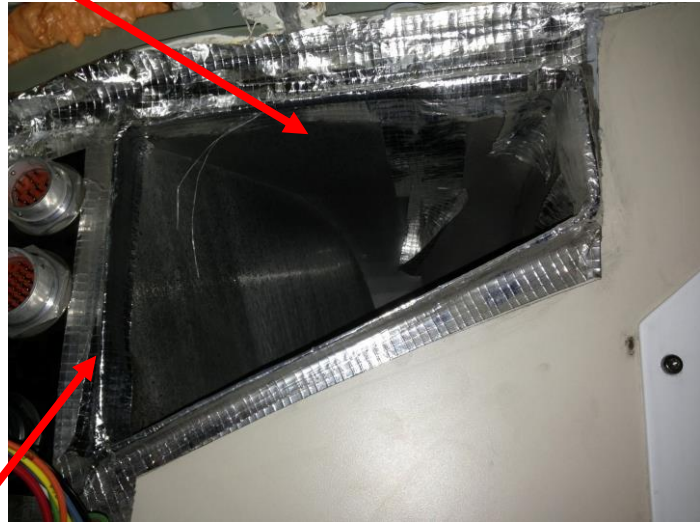
26. Apply foil tape around AC duct as required.

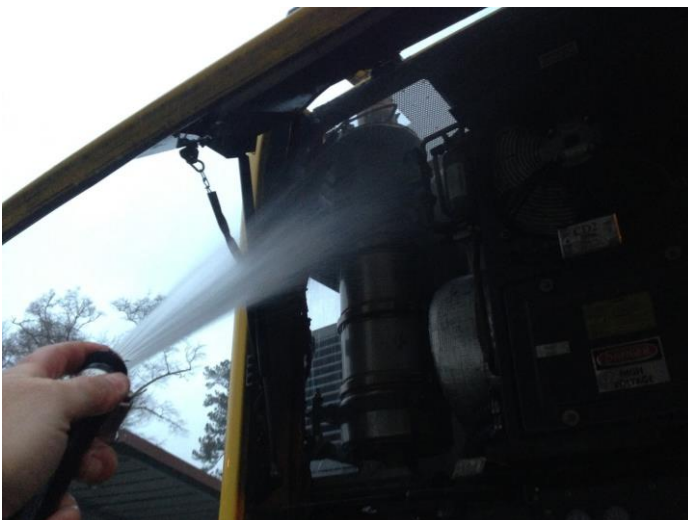
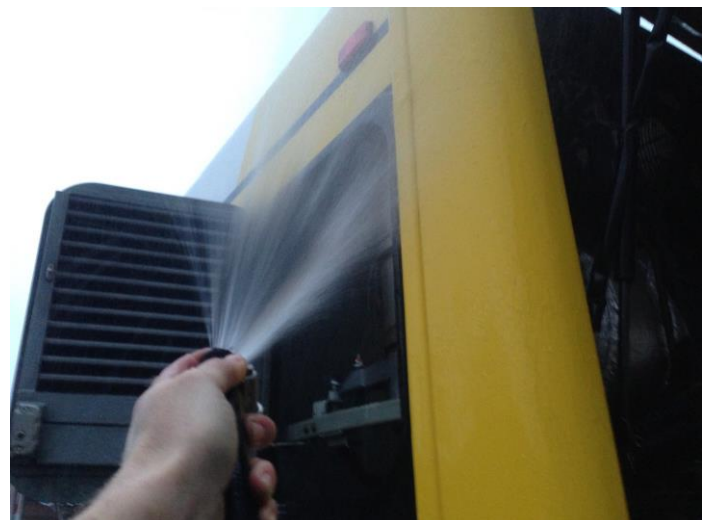
- Ensure that the battery cables are disconnected.
- Spray water to the repaired area from the attic compartment. Direct the water to the top corner of the street side and curb side of the bus where the harnesses going through the bulkhead.

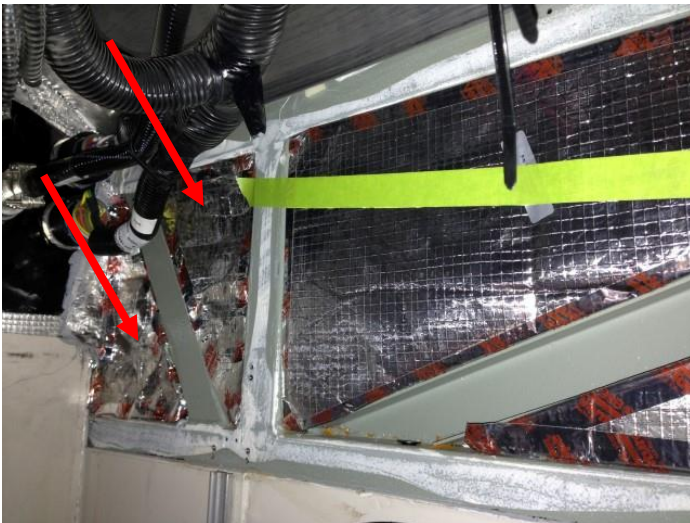
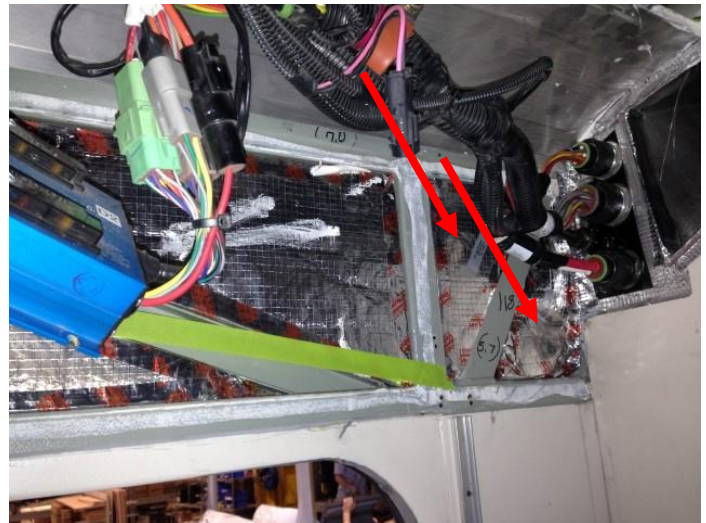
29. Remove remaining Sikaflex adhesive from structure by using scrapers and utility knife.
30. Clean and prep structure and new aluminum closeout panels per NABI standards.
31. Reinstall insulation between the frame tubes.
