<b style="font-size: 1.2em; margin-left: 10px;">HYUNDAI NEW THINKING. NEW POSSIBILITIES. <h2 style="margin: 0;">Technical Service Bulletin</h2>	GROUP HYBRID CONTROL	NUMBER 14-HC-002-1
	DATE OCTOBER 2014	MODEL SONATA (YF HEV)
SUBJECT: HYBRID POWER RELAY DTC P1B25, P1B76, P1B77, P0A0D

This TSB supersedes TSB 14-HC-002 to revise Parts Information.

Description: On certain Sonata (YF HEV) vehicles, the power relay assembly (PRA) or HEV safety plug may cause the following symptoms and related DTC. Follow the Service Procedure before diagnosing the Hybrid battery.

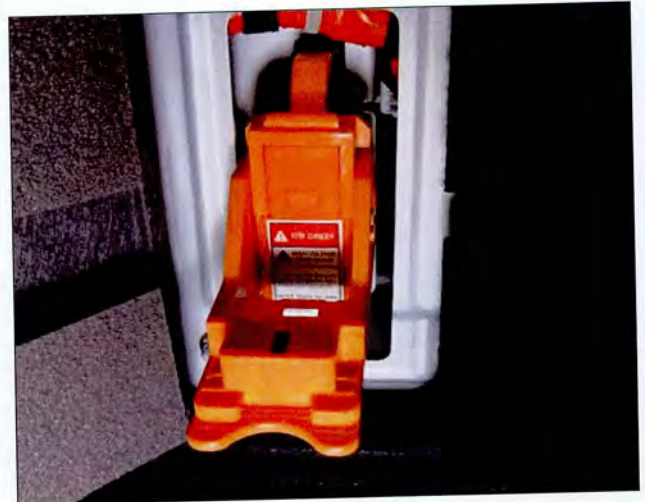
- Open the rear trunk and open the cover to the safety plug.

Put on insulation gloves and pull up on the black tab and pull out the safety plug.

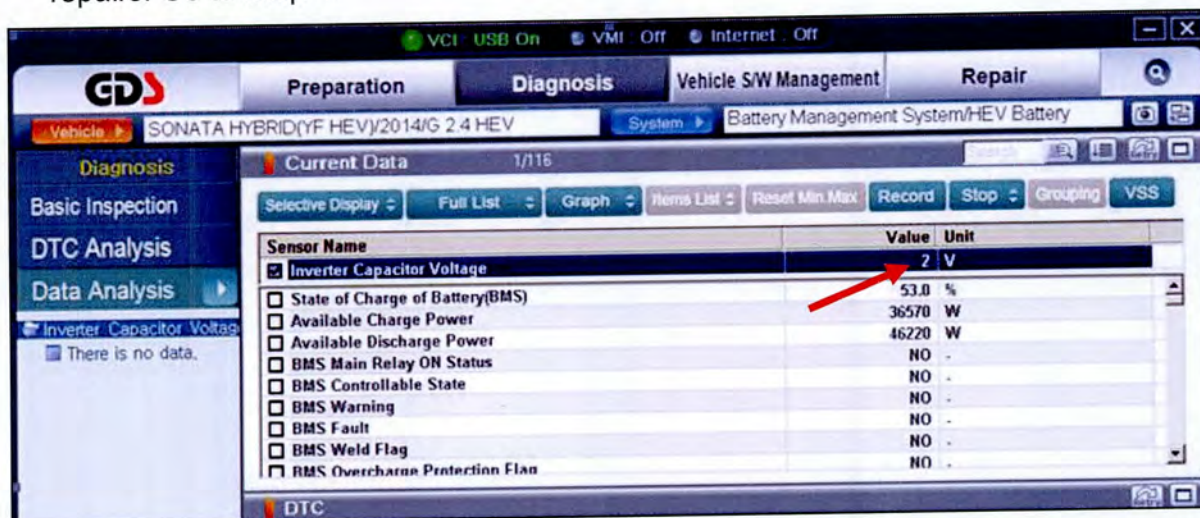
Attach a GDS and select **BMS** menu, **Current Data** and **Inverter Capacitor Voltage**. Confirm the **Inverter Capacitor Voltage** is less than 30V.

- If less than 30V, the system voltage is safe for the technician. Turn off the ignition and disconnect the 12 volt negative battery cable. Go to Step 4.
- If more than 30V, wait until the voltage is within specification before performing any repairs. Go to Step 4.

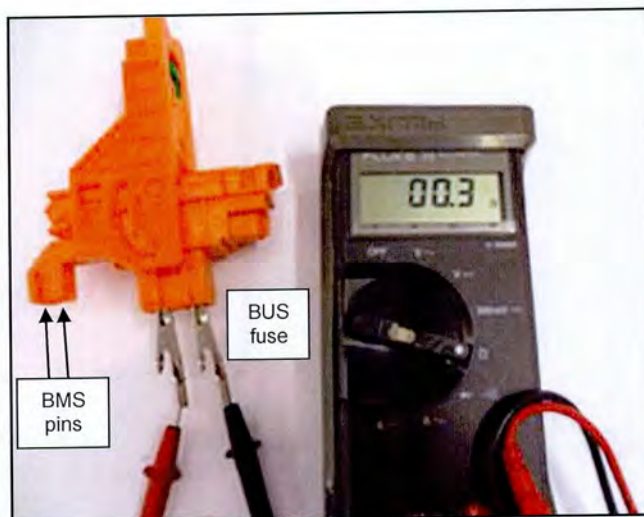
4. Use a DVOM to measure the resistance of the BUS fuse inside the safety switch.

Measure the resistance between the BMS pins.

Specification: 1Ω or less

- Not within specification, replace the safety plug.
- Within specification, go to Step 5.

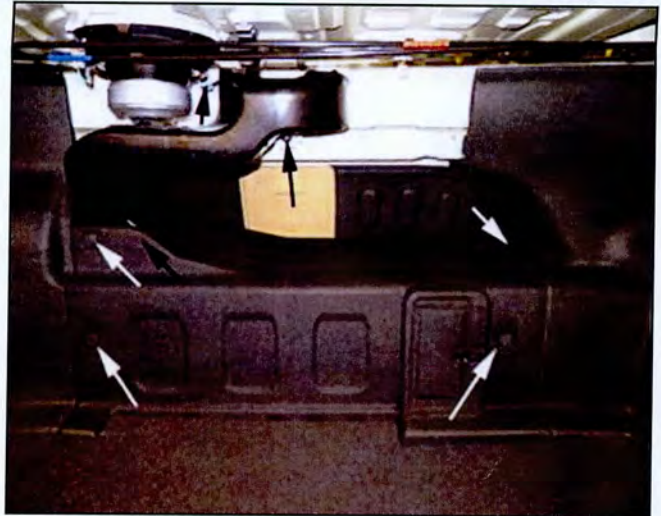
5. Remove 4 fasteners and remove the carpet trim (white arrows). Refer to BD Section, Interior, of the shop manual.

Remove 3 nuts securing the air duct and remove the air duct (black arrows).

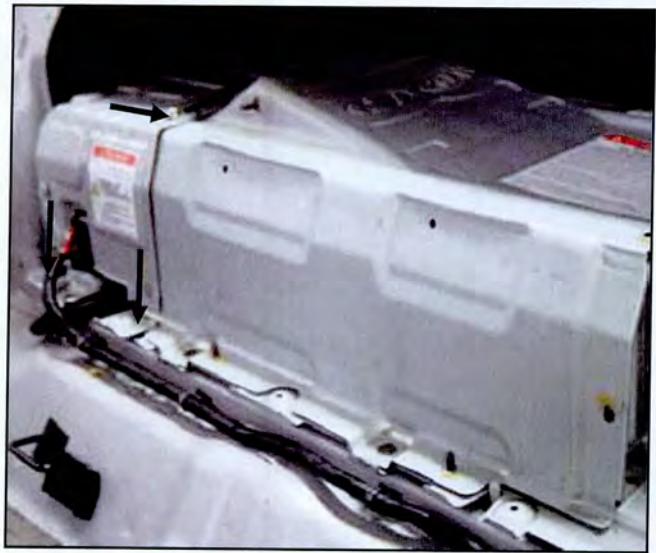
6. Remove the nuts and bolts securing the steel cover and remove the cover for the PRA.

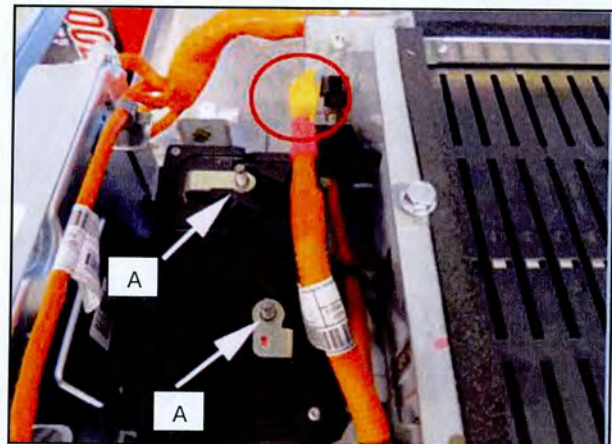
Remove the high voltage cables (A) and wrap the cable ends with insulation tape (red circle).

5.8~8.7 lb-ft (0.8~1.2 kgf.m, 7.8~11 N.m)

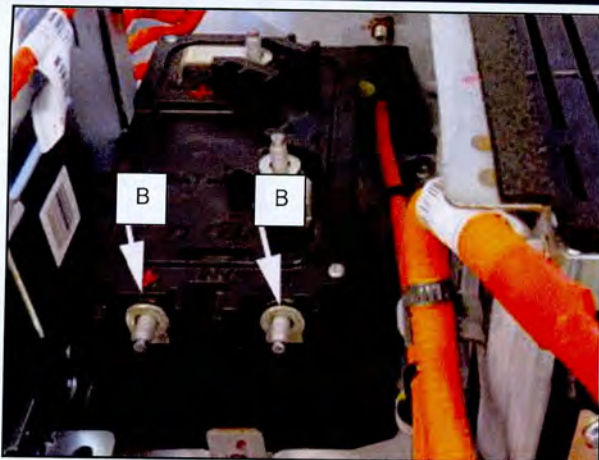
8. Remove the inverter cables (B) on the side of the PRA.

Torque:
5.8~8.7 lb-ft (0.8~1.2 kgf.m, 7.8~11 N.m)

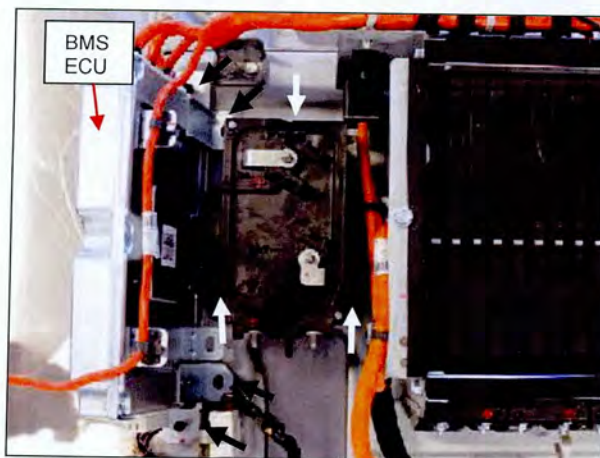
9. Loosen four nuts (black arrows) and tilt the BMS ECU to the left to provide clearance between the PRA.

Remove 3 mounting nuts (white arrows) and remove the PRA. Install a new PRA.

Torque:
5.8~8.7 lb-ft (0.8~1.2 kgf.m, 7.8~11 N.m)
