Service Action **REVISION**

Code: 97AM

Subject: 2009-2010 MY Jetta Sedan and 2009 MY GTI
Fuse (Plug-in Position F16)

May 06, 2014

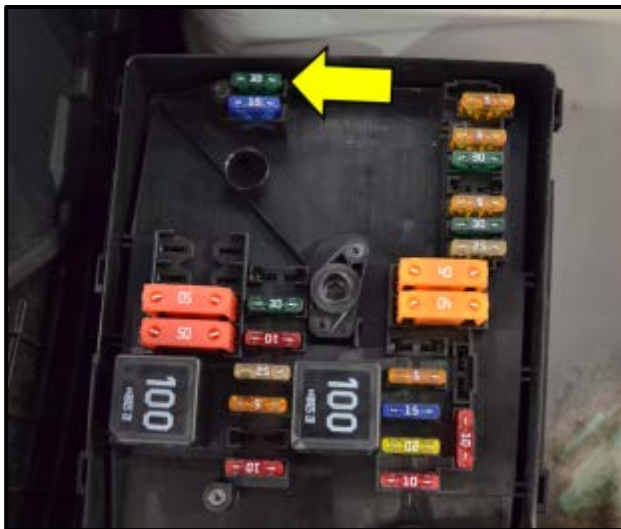
- Open the hood.
- ⇐ Disengage the two locking tabs <arrows> and remove cover from the SA/SB fuse panel.

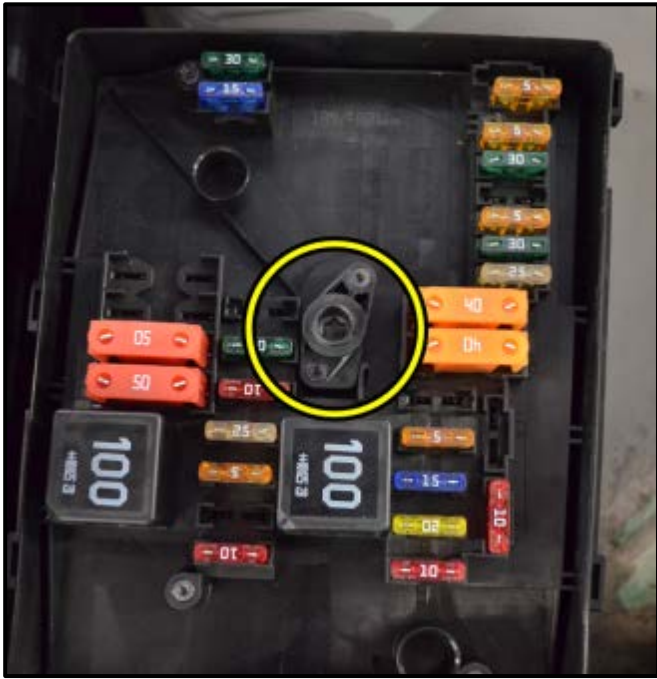
- Disconnect and isolate the negative battery cable.
- ⇐ Remove the hex nuts from the SA fuse panel connections where shown <circles>.

i Tip: Note the location of all wires attached in this step prior to disassembly. Wire locations may vary based on model year and vehicle equipment.

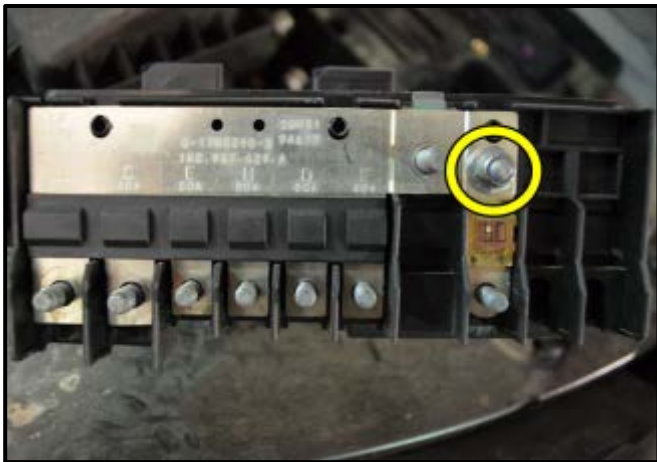
⇐ Remove the fuse panel mounting screw <circle>.

- Remove the upper SA/SB fuse panel from the vehicle.
