SERVICE ADVISORY # 14-211

Bullet 310BHS Exterior Shower

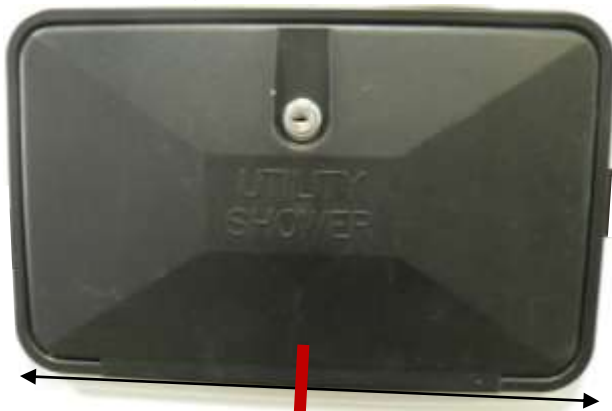
Figure 1

It has been determined that certain Bullet model 310BHS are missing a door stop on the exterior shower located above the water heater. The missing stop will allow the shower door, when in the open position, to contact the water heater exhaust grill leading to the potential for heat damage to the exterior shower door when the water heater is in operation. This service advisory explains how to correct the installation.

Step 1 Locate the center-bottom of the exterior shower. See Figure 1. Apply butyl to Bumper (KRV #318416) and install under bottom-center of exterior shower enclosure. See Figures 2, 3, & 4.
