Program Bulletin

SB-10056450-4367

CUSTOMER SATISFACTION PROGRAM

SUBJECT: Illuminated Door Handles

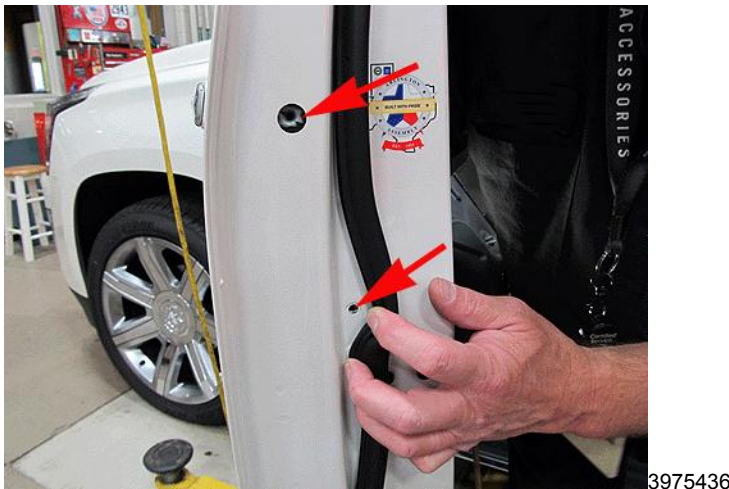
NOTE: The left front door may have an anti-tamper bracket around the lock. This is indicated by two screws in the door frame area. Remove these screws along with one internal fastener and reposition the bracket to allow access to the door lock cylinder screw.

1. Remove the two front door outside handles. Refer to *Front Side Door Outside Handle Replacement (with ATH)* in SI.

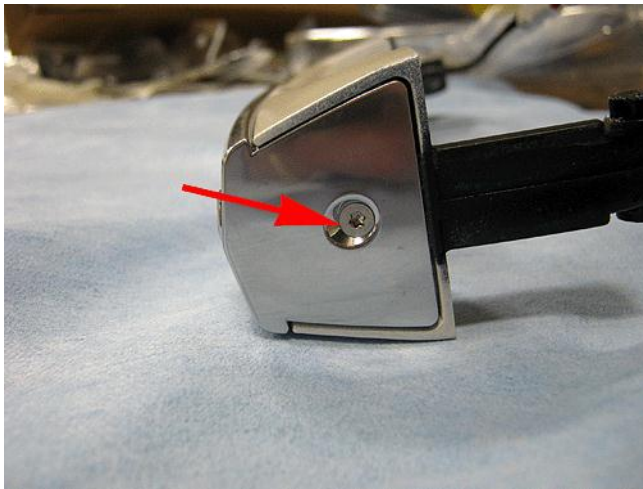
3975437

3. Remove the fastener at the rear of the handle.

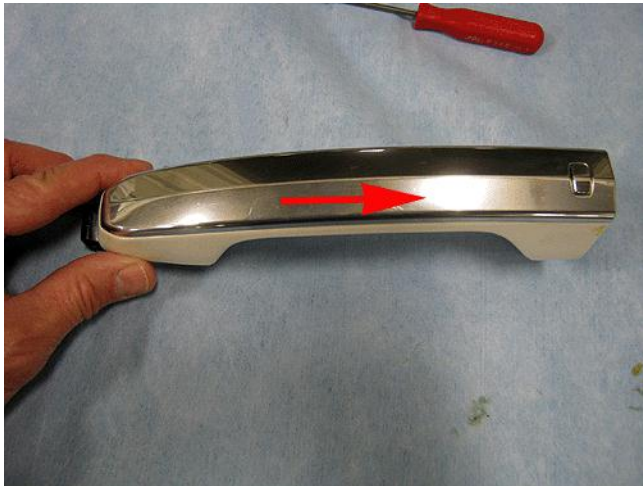
3975439

4. Slide the insert out of the handle.

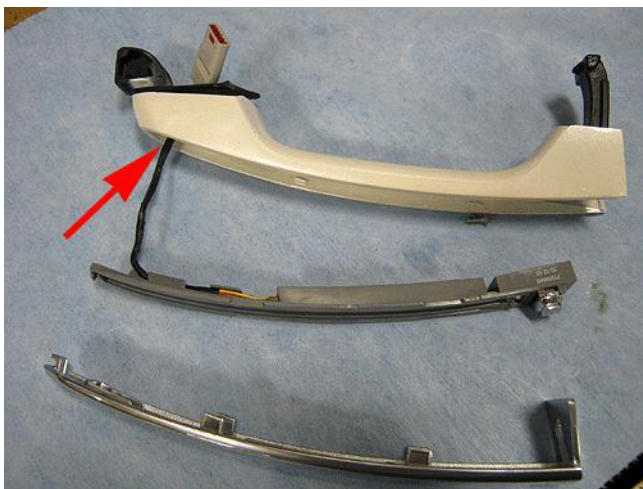
3975440

5. Install the new illuminated insert. Route the wiring harness through the handle seal as shown. The front door illuminated inserts have a 5 wire harness and connector, the rear door illuminated inserts have a 3 wire harness and connector.

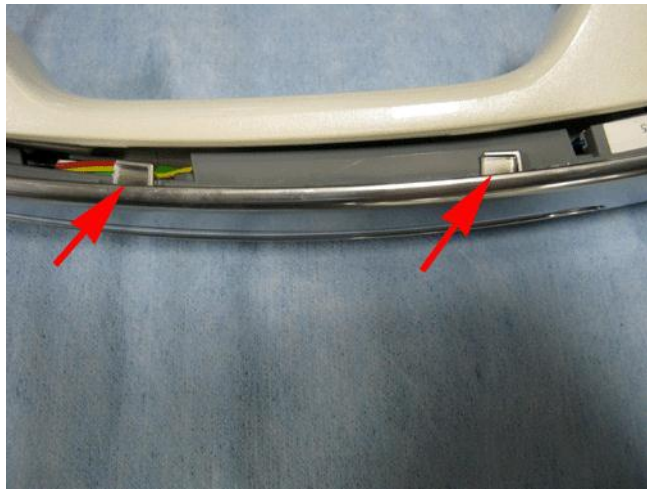
3975441

6. Ensure the 4 side attachment slots are aligned and fully engaged.
7. Reinstall the two front door outside handles. Refer to *Front Side Door Outside Handle Replacement (with ATH)* in SI (Reinstall the anti-tamper bracket if required). Ensure the illumination wiring harness is connected.
8. Reinstall the two rear door outside handles. Refer to *Rear Side Door Outside Handle Replacement (with ATH)* in SI. Ensure the illumination wiring harness is connected.
