GROUP ENG	MODEL 2015MY Sorento (XMa) Optima (QF)
	NUMBER 143 (REV 1, 09/18/2014)	DATE September 2014
TECHNICAL SERVICE BULLETIN		
SUBJECT: SERVICE ACTION: ENGINE CRANKSHAFT PULLEY AND BOLT REPLACEMENT (SA170)

SUBJECT: SERVICE ACTION: ENGINE CRANKSHAFT PULLEY AND BOLT REPLACEMENT (SA170)

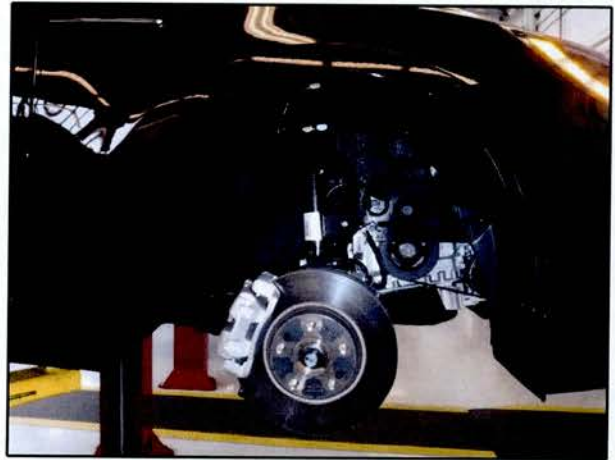
1. Place the vehicle on the lift and remove the right front tire.

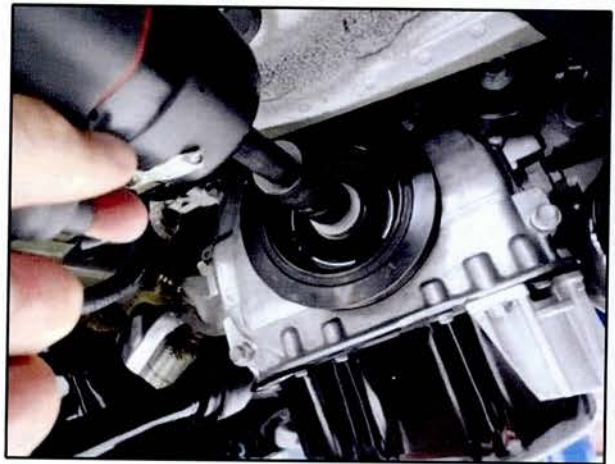
4. Remove and discard the crankshaft pulley bolt.

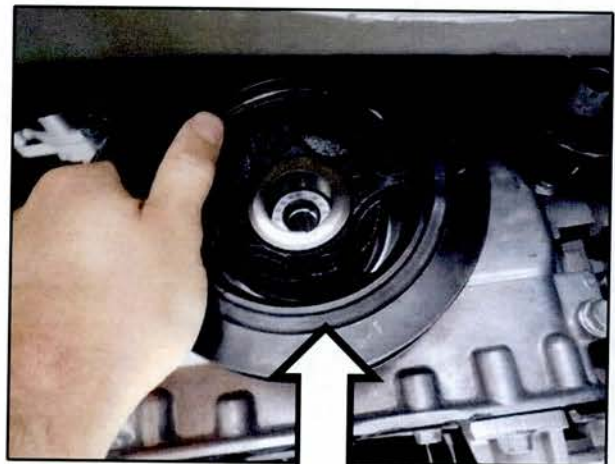
5. Remove and discard the crankshaft pulley. If necessary, use a harmonic balancer puller to remove the crankshaft pulley. In most cases, the puller will not be required.

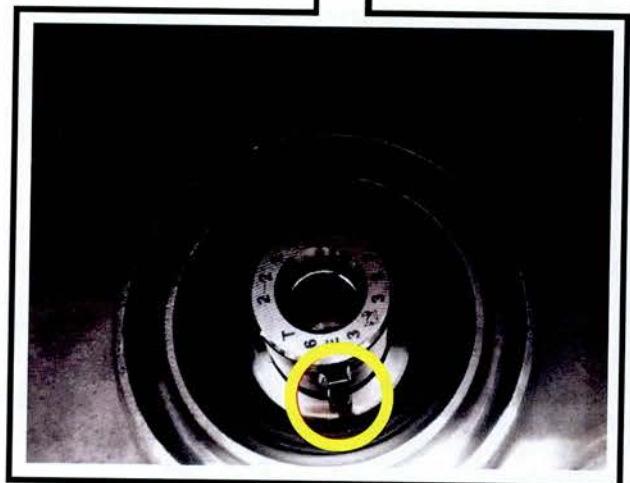
Pay particular attention during removal of the Woodruff key to prevent it from falling into the engine through the front seal.

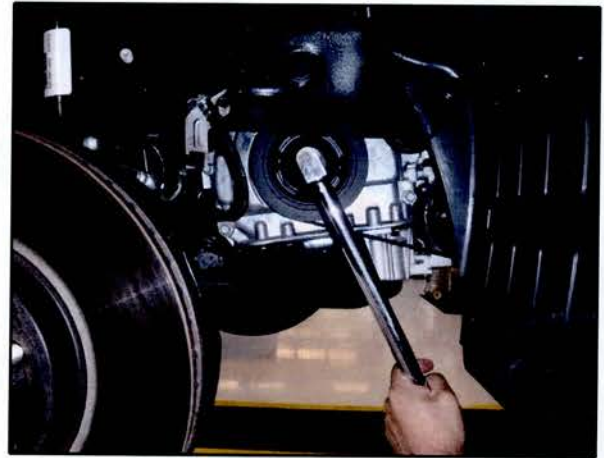
- 6. Install the new crankshaft pulley and new crankshaft pulley bolt supplied in the kit and tighten to specification using a torque wrench. For detailed reinstallation procedures requiring the flywheel/flexplate to be held stationary, refer to:

Tightening Torque
122.8 ~ 130.1 lb-ft (166.6 ~ 176.4 Nm)

Do NOT, under any circumstances, use an electric or air powered impact gun to install the crankshaft retaining bolt; bolt failure can occur and cause engine damage.

The crankshaft bolt is a “one-time” use bolt and must be replaced every time it is removed after it was torqued to specification!

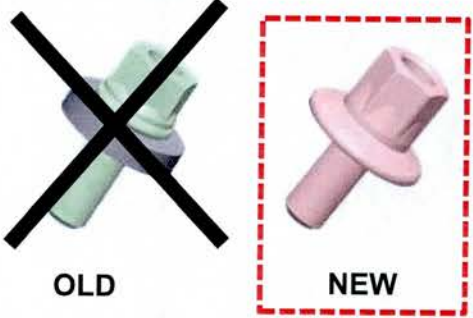
OLD NEW

The replacement bolt and washer will be a one piece design. Do NOT use the two piece design.

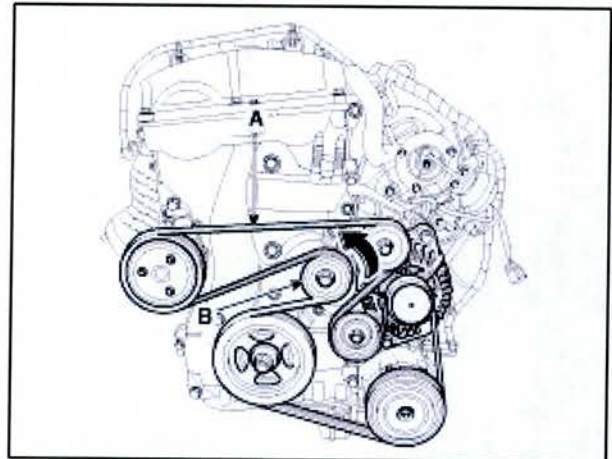
- 8. Refer to the Service Information on KGIS to correctly route the engine serpentine drive belt and to reinstall all removed components. **Make sure the wheel lug nuts are torqued to the specification shown below:**

Tightening Torque
65.1~ 79.6 lb-ft (88.3 ~ 107.9 Nm)

- 9. Road test the vehicle and inspect for any fluid leaks, prior to returning the vehicle to the customer or dealership sales lot.
