To: All Toyota Region General Managers/Vice Presidents
From: Bob Waltz, *Bob Waltz*
Group Vice President, Product Quality and Service Support
Subject: Limited Service Campaign (LSC) E0U
2007-2011 Model Year Camry Hybrid Vehicles
Brake Reservoir Tank Replacement

TECHNICAL INSTRUCTIONS
FOR
LIMITED SERVICE CAMPAIGN E0U
2007 – 2011 MODEL YEAR CAMRY HV
BRAKE RESERVOIR REPLACEMENT

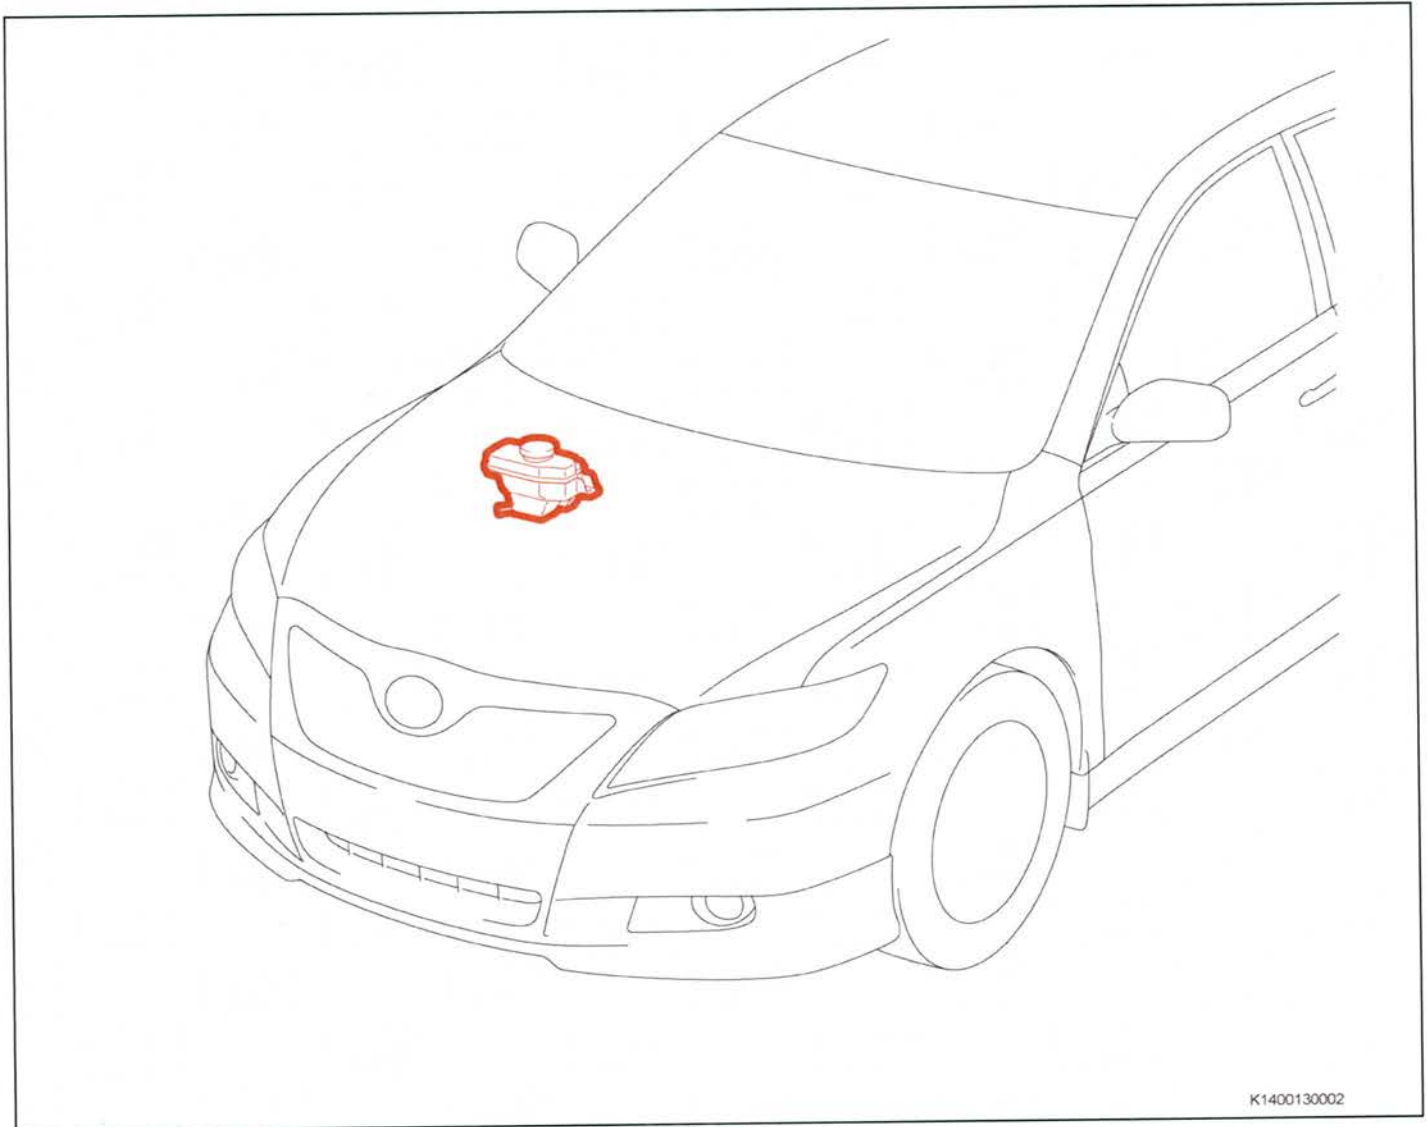
IV. BACKGROUND

In 2007 through 2011 model year Toyota Camry hybrid vehicles, the front brake assist may be lost while the rear brake continues to be operated with normal assist. In that situation some warnings appear as below.

1. The Brake system warning lights in yellow and red
2. ABS warning light
3. Master warning light
4. Slip indicator
5. "CHECK VSC SYSTEM" in the Multi-information display

After these warning lights illuminating for 10 seconds, the brake assist for the front brake would be lost as described at the top of this paragraph.

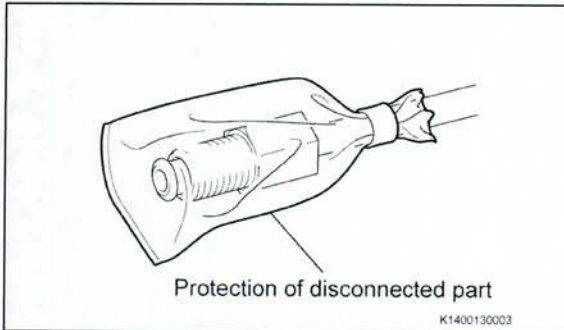
1. PREVENTION OF FOREIGN MATTER FROM GETTING INTO BRAKE SYSTEM

- a) After disconnecting the brake system parts, use a cover to prevent intrusion of foreign matters.

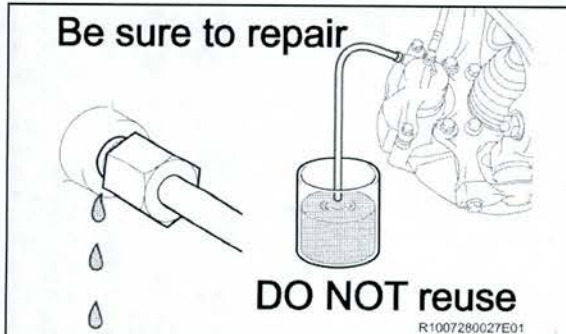
2. HANDLING OF BRAKE FLUID

- a) **DO NOT** reuse brake fluid. Brake fluid is hygroscopic and will absorb moisture that could cause a brake failure and cause an accident.

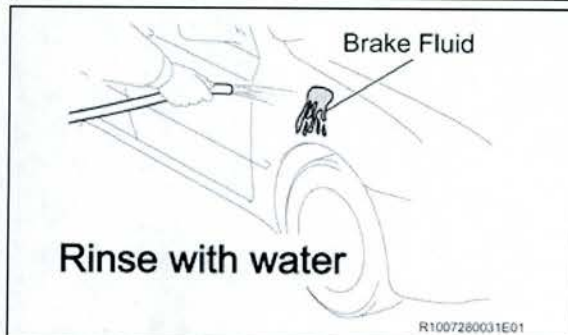
- b) Brake fluid damages paint. **DO NOT** allow brake fluid to contact any painted surface. If brake fluid adheres to a painted surface, immediately rinse it off with water.

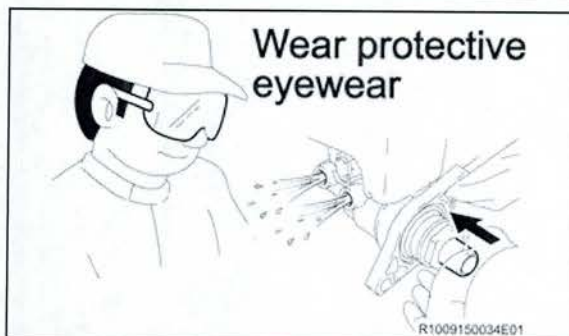
- c) Brake bleeding may cause brake fluid to spray outwards. Wear protective eyewear when bleeding the brakes.

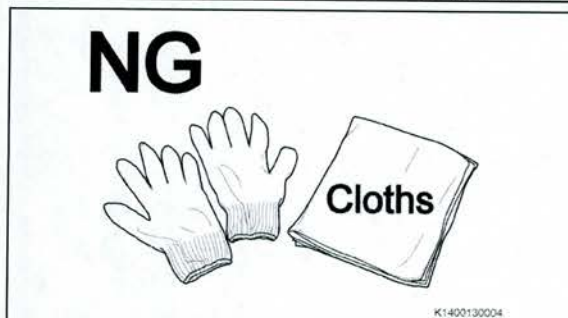
3. DO NOT USE CLOTH RAGS OR GLOVES

- a) **DO NOT** use any fabric near open brake system components, to avoid threads and fibers from entering the braking system.

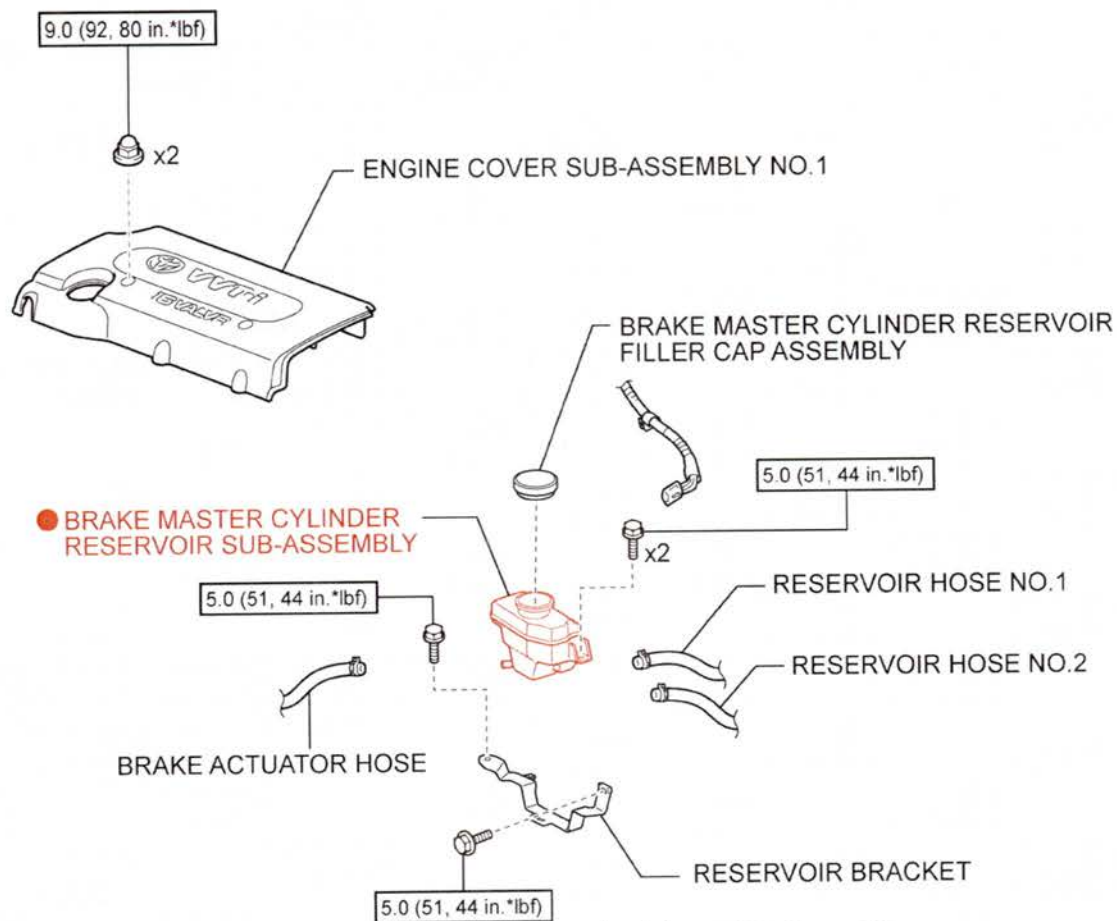
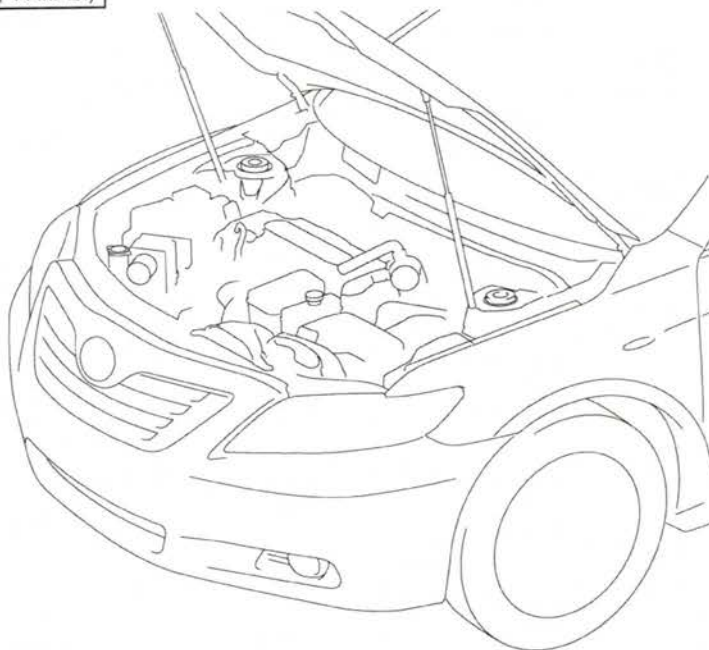
VI. COMPONENTS

● : Replacement part

N*m (kgf*cm, ft.*lbf) : Specified torque

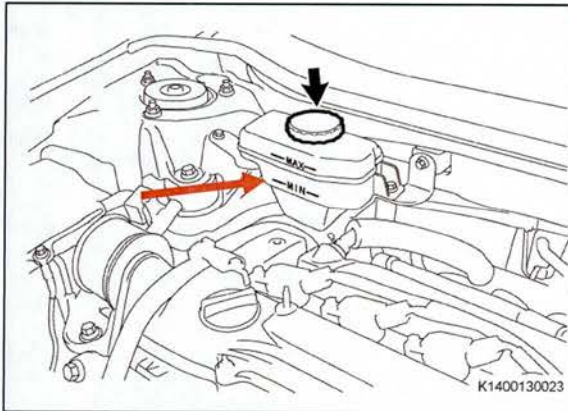
2. LOWER THE BRAKE FLUID LEVEL

- Remove the brake reservoir filler cap.
- Lower the brake fluid level to MIN.

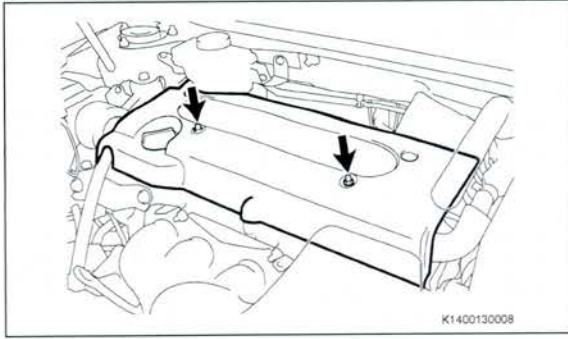
4. REMOVE THE ENGINE COVER SUB-ASSEMBLY NO.1

- a) Remove the 2 nuts
- b) Remove engine cover sub-assembly No.1.

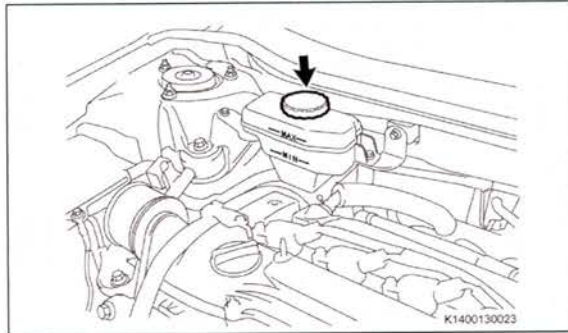
5. DRAIN BRAKE FLUID

- a) Remove the brake reservoir filler cap.

The brake reservoir filler cap will be re-used.

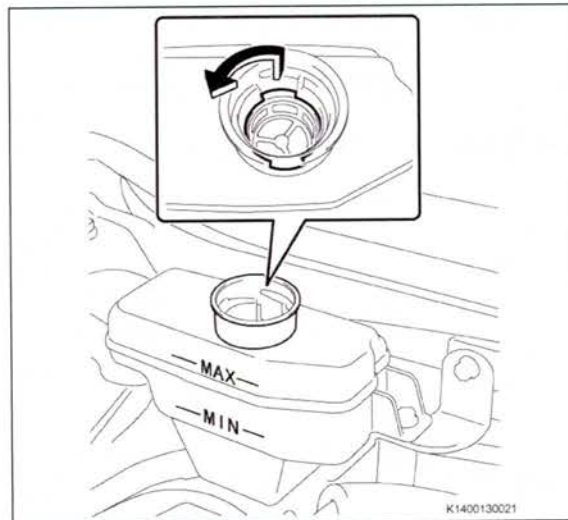
- b) Remove the brake reservoir strainer, and drain the brake fluid from the reservoir to prevent spillage.

- c) Mark the removed brake reservoir strainer so it is not reused.

- **DO NOT** use a fluid extractor that has been used on anything other than brake fluid to avoid contamination.
- **DO NOT** allow brake fluid to contact any painted surfaces.

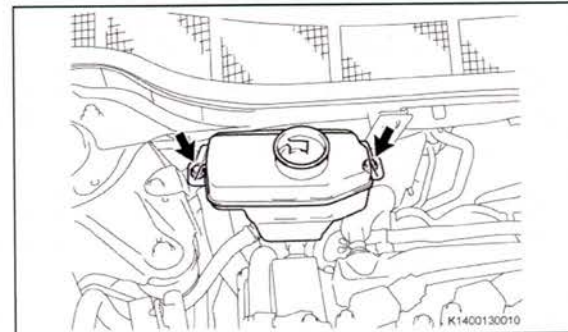
6. REMOVE THE BRAKE MASTER CYLINDER RESERVOIR

- a) Remove the 2 bolts.

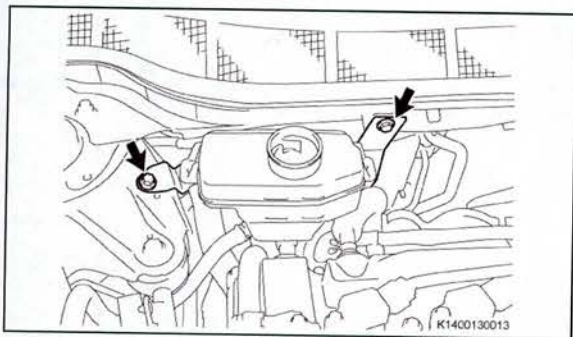
- b) Remove the 2 bolts, and separate the reservoir bracket from the brake reservoir.

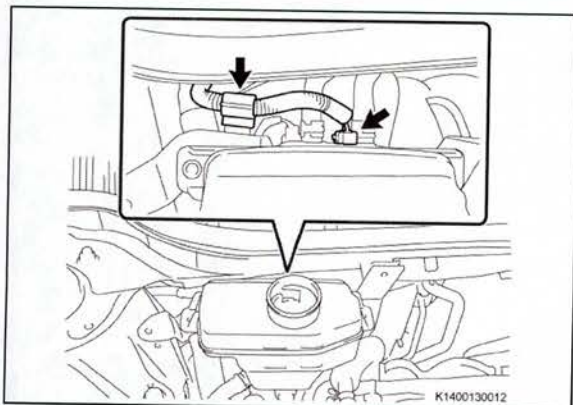
- c) Detach the harness clamp and disconnect the connector.

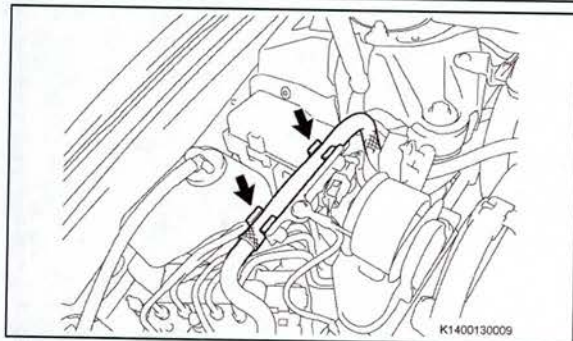
- d) Detach the brake actuator hose from the 2 clamps.

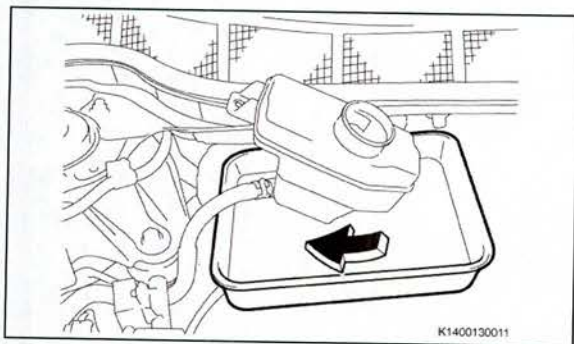
- e) Place a tray under the brake reservoir.

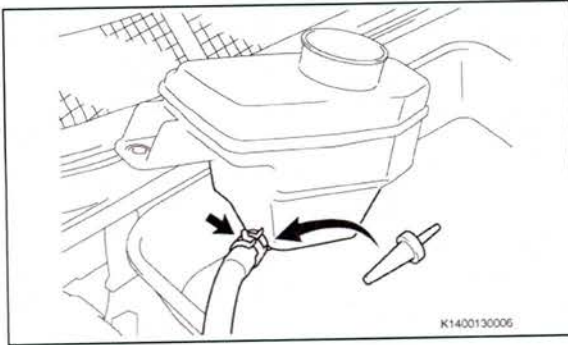
- f) Slide back the hose clip, disconnect, and immediately plug the brake actuator hose.

NOTE: Clean the surrounding area prior to disconnecting the hose

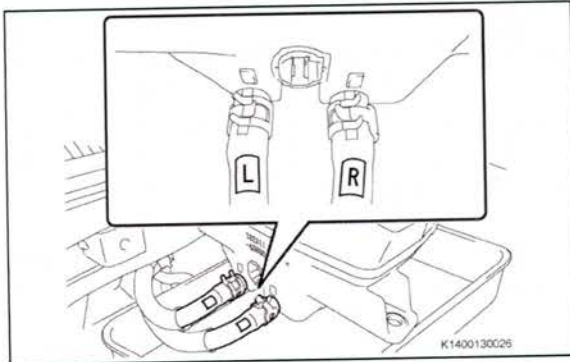
- g) Apply tape and mark the reservoir hoses to distinguish between left and right.

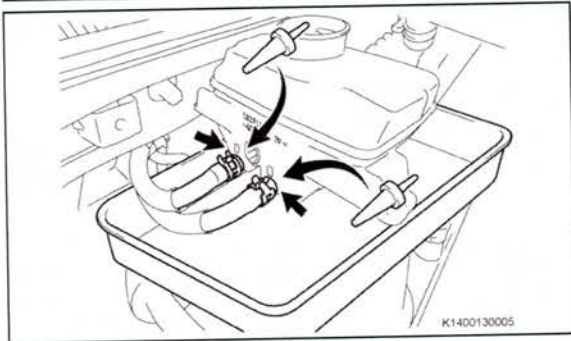
- h) Slide back the 2 hose clips, disconnect, and immediately plug the 2 reservoir hoses.

NOTE: Clean the surrounding area prior to disconnecting the hose.

- i) Remove the brake reservoir.

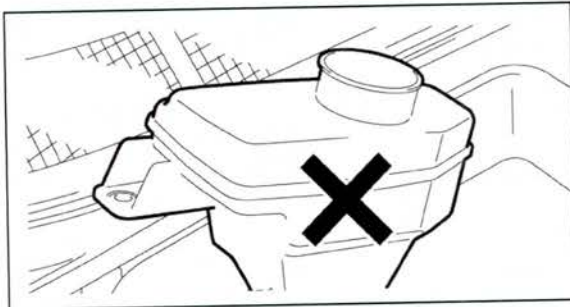
- j) Mark the brake reservoir so it is not reused.

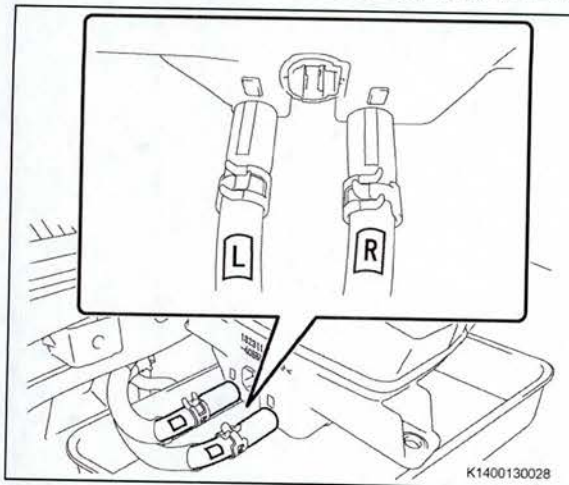
1. INSTALL THE NEW BRAKE RESERVOIR

- a) Reinstall the left and right side hoses, remove the 2 hose plugs and reconnect the reservoir hoses to the **NEW** brake reservoir.

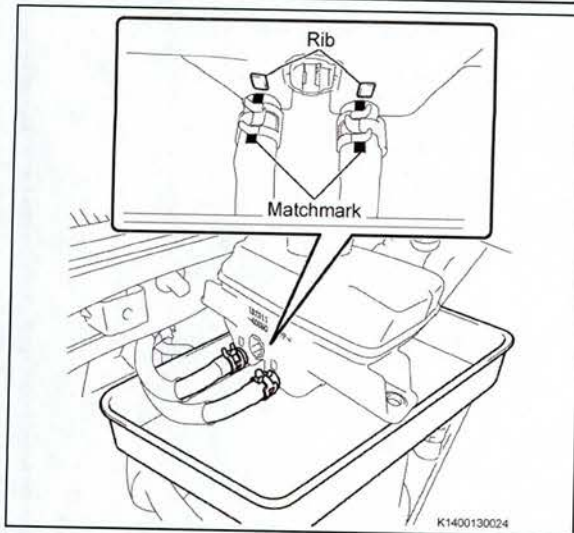
- b) Align the matchmarks on the 2 reservoir hoses and the ribs on the new brake reservoir.

- c) Slide on the 2 hose clips to secure the hoses.

Connect the hose immediately after removing the plug to prevent brake fluid from leaking.

Reinstall the hose clips into their original positions.

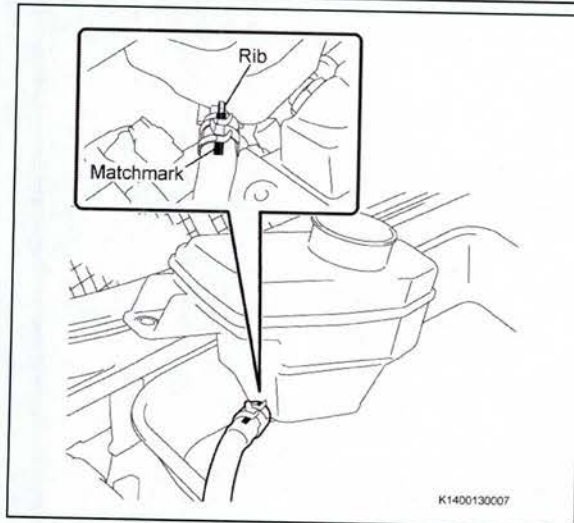
- e) Remove the hose plug and reconnect the brake actuator hose to the brake reservoir.

- f) Align the matchmark on the hose and the rib on the brake reservoir.

Connect the hose immediately after removing the plug to prevent brake fluid from leaking.

Install the hose clips into their original positions.

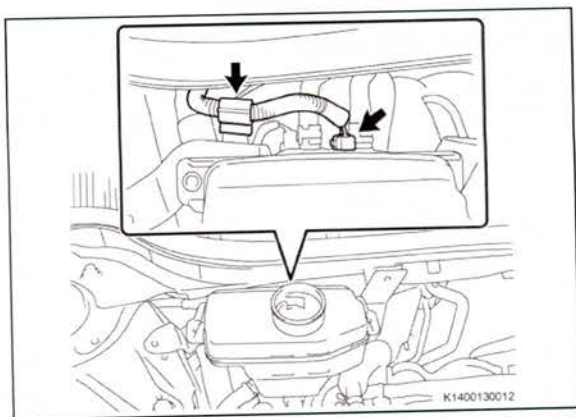
- h) Reconnect the connector, and attach the harness clamp to the reservoir bracket.

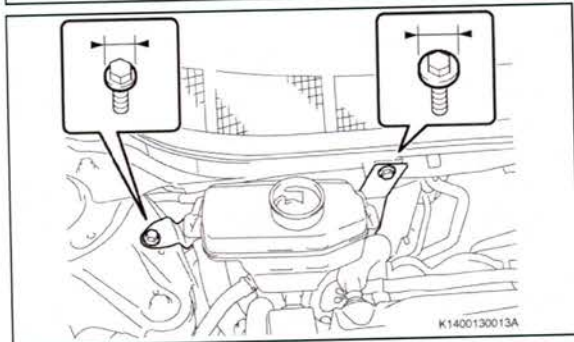
- i) Reinstall the reservoir bracket with the 2 bolts.

Torque: 5.0 N*m (51 kgf•cm, 44 in.•lbf)

NOTE: Each of the bolts have a different bolt head/washer design.

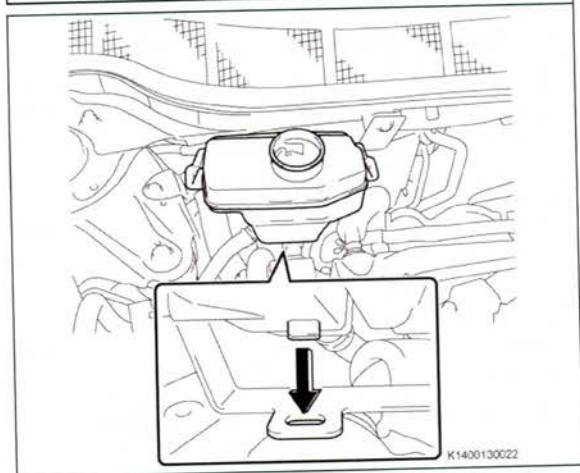
- j) Align the guide and install the brake reservoir with the 2 bolts.

Torque: 5.0 N*m (51 kgf•cm, 44 in.•lbf)

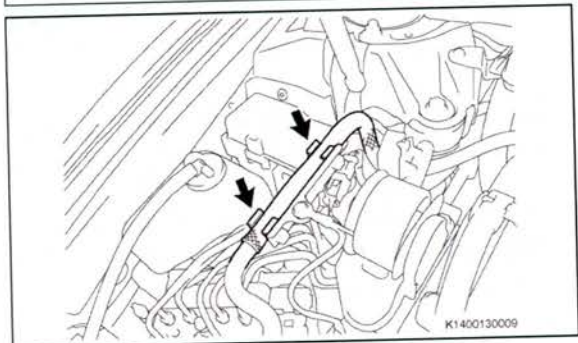
- k) Reattach the brake actuator hose to the 2 clamps.

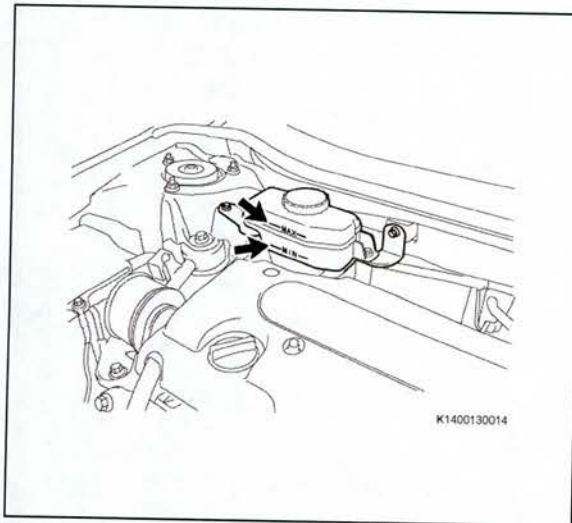
1. RAISE THE VEHICLE AND REMOVE THE WHEELS
2. ADD BRAKE FLUID TO THE RESERVOIR

- a) Add brake fluid to the MAX line of the reservoir.

NOTE: Add brake fluid carefully and check that the reservoir level remains between the MIN and MAX lines while bleeding the brakes.

DO NOT stand the fluid can on the reservoir inlet when air-bleeding the brake actuator. Doing so will cause brake fluid to overflow.

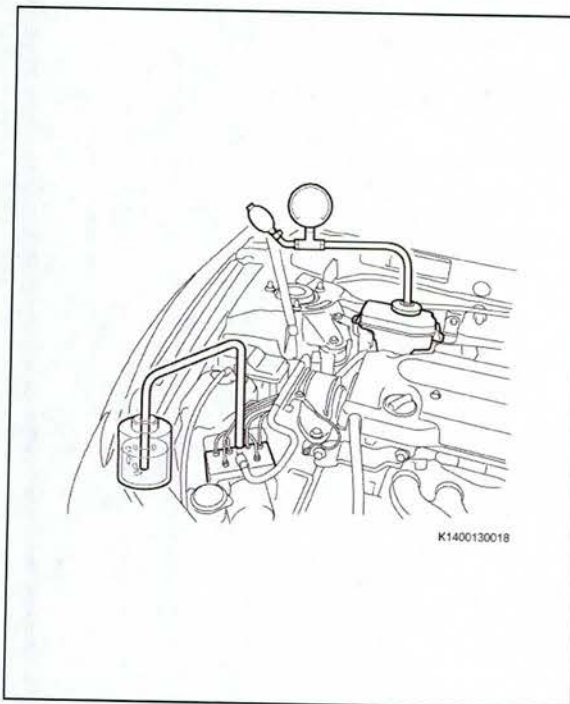
3. BLEED AIR FROM THE BRAKE ACTUATOR HOSE

- a) Connect the SST to the reservoir with the brake reservoir pressure adapter.

- b) Connect a vinyl tube to the bleeder plug of the actuator.
- c) Quickly loosen the bleeder plug of the actuator, then tighten it lightly to release.
- d) While the bleeder plug is loosened, use the SST to boost pressure in the reservoir and drain approximately 500 cc (16.9 fl.oz.) of fluid.

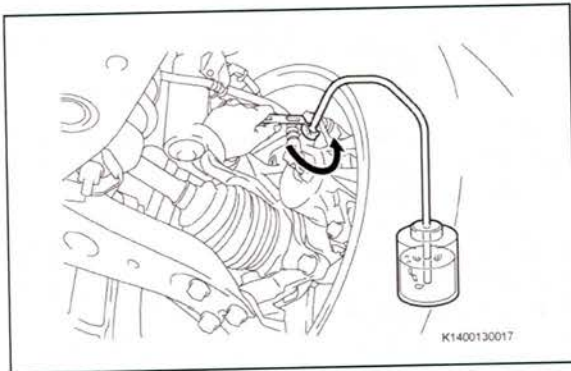
5. BLEED THE FRONT BRAKE SYSTEM

Torque: 8.3 N*m (85 kgf*cm, 74 in.*lbf)

- Repeat procedure on the other side.

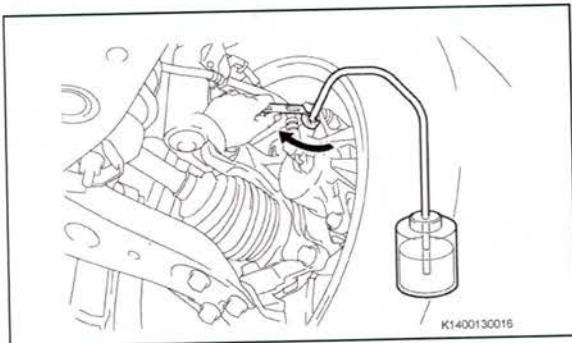
6. BLEED THE REAR BRAKE SYSTEM
