SB-10056520-1881

Volume: XIX
Number: TC14-015
Date: 07/24/2014
 Action
 Retain
 Information

Group Vice President, Product Quality and Service Support
Subject: Limited Service Campaign (LSC) E0J
Certain 2013 – 2014 Model Year Avalon and Avalon Hybrid Vehicles
Driver and Passenger Front Seatback Board

TECHNICAL INSTRUCTIONS
FOR
LIMITED SERVICE CAMPAIGN E0J
FRONT SEATBACK COVER REPLACEMENT
CERTAIN
2013 - 2014 MODEL YEAR AVALON & AVALON HV

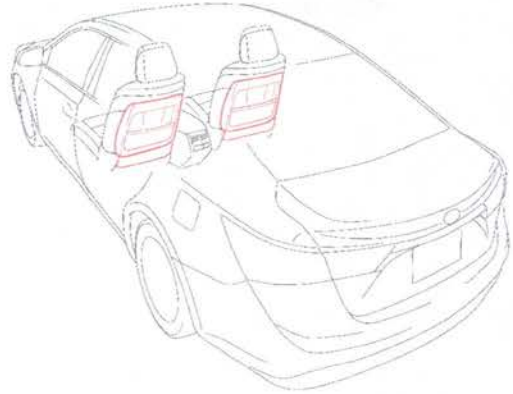
A1a: The plastic portion of the seatback which secures the retention clip can develop a crack resulting in a loose seatback board.

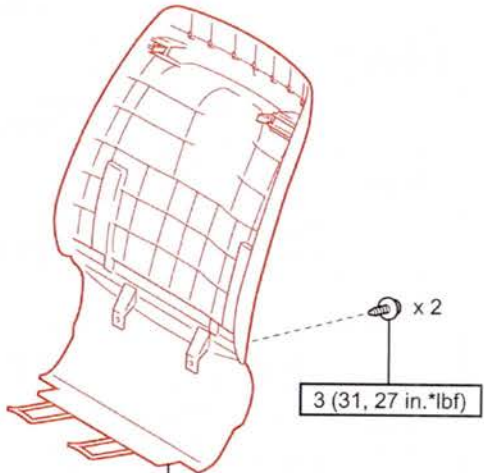
● FRONT SEATBACK BOARD
SUB-ASSEMBLY RH

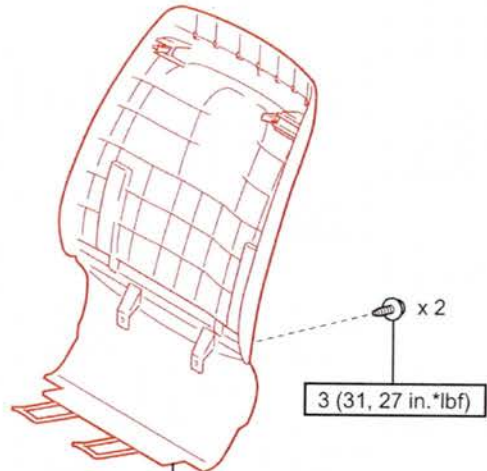
● FRONT SEATBACK BOARD
SUB-ASSEMBLY LH

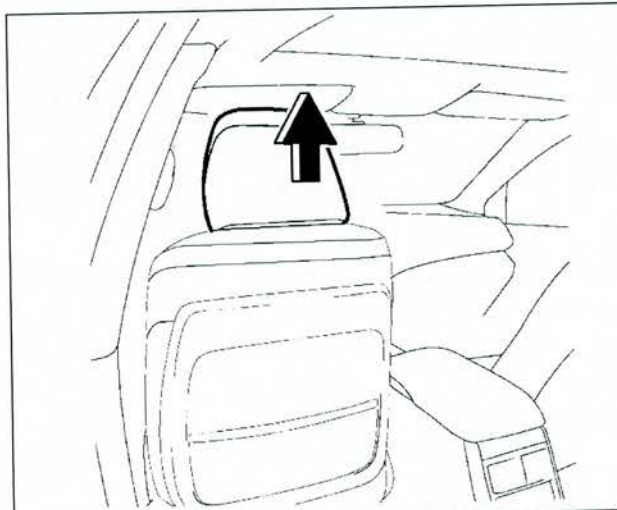
1. RECORD FRONT SEAT POSTION
2. REMOVE THE FRONT HEAD REST

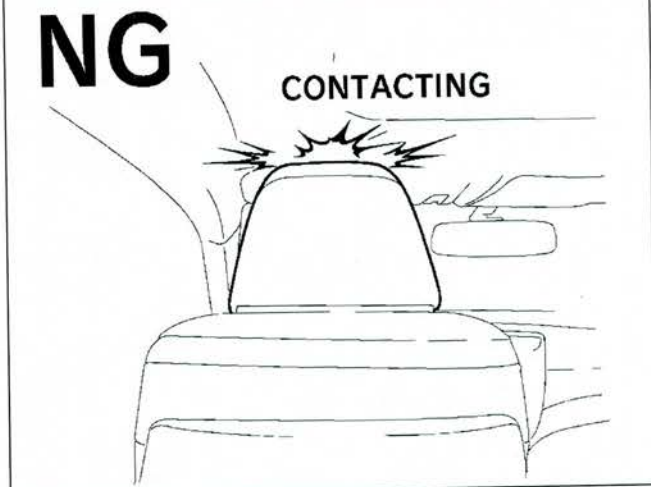
The headrest needs to be removed to prevent damaging the headliner, when the seat is in its uppermost position.

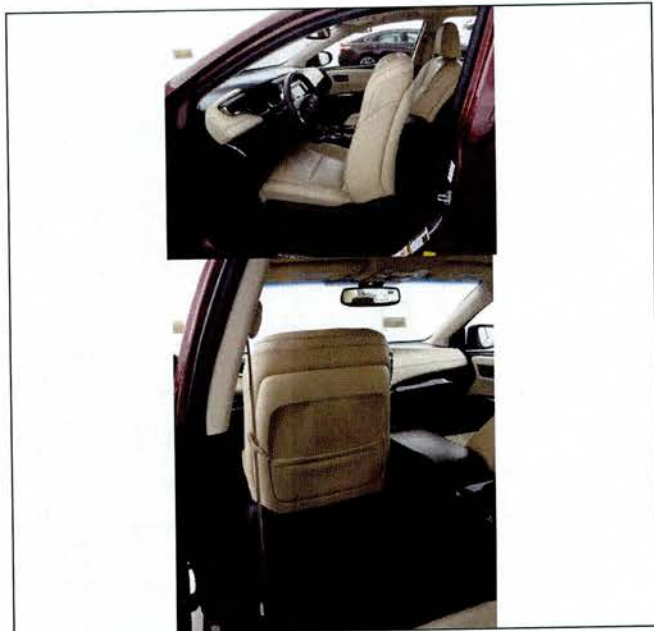
3. ADJUST SEAT POSITION

- a) Adjust the seat to the following:
 - The upper most position
 - The most forward position
 - The backrest to the most forward position

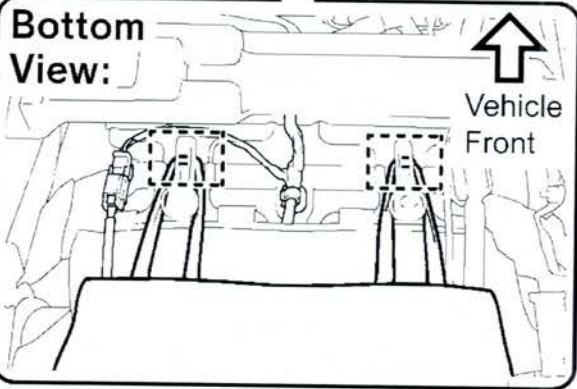
4. REMOVE THE FRONT SEATBACK COVER

Wear protective gloves. There are sharp edges that could injure your hands.

- a) Unhook the 2 straps for the seatback fabric cover from the 2 hooks underneath the bottom seat frame.

Note: Do not disturb the wiring for the seat SRS system.

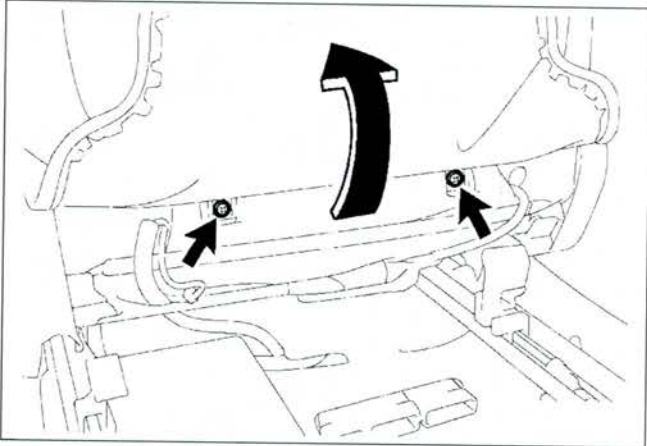
- b) Raise the cover and remove the 2 screws.

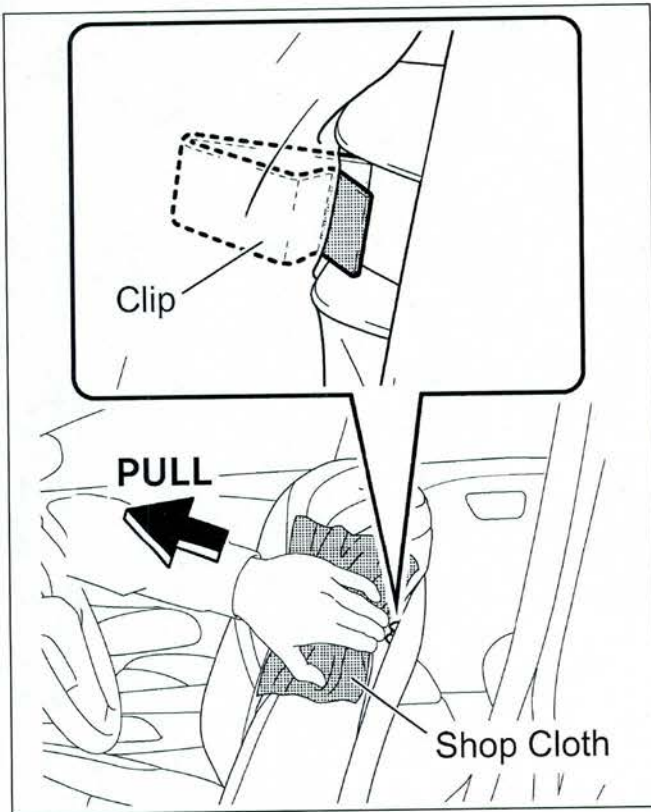
c) Cover the area shown with a clean cloth to prevent the seat cover from being damaged or soiled.

- Cover the area where the retainer clips are located. You may need to pull the seat fabric slightly forward to locate the clips.
- If necessary refer to the new seatback cover to locate the clips.

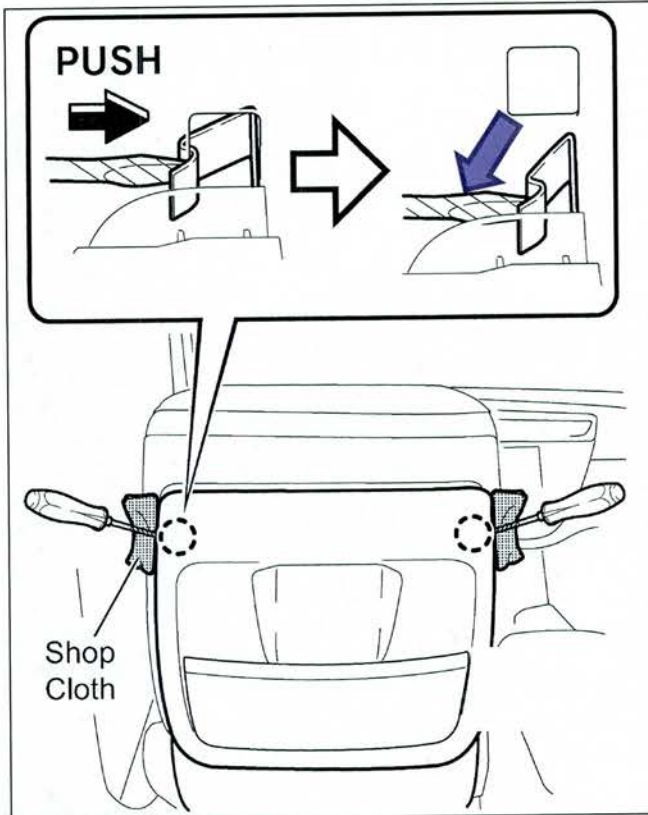
d) Using a clean screwdriver, wrap the tip with tape.

e) Carefully pull back on the top of the seatback cover enough to insert the screwdriver and release the clip on each side of the seatback cover.

f) After the 2 clips are disengaged tilt the top of the cover back.

Note: The clips may come out of there grooves and fall down to the bottom of the seatback cover.

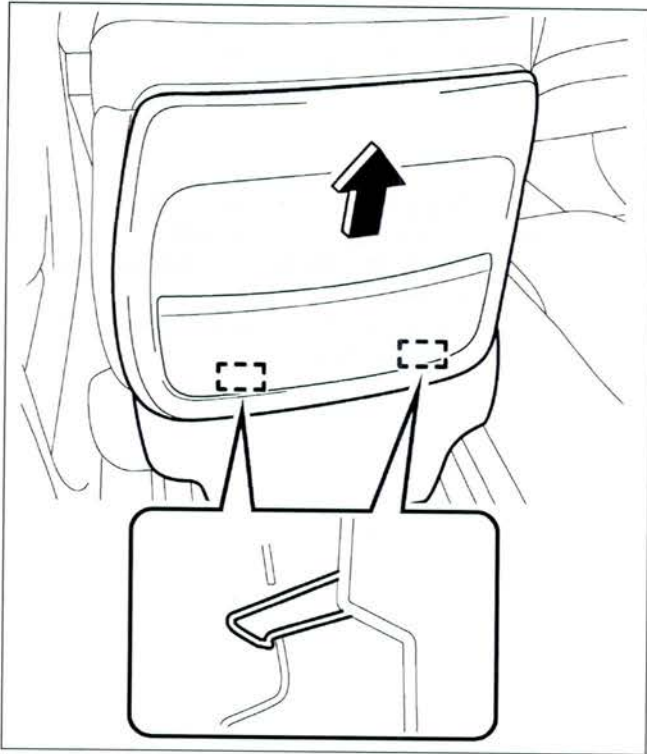
- g) Disengage the 2 lower guides as shown and remove the cover from the seat.
- h) Mark the old seatback cover so it cannot be reused.

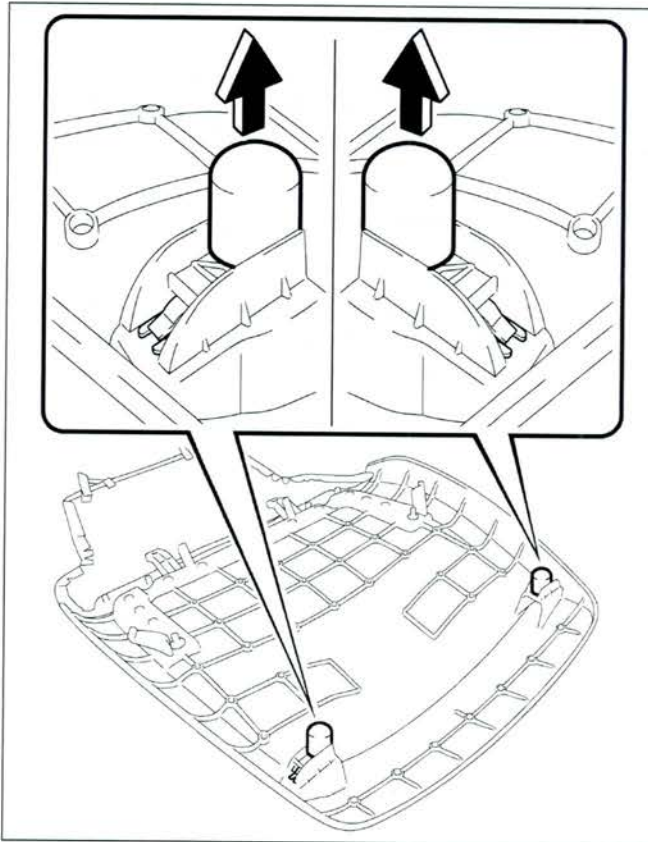
1. INSTALL THE NEW SEATBACK COVER

- a) Remove and discard the 2 rubber caps from the lower guides.

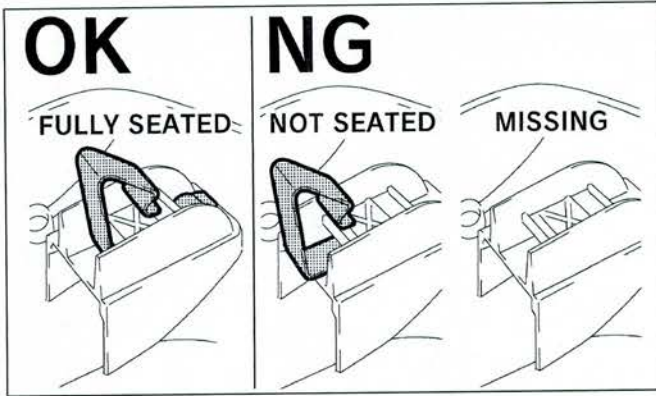
b) Check that the 2 clips are properly installed.

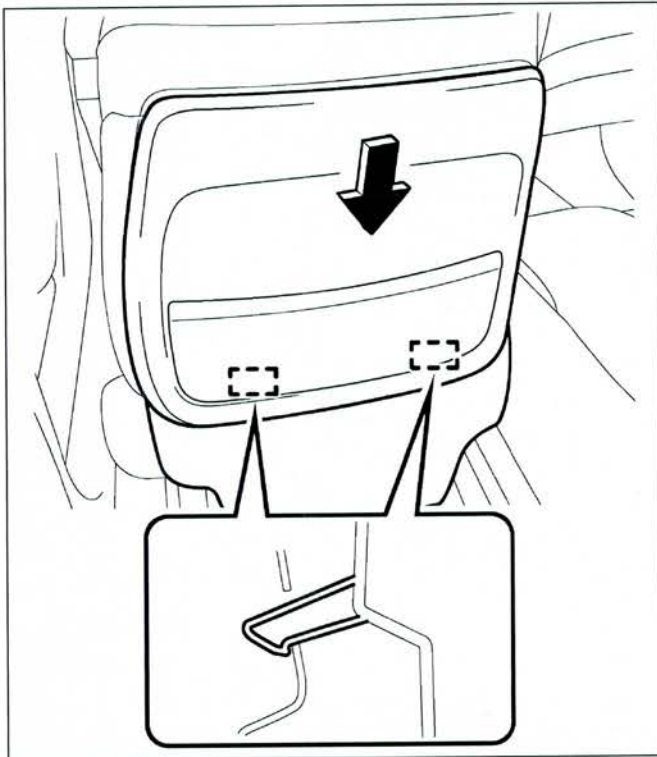
c) Engage the 2 lower guides into the backrest.

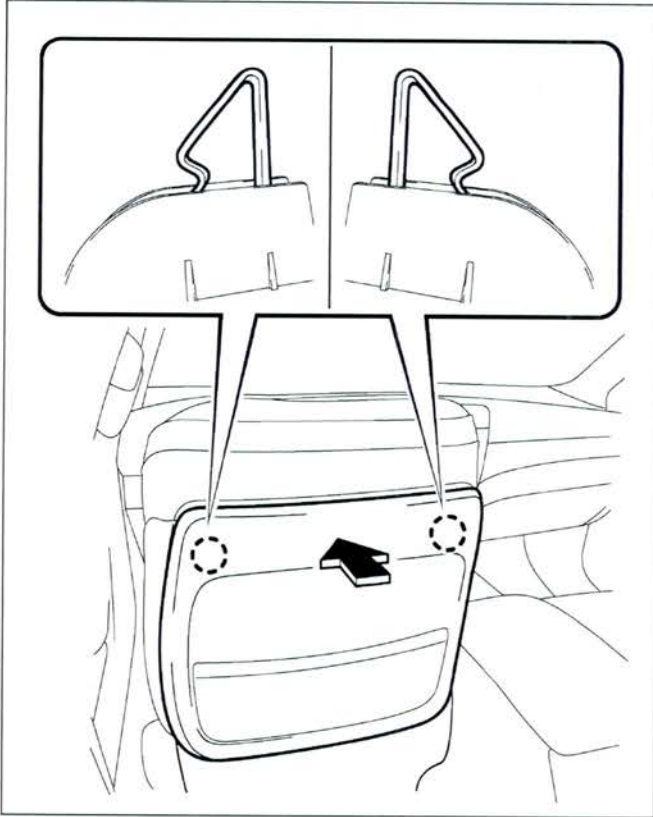
d) Push on the top of the cover until the 2 clips engage into the seatback.

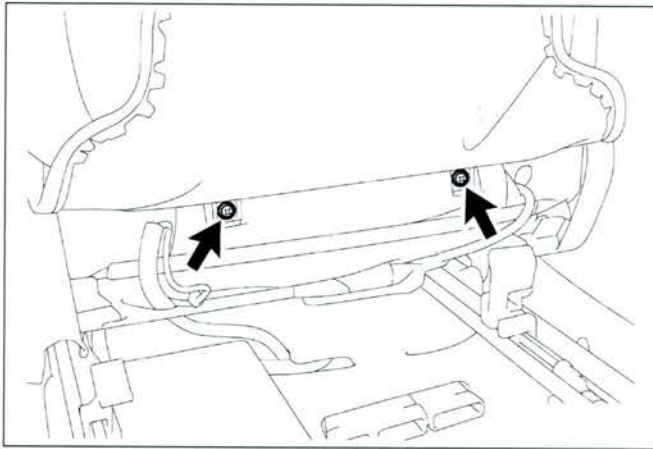
e) Reinstall the 2 screws.

Torque:
3.0 N m (31 kgf cm, 27 in lbf)

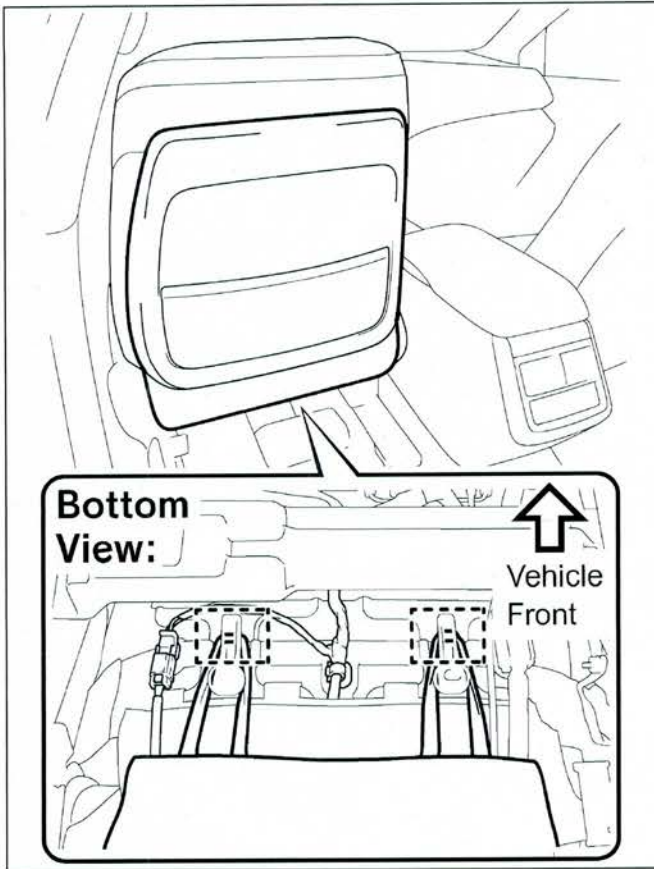
- f) Reconnect the 2 straps for the seatback fabric cover onto the 2 hooks on the bottom of the seat frame.

Note: When reconnecting the 2 straps do not disturb the seat wire harnesses.
