Service Bulletin

SB-10056599-9337

SUBJECT: Service Update for Inventory and Customer Vehicles
Contact between the Fuel Feed Line and the A/C Pipe
Expires with Base warranty

MODELS: 2013 – 2014 Chevrolet Trax with 1.4L Turbo engine

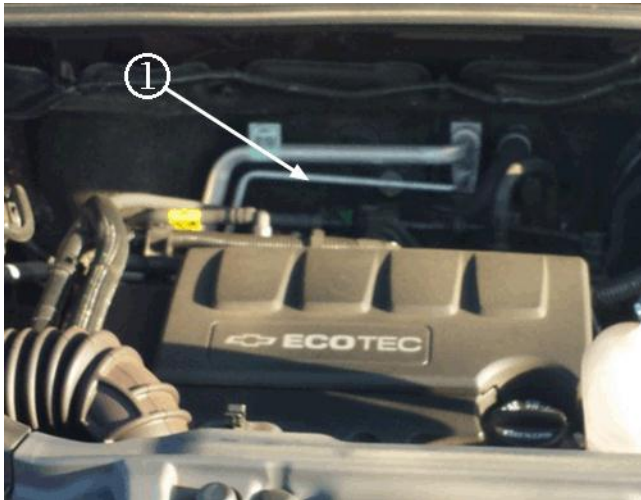
4004602

Certain vehicles may have been produced with insufficient clearance between the fuel feed line and the A/C pipe. Should these lines contact one another, the AC line may wear, possibly resulting in a refrigerant leak.

- b. Locate the A/C pipe (1) for inspection.
- c. Inspect the A/C pipe section (1) that is adjacent to the fuel hose (2):
 - i. If the A/C pipe does not show any sign of wear or damage, proceed to step 2.
 - ii. If the air conditioner pipe is worn or damaged, replace the A/C line, refer to *Air Conditioning Evaporator Hose Assembly Replacement Procedure* in SI.

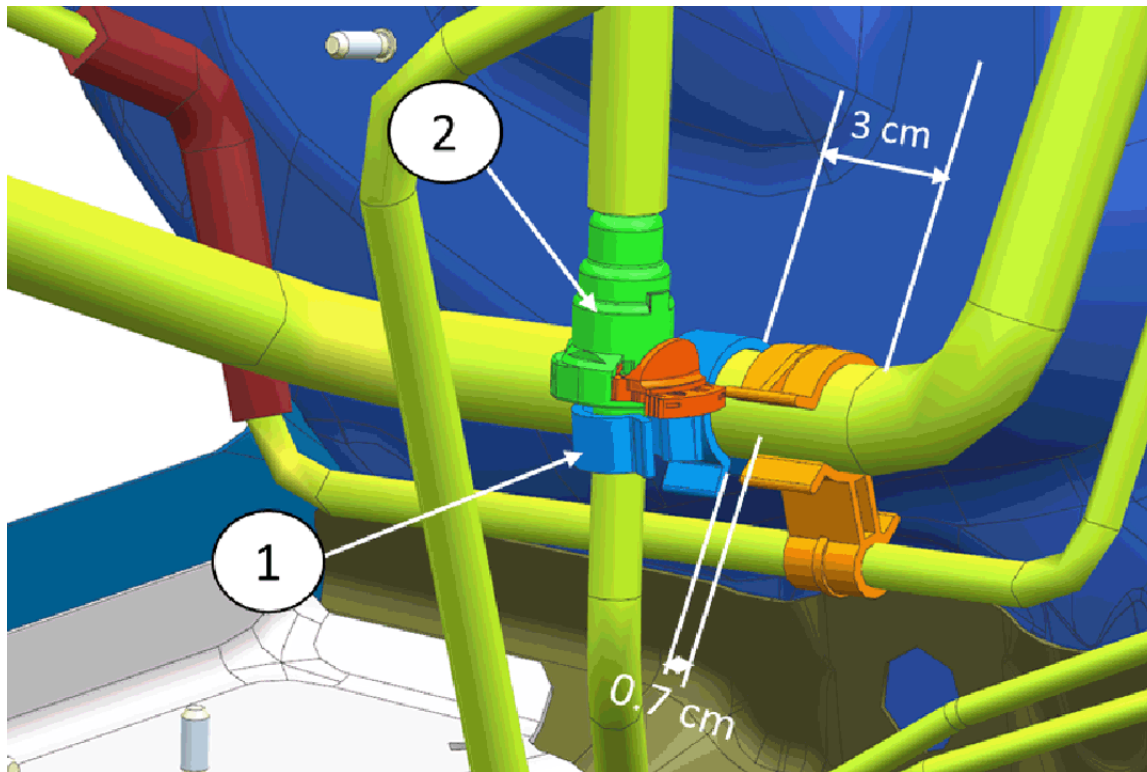
4004608

- a. Install the swivel clip (1) underneath fuel hose quick connector (2) as pictured above.

Dealers are to inspect the A/C pipe for wear and if present, replace the AC line. In addition, dealers are to install a swivel clip to maintain clearance between fuel feed line and A/C pipe
