**September 16, 2014****SB-10056638-9883**

ATB 52107 (1409)

## Product Update: 2015 Fit Front Bumper Beam

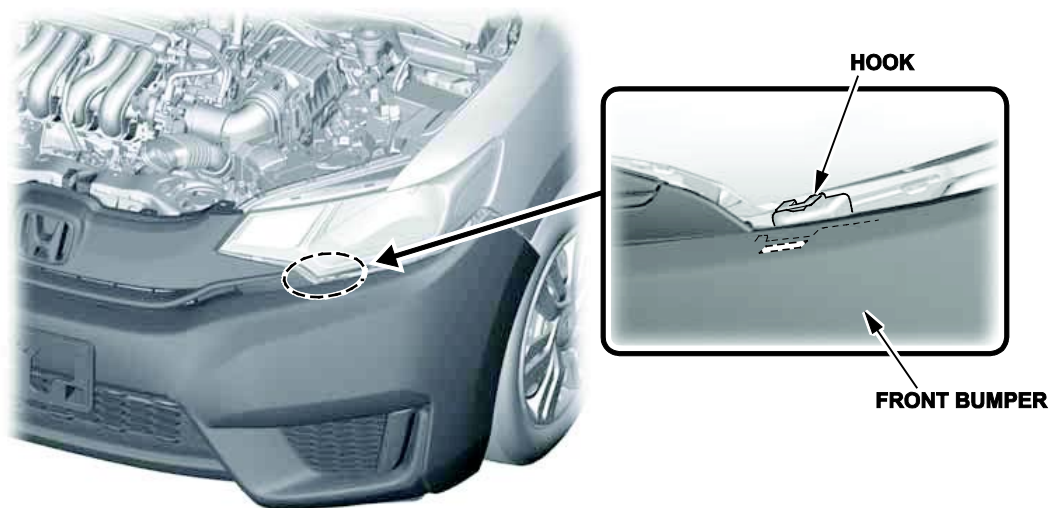
6. With the help of an assistant, gently pull the front bumper away from the side spacer and release the bumper from the hooks on the upper beam, then remove the front bumper.

NOTE: If the vehicle is equipped with fog lights, disconnect the connectors while your assistant holds the front bumper.

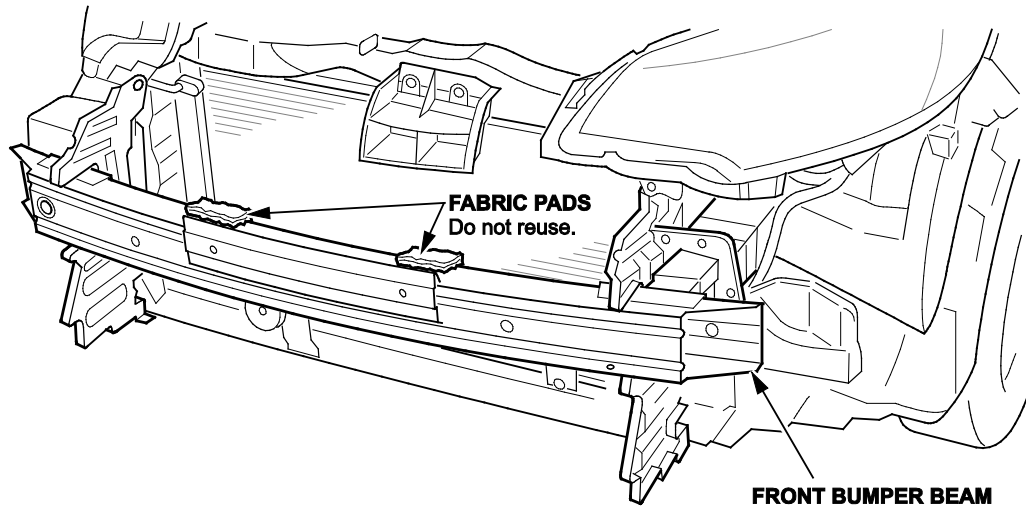
NOTE: There may be two fabric pads located on the front bumper beam. Do not reuse or replace these pads when you replace the bumper beam.

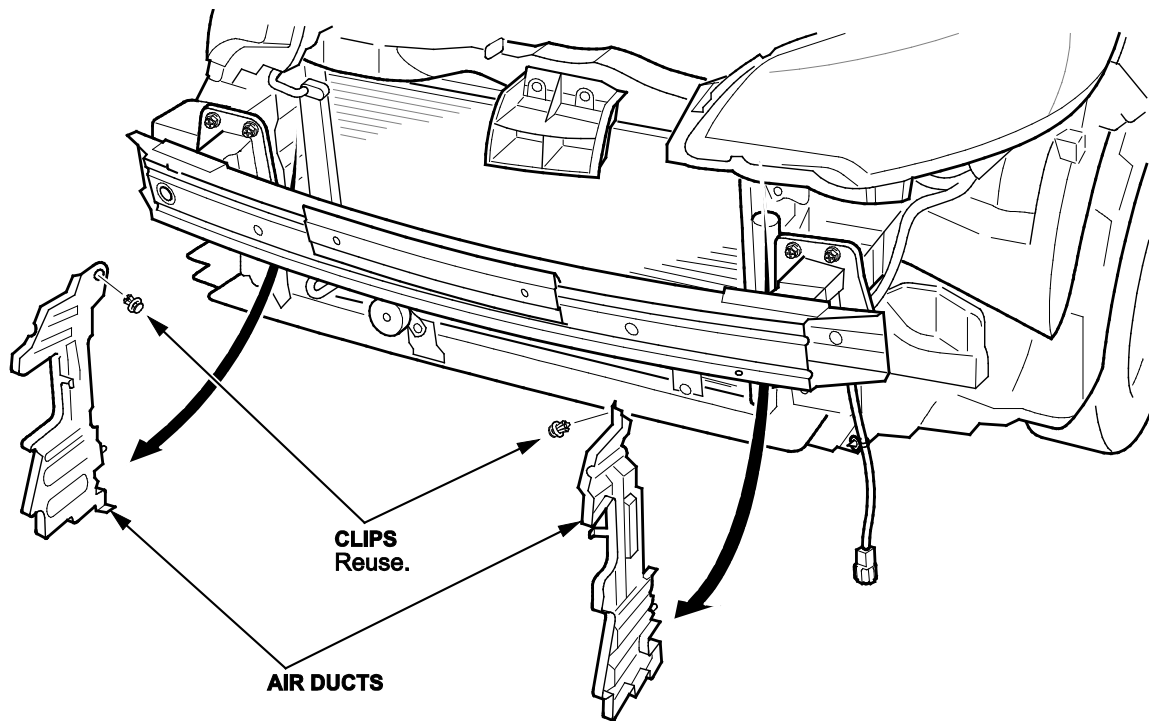
9. Remove the air ducts.

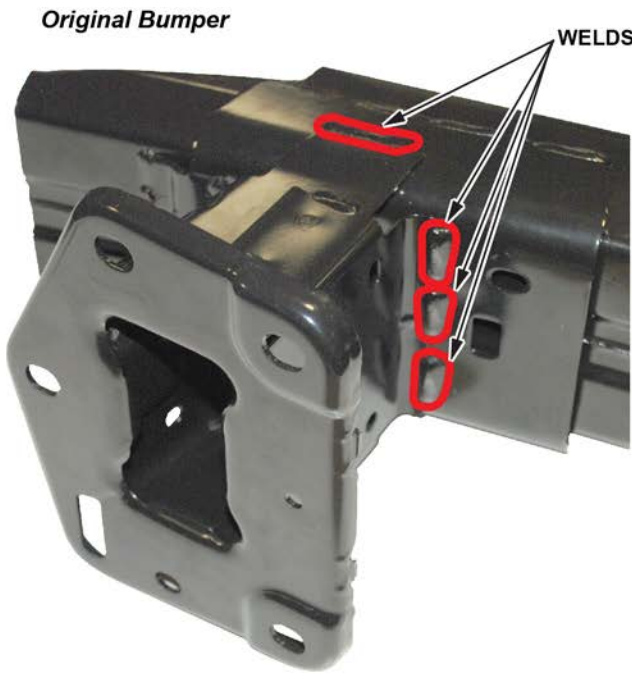
NOTE: Both parts are similar but you can tell the new part from the original part by looking at the weld seams where the bracket connects to the beam as shown.

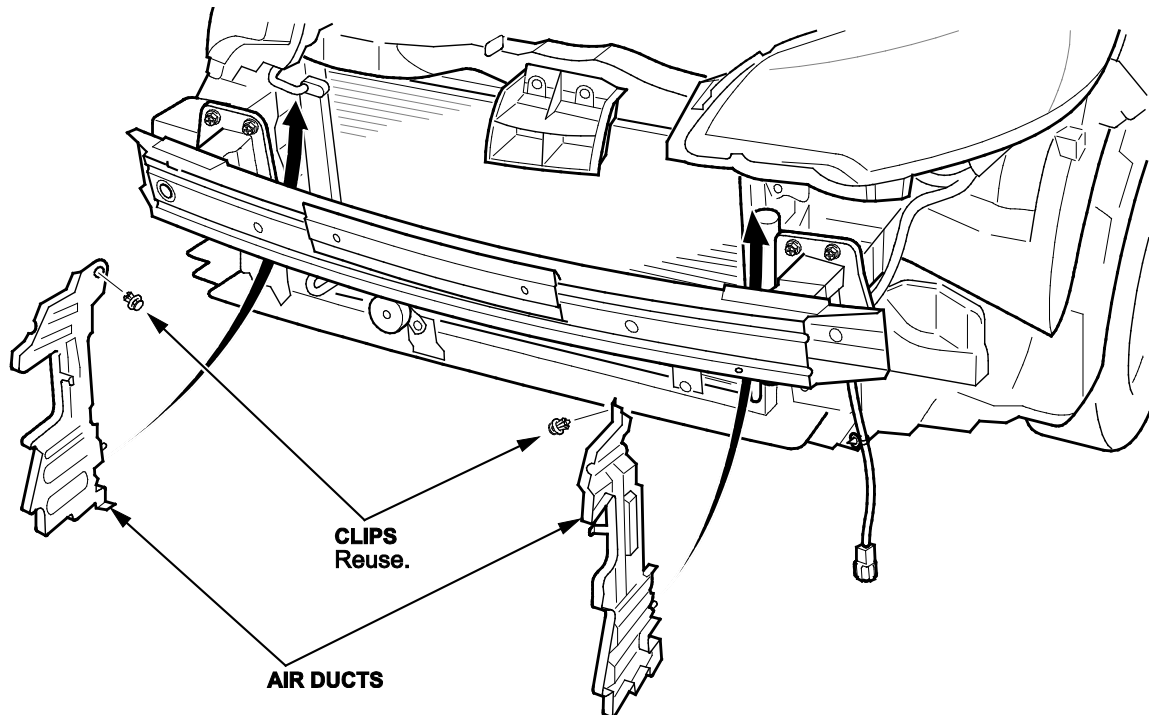
13. Install the air ducts.
