**Micro Bird Inc****SERVICE  
BULLETIN****TITLE: Remedy battery drainage issues****TO: Micro Bird dealers****PRODUCT: Micro Bird buses, GM MY 2014, with lift  
interlock working without Key****FROM: After Sales and Warranty department****PLANNING****Description**

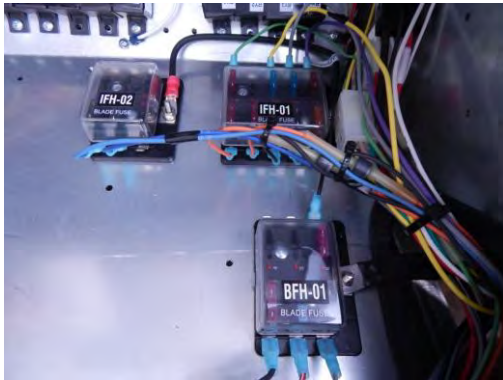
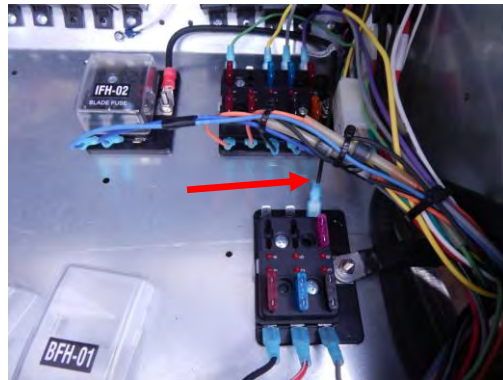
### **Remove the fuse holders covers (IFH-01 and BFH)**

- 1- Remove both covers from the battery fuse holder (BFH) and ignition fuse holder (IFH).
- 2- Locate the black wire 16BLK228 going from relay RY10 to the BFH fuse holder.
- 3- Remove the wire and its fuse from the fuse holder.

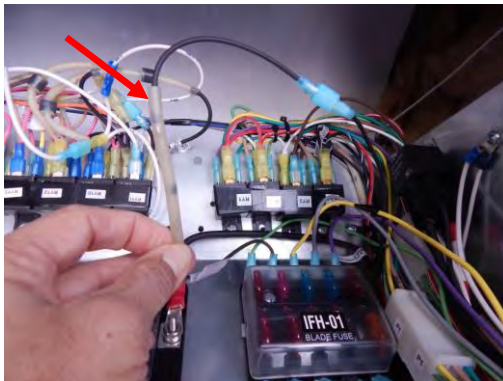
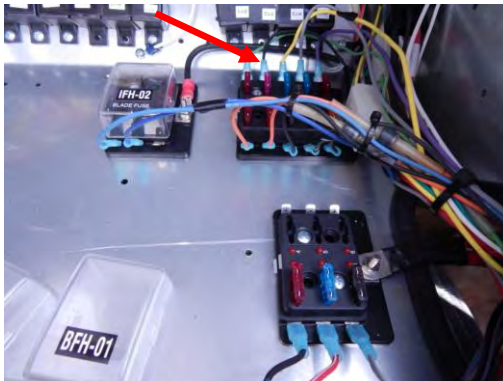
- 4- Connect the 1 amp diode on this black wire.
- 5- Connect the diode wire in the IFH-01 fuse holder (if there is no room for an additional fuse, fix the wire into IFH-02) and insert the fuse next to it.
- 6- Re-install the fuse holder covers.
