Emissions Service Action

SB-10056904-8874

**Subject: 2012-2013 MY Jetta SportWagen TDI® Clean Diesel Engine Vehicles
Glow Plug Control Module**

October 21, 2014

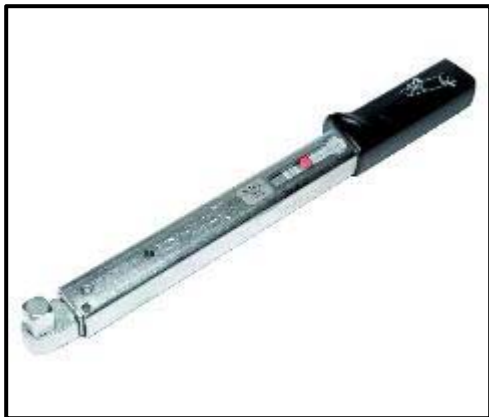
- VAG 1331 – Torque Wrench 5-50Nm (or equivalent)

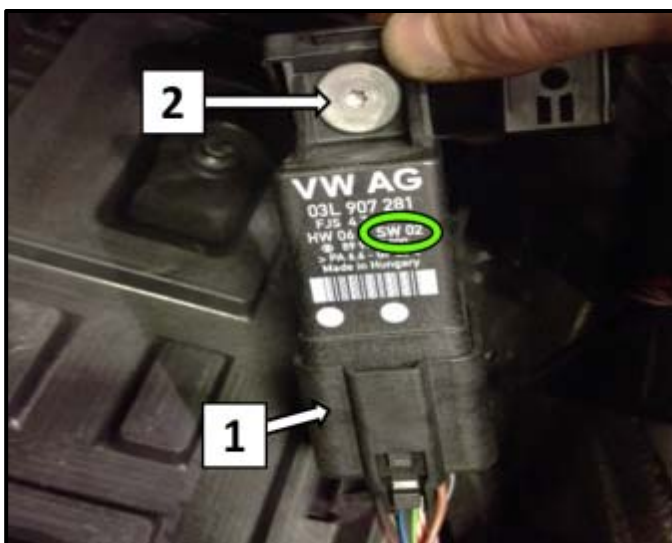
- ⇐ Inspect the software version of the glow plug control module <circle>.
- If the software version <circle> is "SW 02," DO NOT REPLACE the glow plug control module.
 - If the software version <circle> is not "SW 02," REPLACE the glow plug control module with part number (03L 907 281).
- ⇐ If replacing the glow plug control module, disconnect electrical connector <1>, remove screw with bracket <2> and reinstall onto new glow plug control module.
