SB-10056924-3467**FORD:**

2011-2015 Explorer

This article supersedes TSB 12-12-4 to update the vehicle model years and Service Procedure.

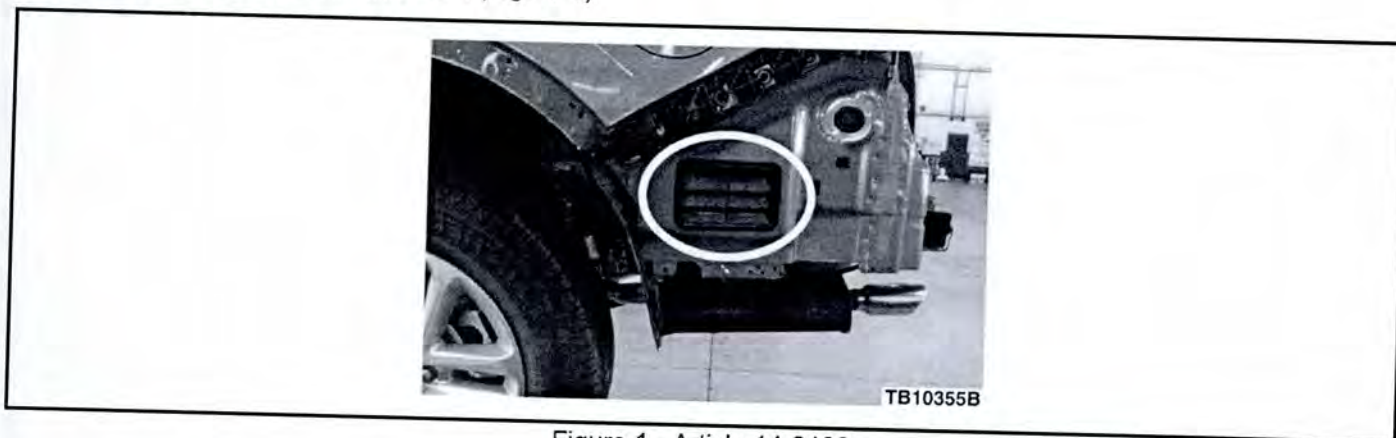
Figure 1 - Article 14-0130

1. Reprogram the Heating Ventilation Air Conditioning (HVAC) module to the latest calibration using IDS release 91.02 or higher. Calibration files may also be obtained at www.motorcraftservice.com.
 - a. When reprogramming the HVAC, IDS will have additional questions that require a yes response to reprogram the module.
2. Remove the rear bumper cover. Refer to Workshop Manual (WSM), Section 501-19.
3. Replace the left side rear air extractor. (Figure 1)

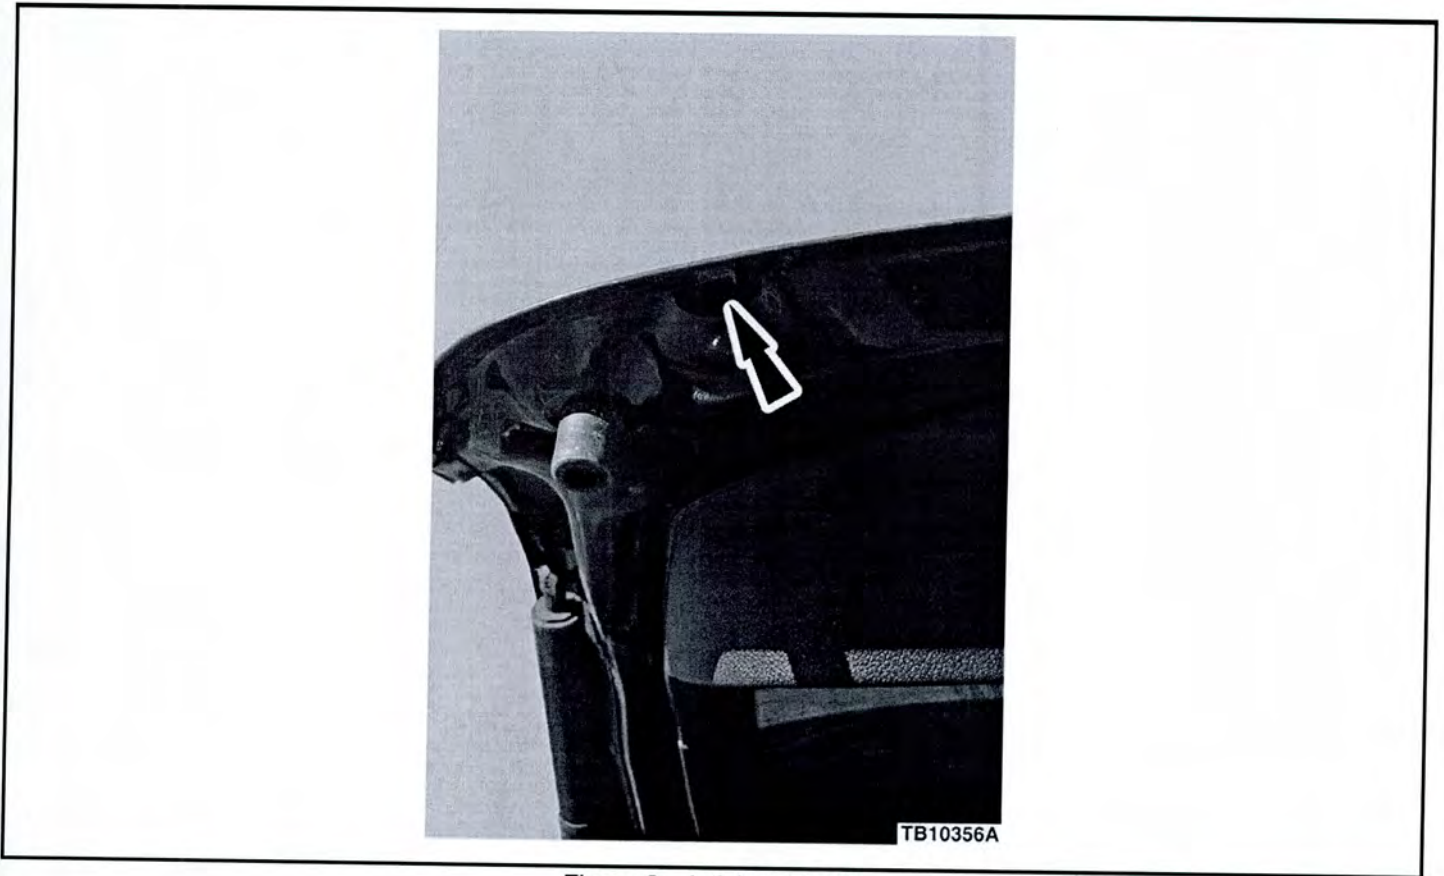
Figure 2 - Article 14-0130

4. Install the rear bumper cover. Refer to WSM, Section 501-19.
 - a. Apply masking tape around the outer edge of the rear fender mouldings to protect the vehicle from damage.
5. Open the liftgate and inspect for the presence of drain valves in the two (2) drain holes on the left and right side of the liftgate. Are the drain valves present? (Figure 2)
 - a. Yes - no further action is required. Repair is complete.
 - b. No - proceed to Step 6.
6. Install a new drain valve in each of the two (2) drain holes on the left and right side of the liftgate. (Figure 2)

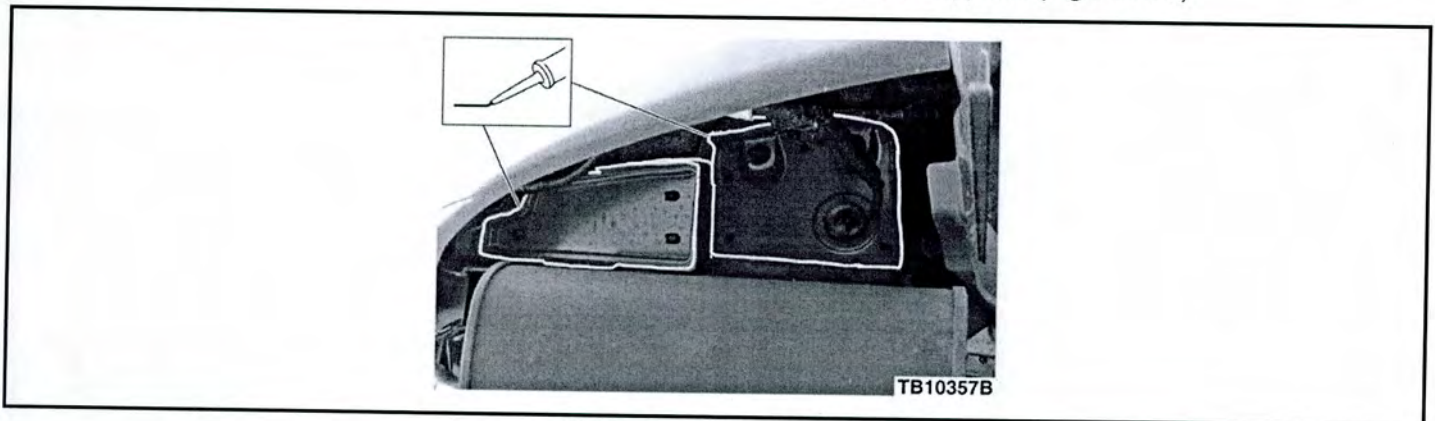
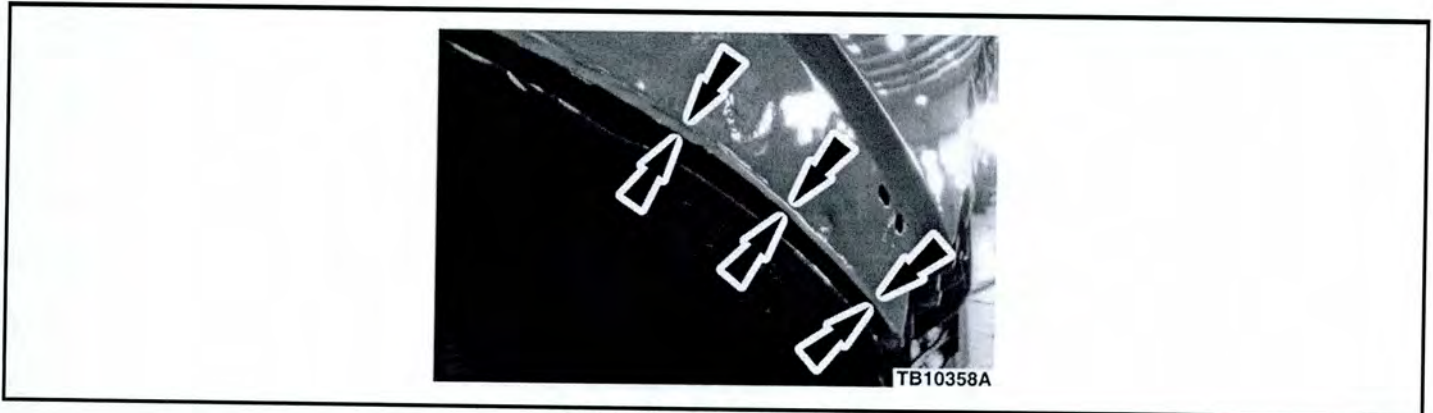
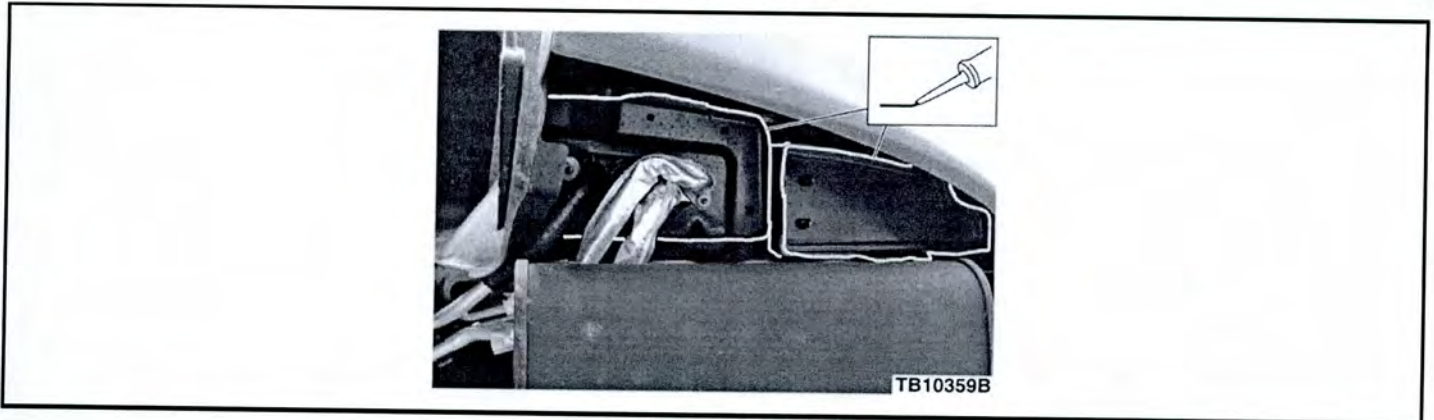
7. Raise the vehicle on hoist. Refer to WSM, Section 100-02.
8. Lower and support the rear section of the exhaust system.
9. Clean the areas on the underside of the vehicle where the seam sealer will be applied. (Figures 3-5)

10. Cover the exhaust system and auxiliary climate control drain.
11. Apply a generous amount of Motorcraft® Seam Sealer to rear horizontal sheet metal lap joints on left and right sides of the vehicle, and the rear sheet metal overlap flange across the rear of the vehicle. (Figures 3-5)
12. Spray a generous amount of 3M™ Rubberized Undercoating around the auxiliary air conditioning lines and seam sealer areas. (Figure 6)
