## **SERVICE BULLETIN**

**SB-10057036-2143**

Subject: **FUEL FILL HOSE SEAT PLATE INTERFERENCE**

Models affected: Collins Buses with Seats installed over fuel tank fill hose

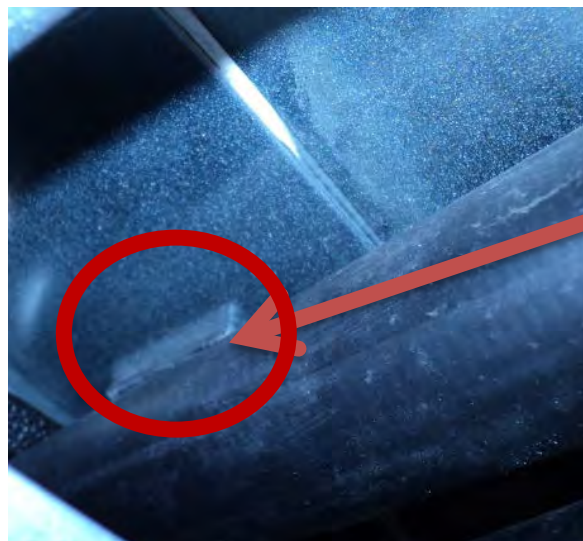
Collins Bus has been determined there may be a possible condition on some Collins School Busses that a seat mounting plate may have a sharp cut edge touching the fuel fill hose and possible weakening of the hose wall may occur over time. While no damage has been reported we feel this possibility may exist and your bus should be inspected for this possible condition.

Seat mounting plate edge  
rubbing on the fuel fill hose

Upon inspection of the fuel fill hose to the mid-ship fuel tank on your Collins School Bus you find the cut edge of the seat mounting plate is directly above the fuel fill hose and is making contact with the fuel fill hose we feel adding the seat mounting plate cover will keep the sharp cut edge on the seat mounting plate away from the fuel fill hose.
