## Service Bulletin No. 415B

| MODEL | J4500 Series | TYPE | Field Change Program | SECTION/GROUP | 7-Electrical | DATE | Sept. 17, 2014 |
| SUBJECT | DD13 ENGINE REGENERATION AT LOW AMBIENT TEMPERATURE | | | | | | |

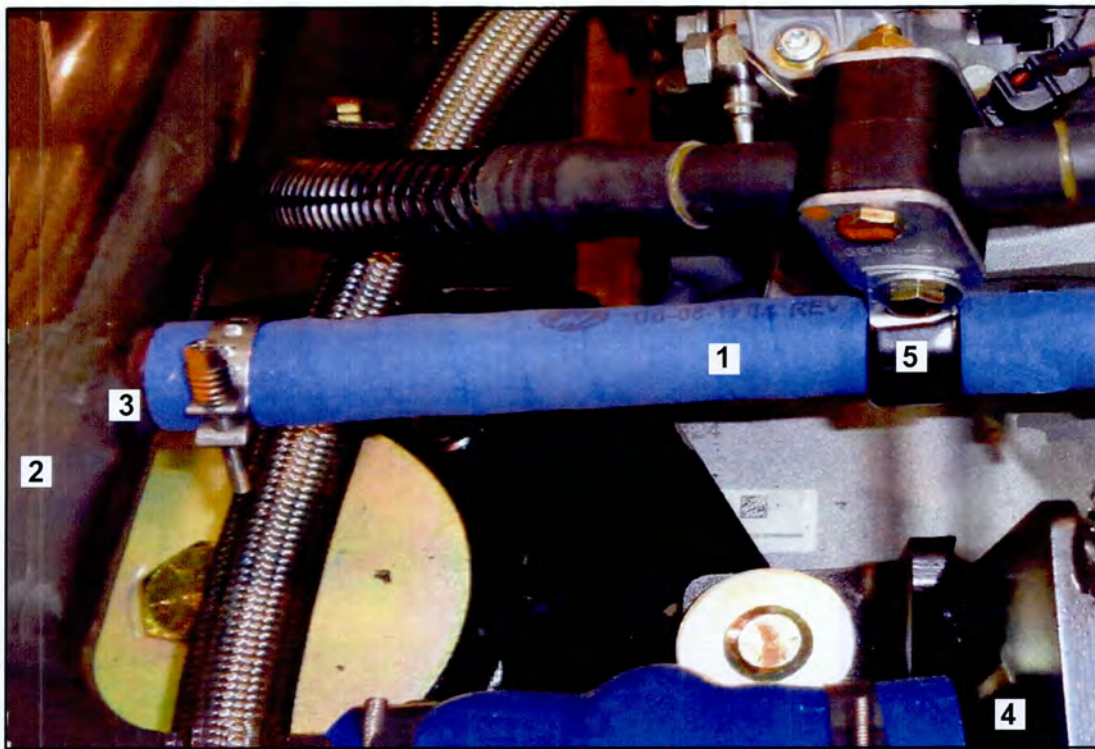
**Figure 3.**

| Item | Description |
| 1 | Coolant hose |
| 2 | SST Pipe, Oil Cooler to Thermostat |
| 3 | Measurements, 9.50 and 14.0, inch, to be taken from this point |
| 4 | Transmission cooler, reference location |
| 5 | Remove and retain line clamp and mounting hardware |

8. Locate the coolant hose ( refer to Item 1 / Figure 3).
9. Locate the coolant hose line clamp ( refer to Item 5 / Figure 3). Remove and retain the line clamp and mounting hardware.
10. Using a marker and tape measure, mark a line at the 9.50 and 14.00 inch point using Item 3 / Figure 3 as the starting point.

11. Using hose cutters and wire cutters, cut the hose jacket and wire framing at the lines made in Step 10. Discard the cut piece.
