Technical BULLETIN

SAFETY RECALL

ALL 2015 FZ-07 MODELS

FACTORY MODIFICATION CAMPAIGN – Positive Battery Cable

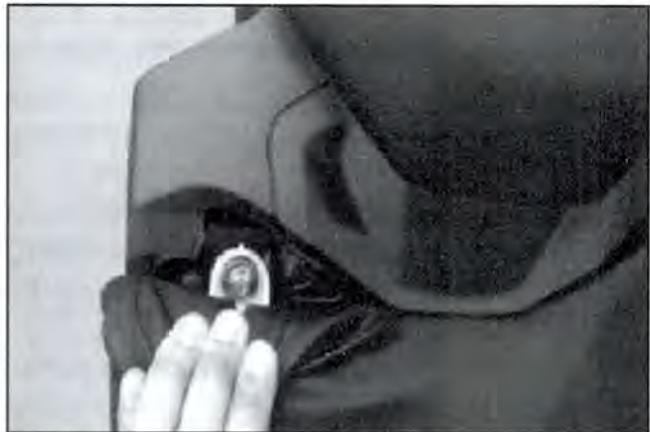
1. Remove the 2 bolts that attach the seat below the rear corners. Remove the seat and set it aside.

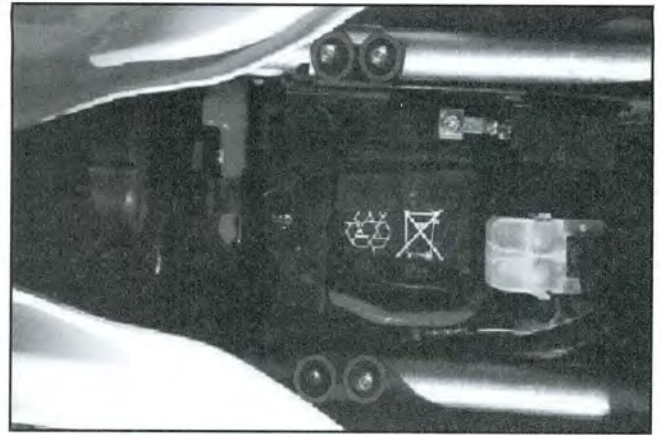
2. Remove the 4 seat bracket bolts and remove the seat bracket. The bolts will be reused.

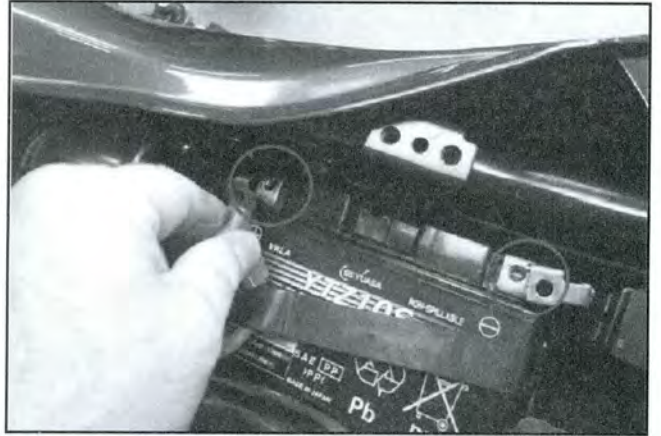
3. Disconnect the negative battery cable from the battery, and then disconnect positive battery cable.

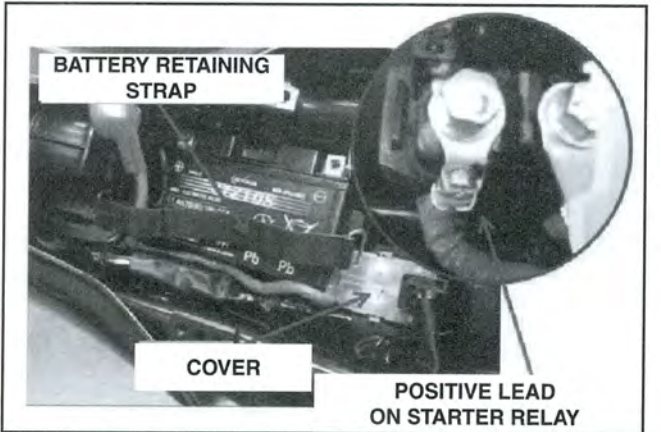
4. Remove the battery retaining strap from the battery tray, and set it aside for reuse. Remove the cover from the starter relay.

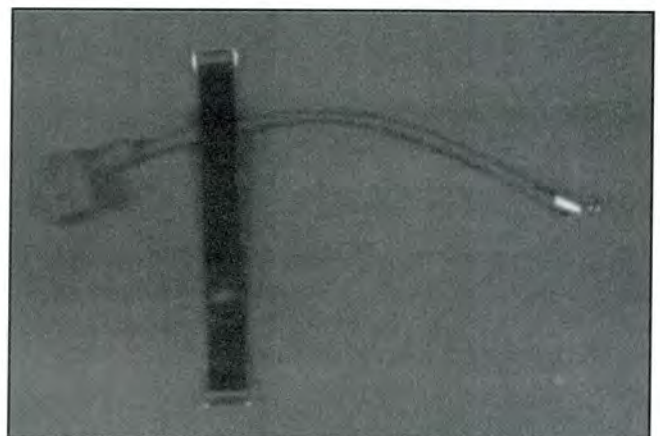
6. Install the new battery cable in the original battery retaining strap as shown.

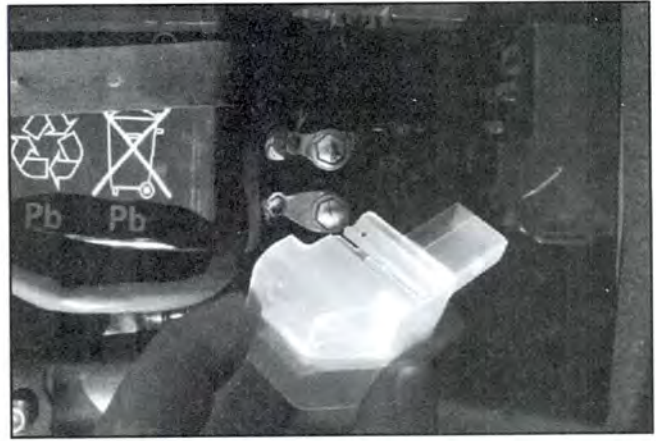
7. Connect the battery positive cable to the starter relay as shown.

Tightening Torque: 2.2 Nm (0.22 m-kgf, 1.6 ft-lbf, 19.5 in-lbf)

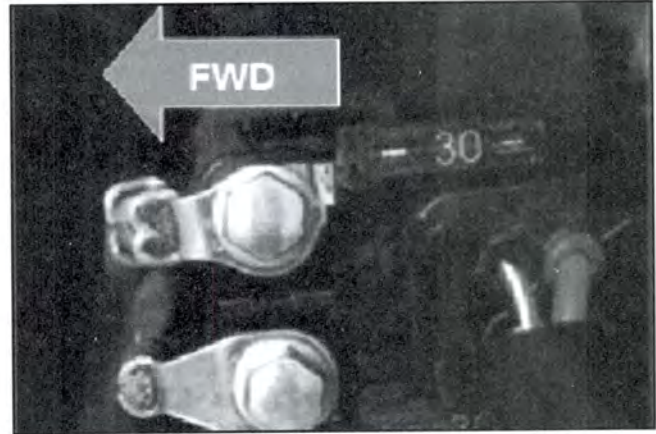
The battery cable terminal must be oriented as shown.

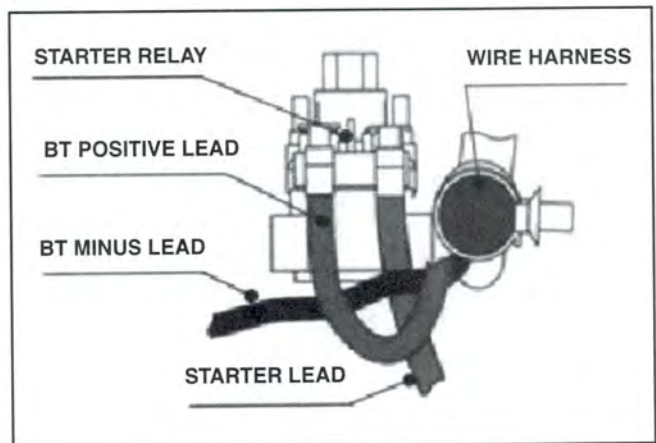
8. Route the wiring as shown in the adjacent figure.

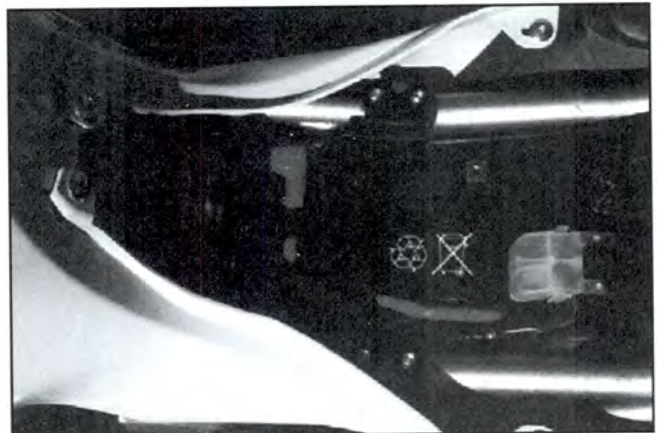
9. Route the battery positive cable as shown in the adjacent figure. Reinstall the starter relay cover removed in step 4.

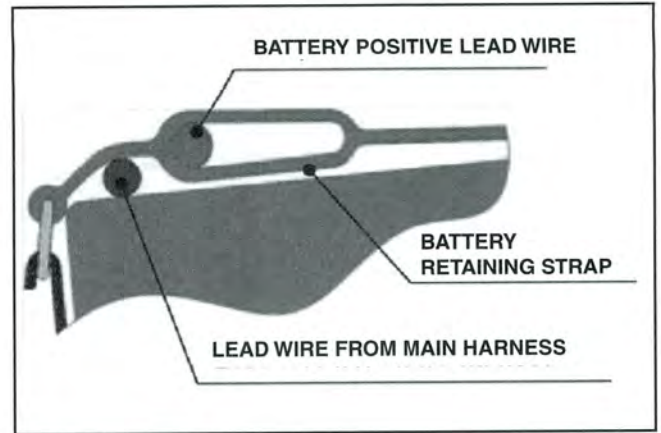
10. Connect the positive battery cable to the positive terminal of the battery and then the negative cable to the negative terminal. Reinstall the battery retaining strap.

Tightening Torque: 2.2 Nm (0.22 m-kgf, 1.6 ft-lbf, 19.5 in-lbf)

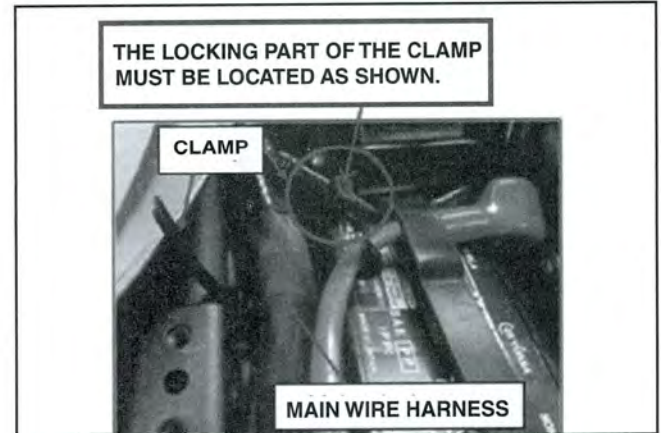
11. Install the clamp (cable tie) under the battery positive cable and the main wire harness.

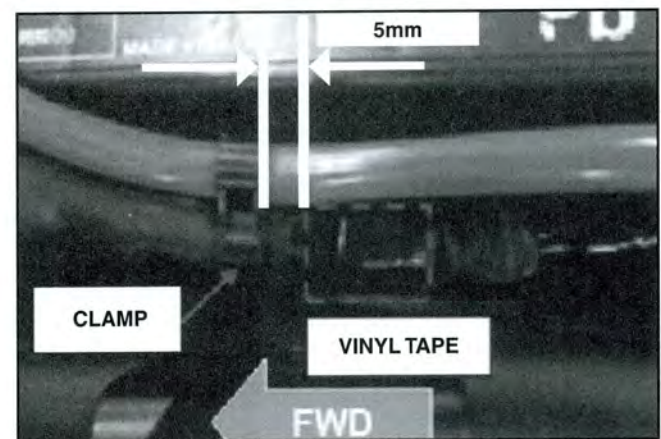
12. Fasten the battery positive cable and the main wiring harness with the clamp 5mm forward of the vinyl tape on the main wiring harness.

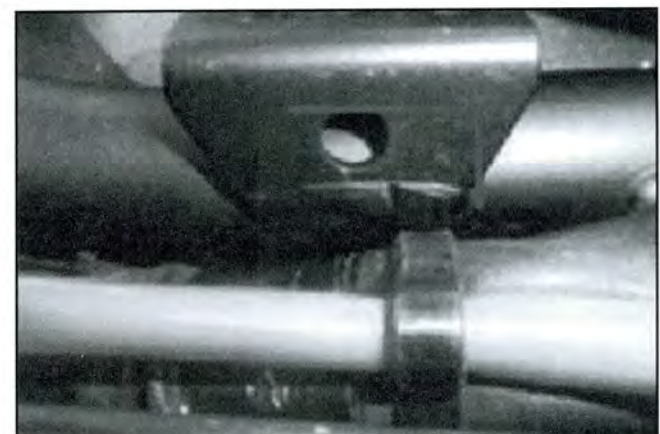
13. Trim excess clamp (cable tie). The cutting position must be below the red line in the adjacent photo.

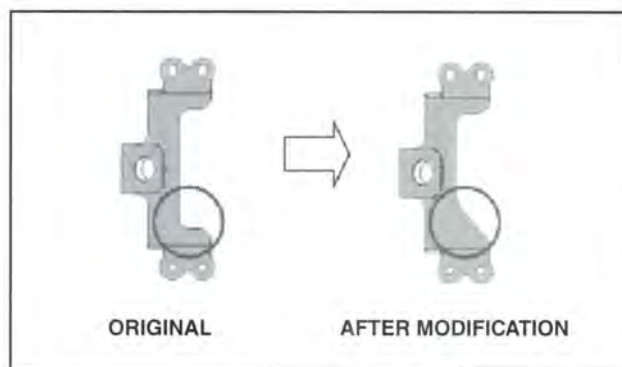
After modifying a unit, make sure to properly record and submit the warranty claim for this safety recall to update the unit's repair history in the Yamaha database. If you encounter an unfamiliar unit, check the Unit Status in YDS. A modified unit can also be identified by the shape of the seat bracket as shown below.

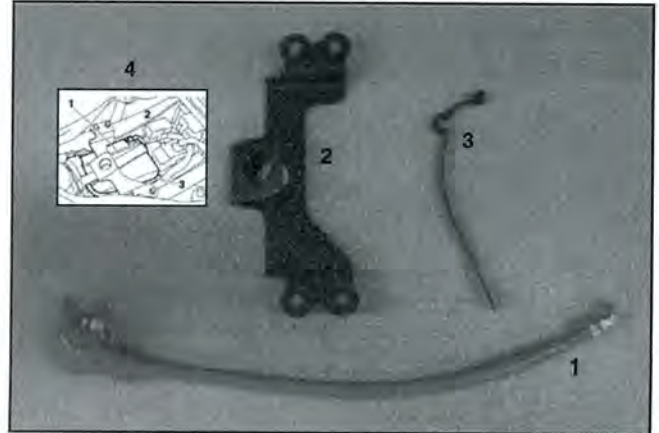
Kit Parts Contents

No.	Part Name	Qty.
1	Wire, Positive Lead (Cable)	1
2	Seat Fitting Bracket	1
3	Clamp (Cable Tie)	1
4	Sticker (Owner's Manual)	1
