Technical Bulletin

21 14 06 December 3, 2014 **2036110** Supersedes technical bulletin V211405 dated July 21, 2014 to modify the 1st bulleted sentence in Step 2.

Engine Lacks Performance, Shaft of Turbine Fan of Turbo Charger Broken or Seized

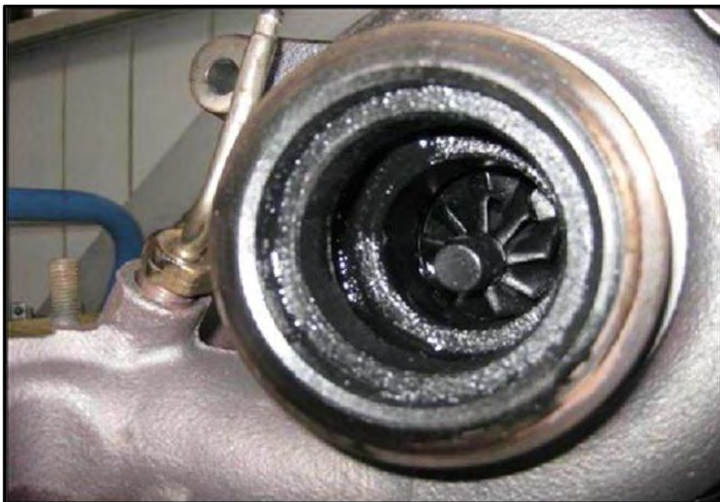
To confirm a broken shaft on the turbocharger the diesel particulate filter (DPF) must be detached on the turbocharger. This is the only way to check the turbocharger for damage and engine oil ingress on the exhaust side (figure 1).

Figure 1 (broken turbocharger shaft, engine oil ingress on exhaust side)

- If turbocharger is found to be damaged, the DPF must be reattached at the turbocharger before proceeding to the following steps:

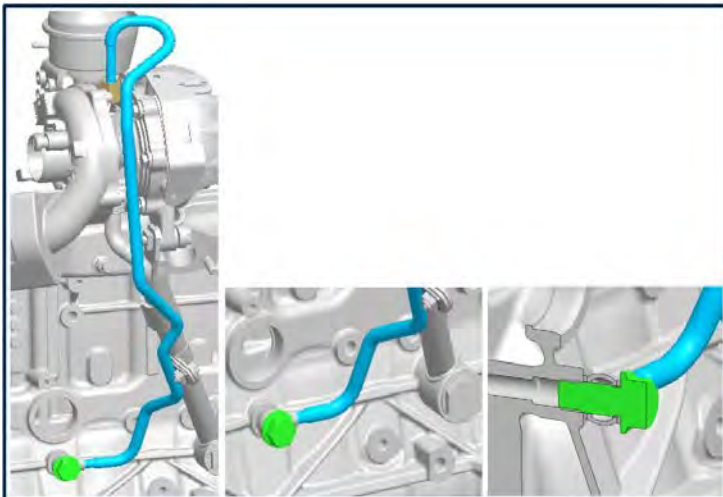
Figure 2

- Replace the oil filter according to the repair manual and thoroughly clean the inside of the oil filter housing.
- Drain the engine oil according to the repair manual.
- Unscrew the banjo bolt for the oil supply pipe on the cylinder block. Replace the banjo bolt with the hex head bolt with part number WHT 005 747 (figure 2, in green) and tighten it according to the repair manual to block oil supply to the damaged turbocharger.
