# PREVOST

## WARRANTY BULLETIN

### WB14-39

DATE :	SEPTEMBER 2014	SECTION :	22 - HVAC
EXPIRATION:	SEPTEMBER 2016		
SUBJECT :	POWER CABLE INSPECTION AND DECAL ADDITION

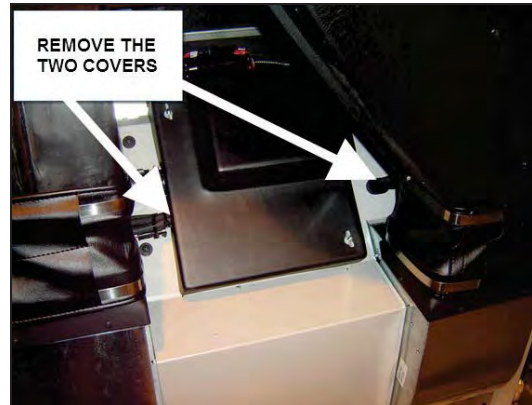
1. Open the evaporator compartment door (road side). Remove the control box cover and the fan housing cover.

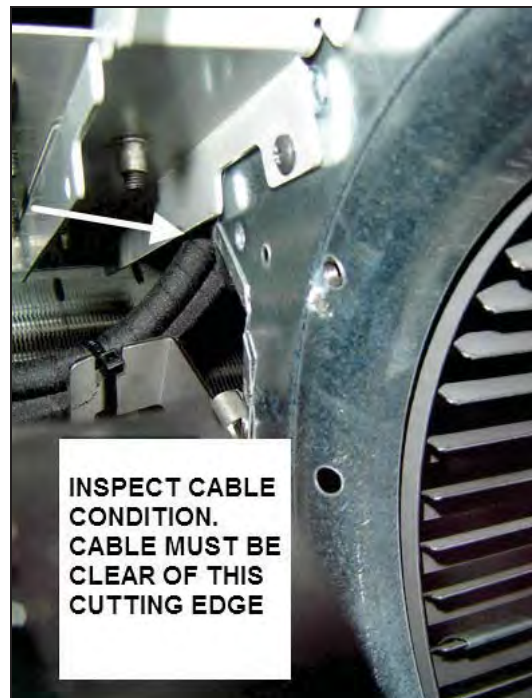
2. Inspect the power cable at location shown in picture.
