TECHNICAL BULLETIN
LTB00566NAS4
10 OCT 2014

SECTION: 310-01

Fuel Gauge Operation Inaccurate

Situation: The fuel gauge may be inoperative or inaccurate.

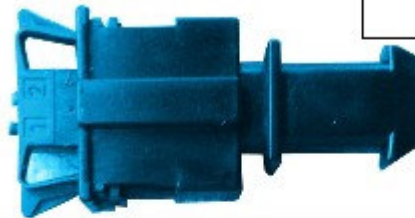
E155232

7. Repeat steps 5-6 to the other wire in the connector.

- Discard the connector.

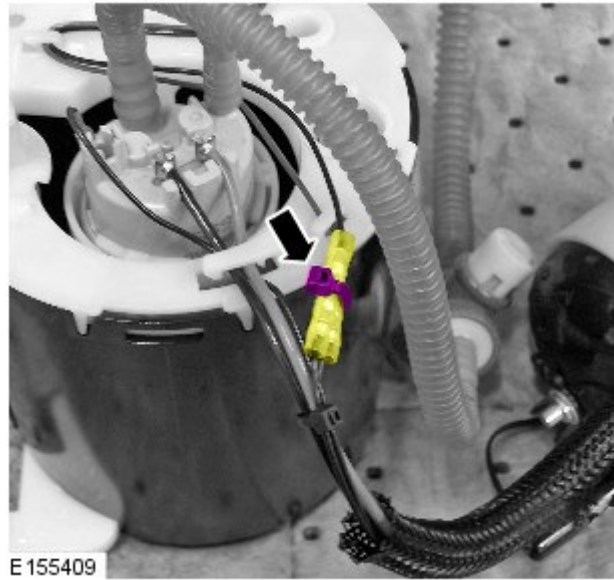
9. Using a suitable tie strap, secure the two splices together.
