# Service Bulletin

Bulletin No.: PI0401B

**Subject:** Rear Vision Camera Appears Obstructed

**Models:** 2011-2015 Cadillac CTS Coupe, CTS-V Coupe

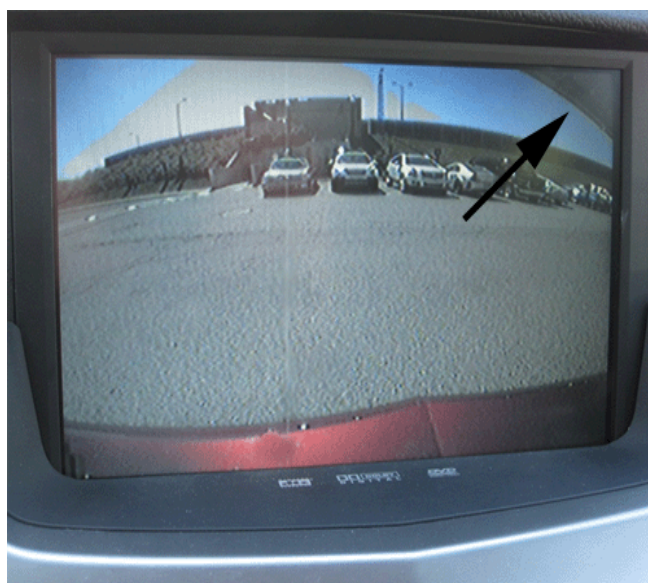
2595992

Some customers may comment that the upper right corner of the rear vision camera image is obstructed, cut off, grey in color or that the rear bumper fascia can be seen in the viewing screen.

The camera position in the CTS Coupe was optimized for rear field of view, resulting in some obstruction of view in the upper right corner of the image due to the rear compartment lid applique and lower obstruction by the rear bumper fascia. To maximize the rear field of view, this slight image of the rear compartment lid applique and the rear fascia was deemed to be acceptable and should be considered a normal condition.

Explain to the customer that this is a normal condition for the camera mounted in the CTS Coupe. Do not replace the camera or make other repair attempts for this condition.
