# Service Bulletin

Bulletin No.: PIP5133C

**Subject:** 6.6L Duramax Fuel Injection Pump Part Restriction

**Models:** 2010 through 2015 Chevrolet Express, Silverado  
2010 through 2015 GMC Savana, Sierra  
Equipped with the 6.6L Duramax Diesel Engine RPO codes LGH and

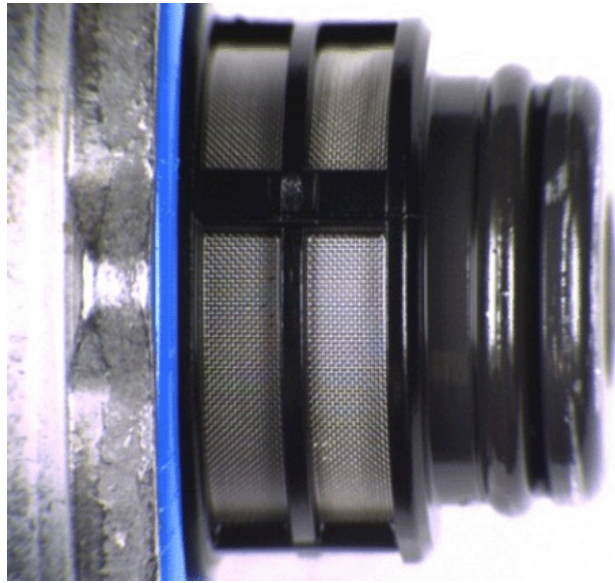
3540874

Clean Fuel Pressure Regulator 1 (View A)

If the debris on the Fuel Pressure Regulator compares closest with Group A; more diagnosis is needed. The Fuel Injection Pump is not experiencing the condition described in the latest version of PIP4949.

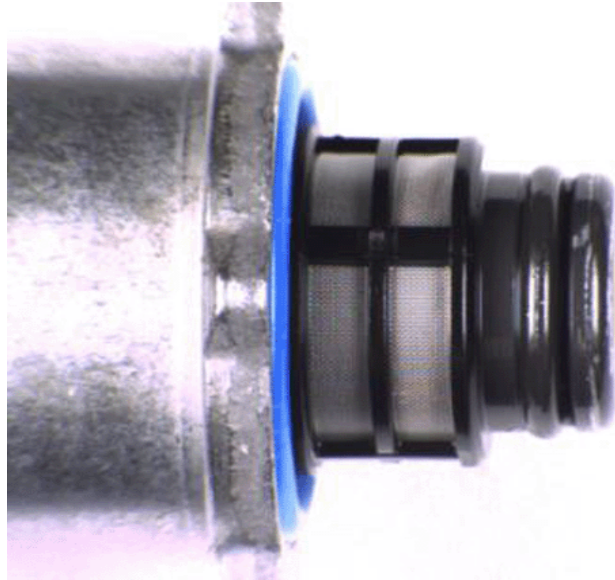
3541158

Clean Fuel Pressure Regulator 1 (View B)

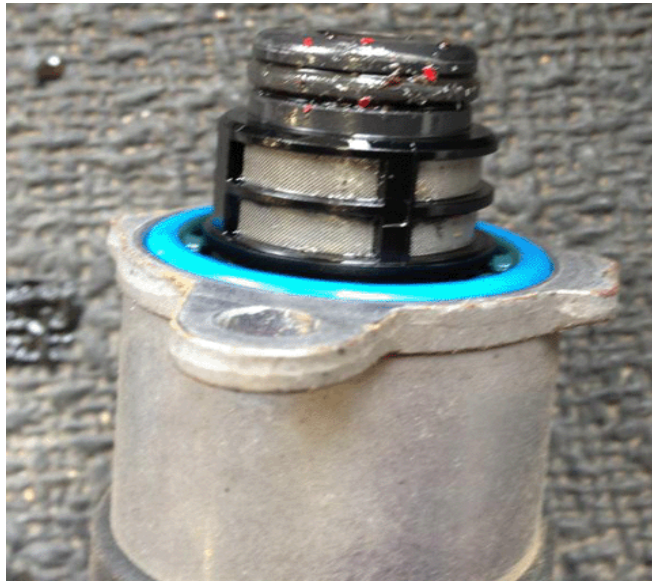
3541170

Questionable Fuel Pressure Regulator 1 (View A)

If the debris on the Fuel Pressure Regulator compares closest with Group B; more diagnosis is needed. Remove the Fuel Rail Pressure Sensor and/or Fuel Pressure Regulator 2 (Pressure Relief Valve) for inspection.

- If the same debris is found and the debris is magnetic, the Fuel Injection Pump is experiencing the condition described in the latest version of PIP4949. Call PQC to request the Fuel Injection Pump.
- If there is no debris found or non-magnetic debris found, the Fuel Injection Pump is not experiencing the condition described in the latest version of PIP4949.

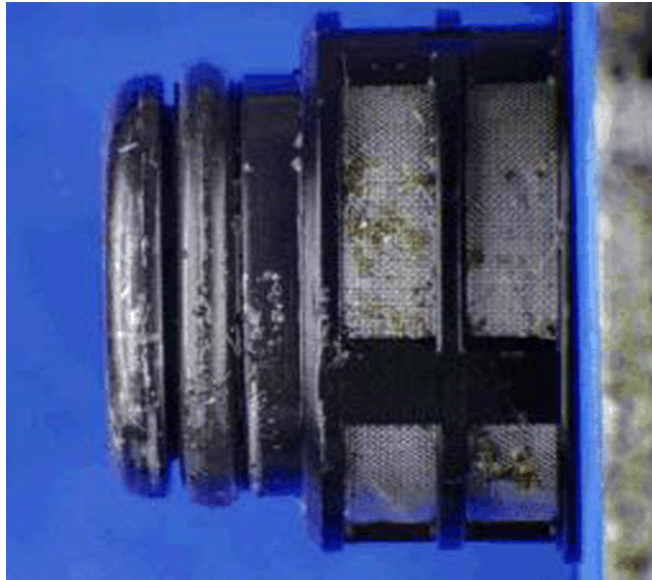
3541172

Questionable Fuel Pressure Regulator 1 (View B)

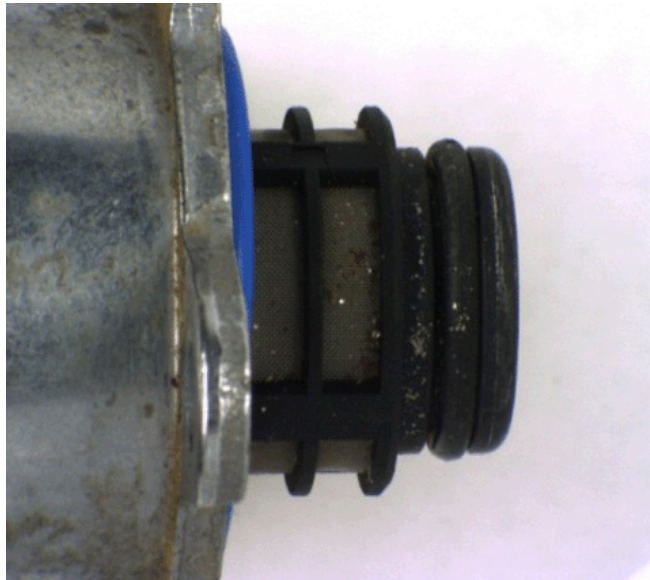
3541174

Questionable Fuel Pressure Regulator 1 (View C)

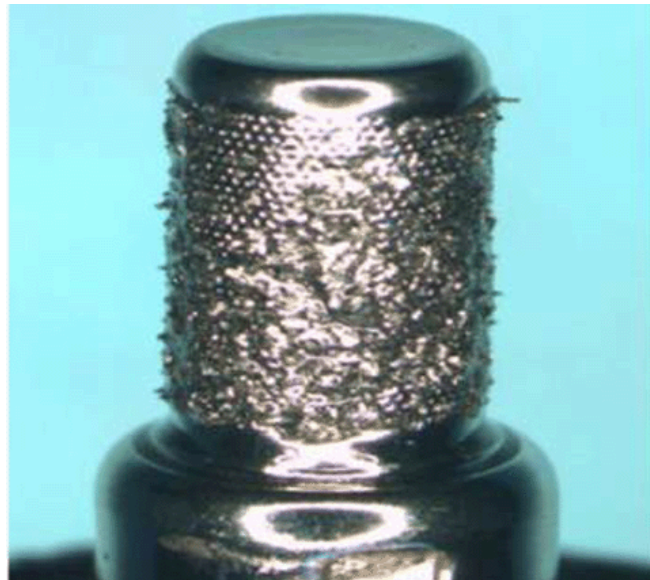
3541168

Contaminated Fuel Pressure Regulator 2

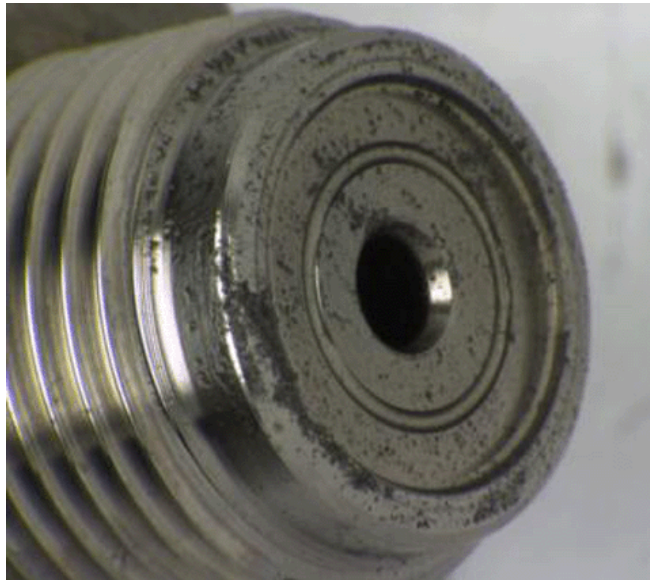
3541159

Contaminated Fuel Pressure Sensor

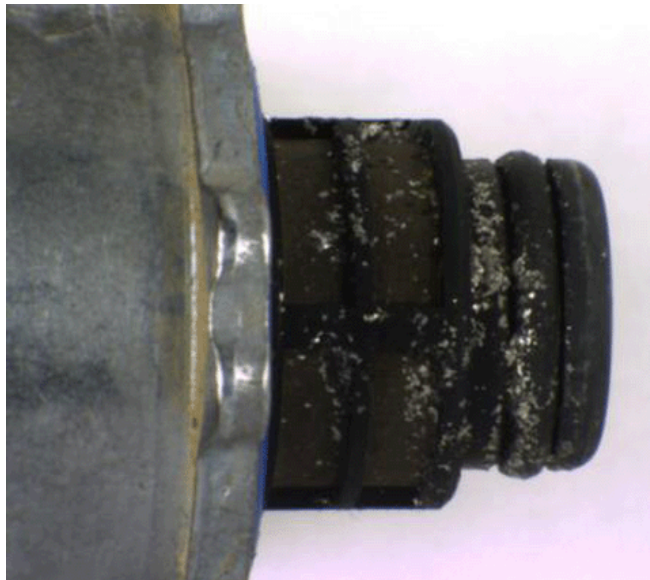
3541162

Contaminated Fuel Pressure Regulator 1 (View A)

If the debris on the Fuel Pressure Regulator compares closest with Group C and the debris is magnetic; the Fuel Injection Pump is experiencing the condition described in the latest version of PIP4949. Call the PQC to request the Fuel Injection Pump.

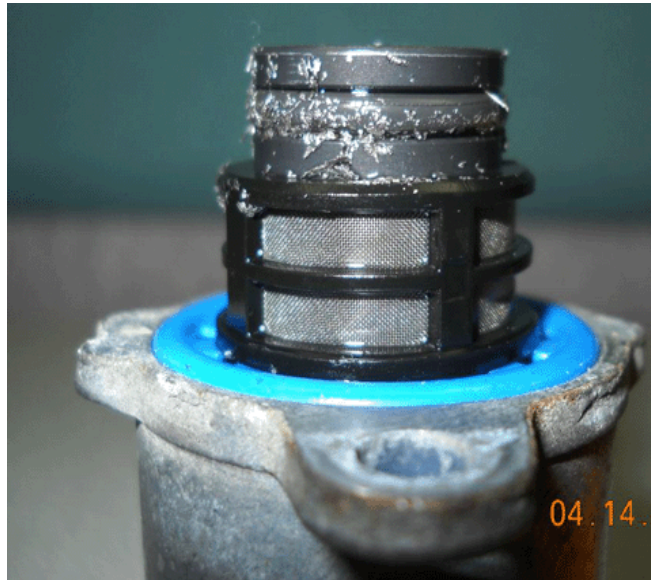
3541164

Contaminated Fuel Pressure Regulator 1 (View B)

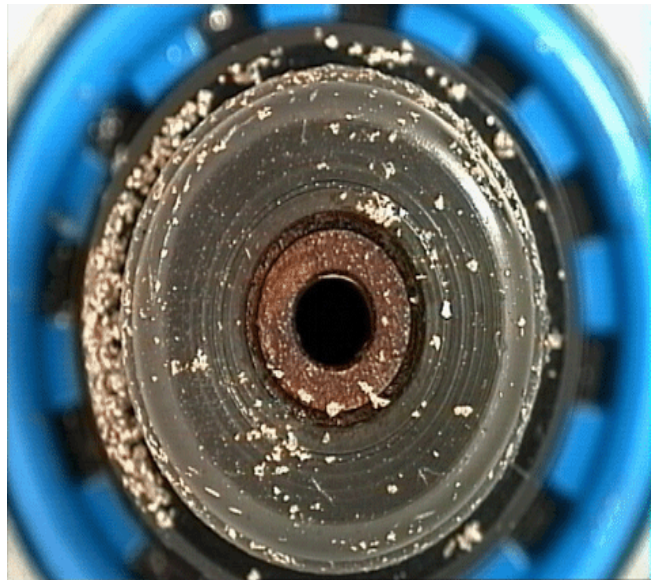
3541165

Contaminated Fuel Pressure Regulator 1 (View C)
