Subject: VEHICLE SPEED DOES NOT INCREASE WITH ENGINE SPEED AND ATX DOES NOT SHIFT UP OR DOWN	Bulletin No: 05-002/14
	Last Issued: 02/14/2014

Subject: SIRIUSXM SATELLITE RADIO REGISTRATION TRANSFER AFTER UNIT REPLACEMENT	Bulletin No: 09-012/14
	Last Issued: 02/14/2014

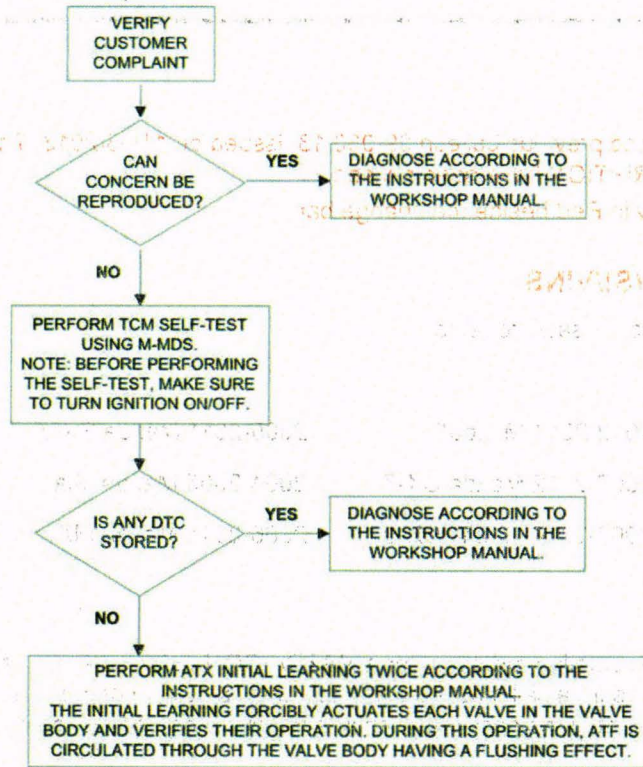
1. Verify customer concern.
2. Follow the chart to determine course of action.

3. Verify repair.

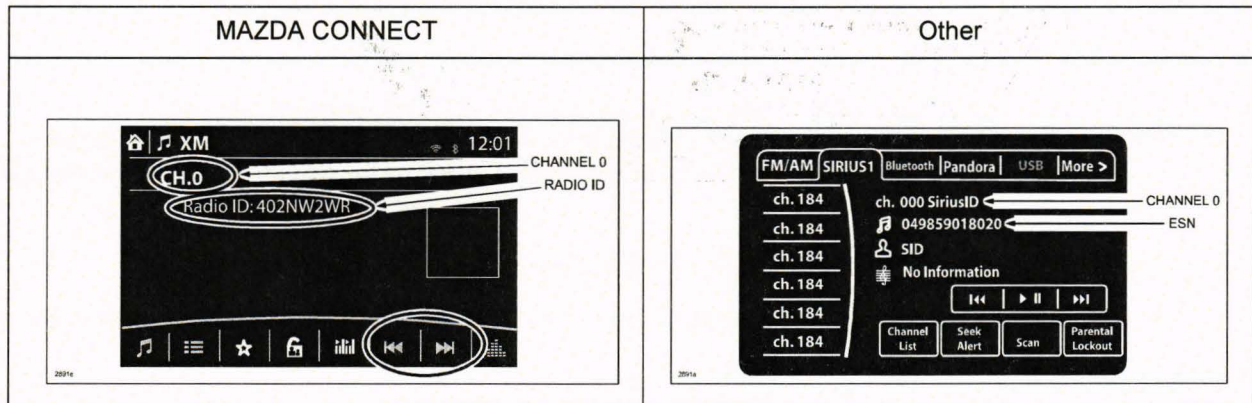
- For most radios, the radio ID (ESN) will display when tuning to channel 0.

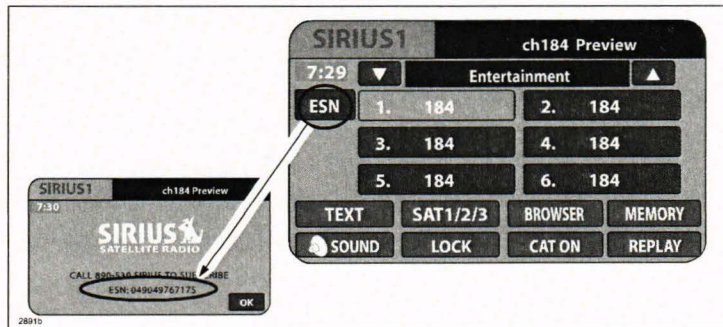
- Some radios will display the radio ID (ESN) using the "Menu" function.

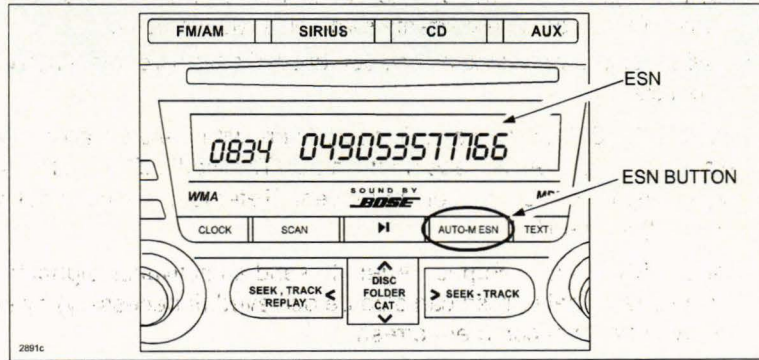
- Some radios will display the radio ID (ESN) using the radio faceplate.

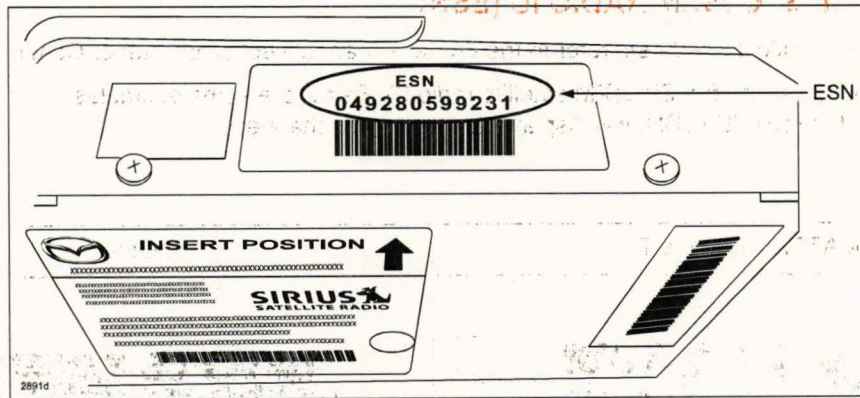
- The radio ID (ESN) can also be found on the SiriusXM satellite radio unit sticker.
