Technical Service Bulletin

GROUP CAMPAIGN	NUMBER 14-01-014
DATE MAY 2014	MODEL(S) SANTA FE SPORT (AN)

SUBJECT: SANTA FE SPORT RH OUTER TAIL LAMP (NON-LED)
REPLACEMENT (SERVICE CAMPAIGN TS9)

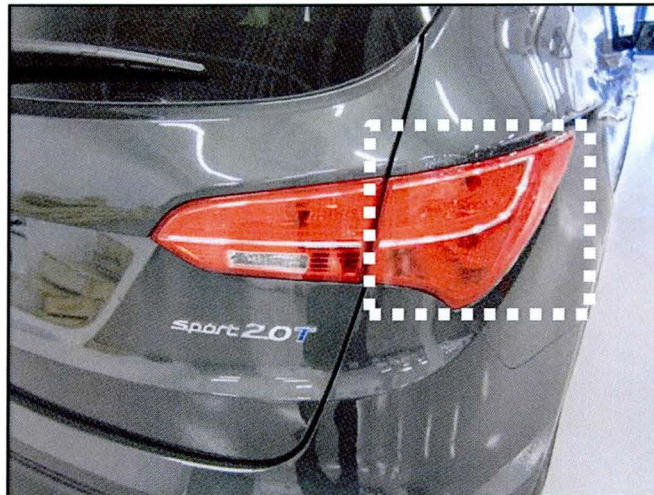
Description: The RH outer tail lamp on certain Santa Fe Sport (AN) vehicles may exhibit a slight misalignment between the tail lamp housing and lens due to a manufacturing process error. This bulletin describes the procedure to replace the RH outer tail lamp
