GROUP Body	MODEL 2014MY Sportage (SL)
	NUMBER PS290	DATE January 2014

SUBJECT: SUCTION CUP RESIDUE ON WINDSHIELD

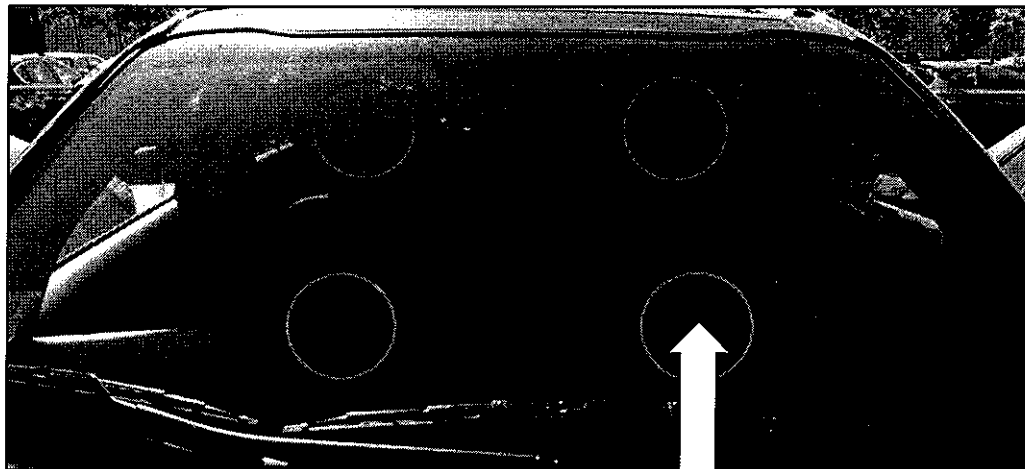
Residue from installation of the windshield may cause four markings in the shape of suction cups to appear on the surface of the windshield, as shown below. This condition is more apparent when condensation occurs on the windshield and the moisture evaporates at different rates, leaving behind visible rings. In order to verify this condition, spray rubbing alcohol over the surface of the windshield at the approximate locations in the image below. Wipe the surface with a cloth and inspect for the presence of the markings. If the markings are evident, continue spraying rubbing alcohol over the marking(s) and wiping with the cloth until all residue is removed from the windshield.
