GROUP Engine	MODEL Optima (QF/TF)
	NUMBER PS322	DATE May 2014

SUBJECT: DTC P0456 AND CHARCOAL CANISTER LEAKS

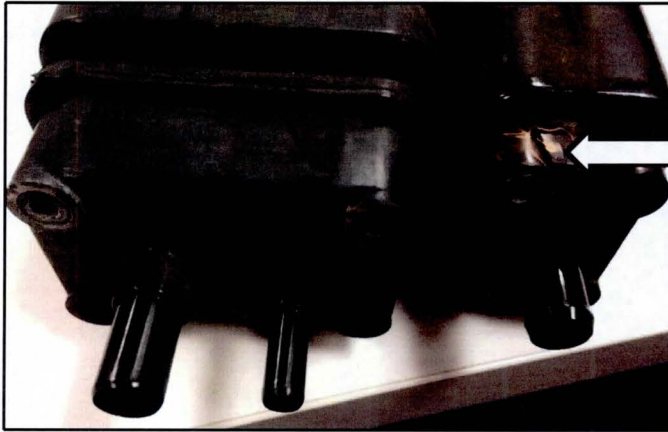
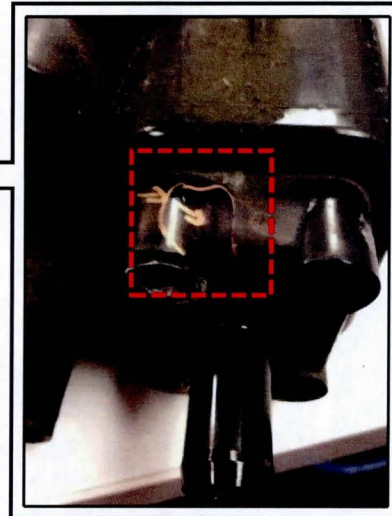
When addressing a concern related to a DTC P0456 (Evaporative Emissions System – Small Leak Detected), and an inspection of the vapor lines, connections and fuel cap reveal no abnormalities, closely inspect the mounting holes of the charcoal canister for visible cracks (refer to the images below). If cracking is found, replace the charcoal canister per the applicable procedure on KGIS. If no cracking is found, proceed with normal evaporative system diagnostics.

Unnecessary replacement of the charcoal canister may be subject to chargeback.
