MODEL  
2014~2015MY  
Sorento (XMa)

NUMBER  
PS334

SUBJECT: WIND NOISE AFTER CROSS BAR INSTALLATION

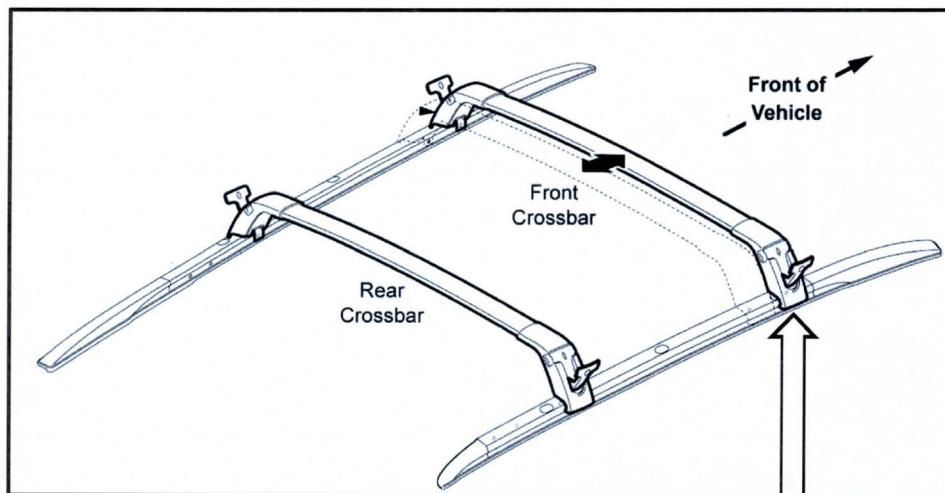
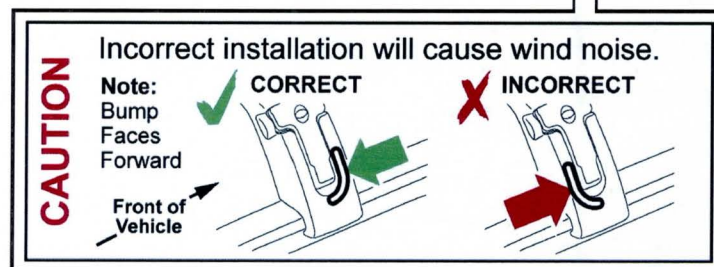
When diagnosing a concern related to wind noise coming from the roof area and the vehicle is equipped with the OE roof rack cross bars, check the roof rack cross bars to make sure they are installed correctly, using the diagram below. If the cross bars were installed incorrectly, remove the cross bars and reinstall them as shown below or by referring to the installation instructions included with the cross bar kit.
