Technical Service Bulletin

GROUP	NUMBER
CAMPAIGN	14-01-042
DATE	MODEL(S)
OCTOBER 2014	EQUUS (VI)

SUBJECT: LEFT AND RIGHT REAR DOOR CURTAIN ECU REPLACEMENT
(SERVICE CAMPAIGN TU4)

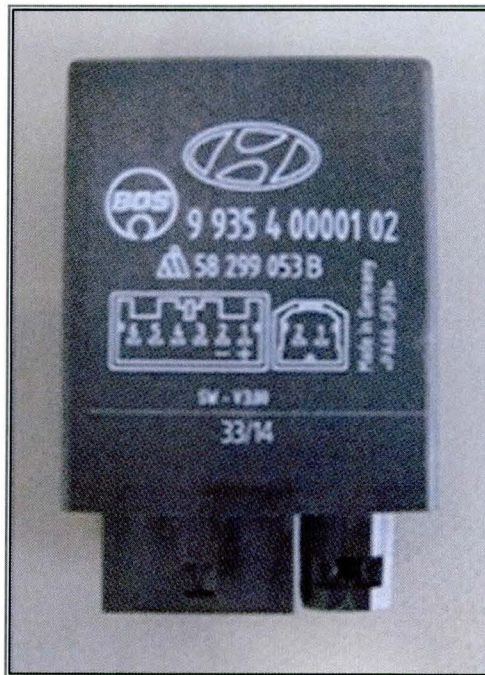
Rear Driver and Passenger
Door Curtain ECU

Description: This bulletin provides a service procedure to replace the rear door curtain ECU. Certain vehicles may exhibit a condition where the rear door curtains will not roll up or down.

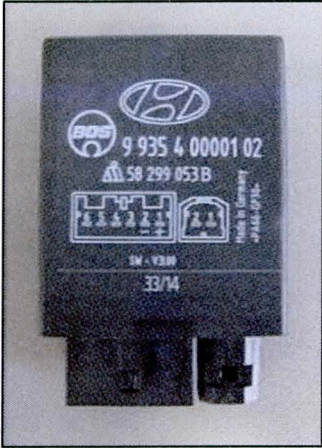
<p>The image shows a black rectangular electronic control unit (ECU) for a rear door curtain. It features the Hyundai logo at the top, followed by the part number '9 935 4 00001 02' and '58 299 053 B'. There are also some smaller markings and a date '33/14' at the bottom.</p>
	83353-3N000QQH (Qty. 2)
	S/W Ver. 3.0 (Rear Driver and Passenger Side)

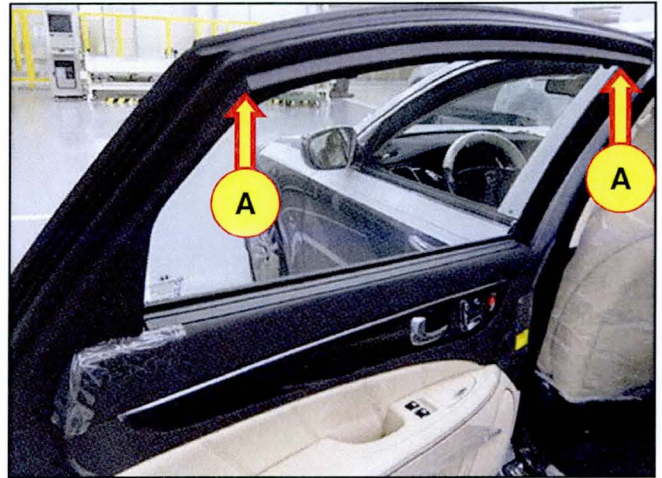
1. Remove the rear driver side door frame inner cover (A).

Carefully pull the top left and top right corner to remove the side door frame cover.

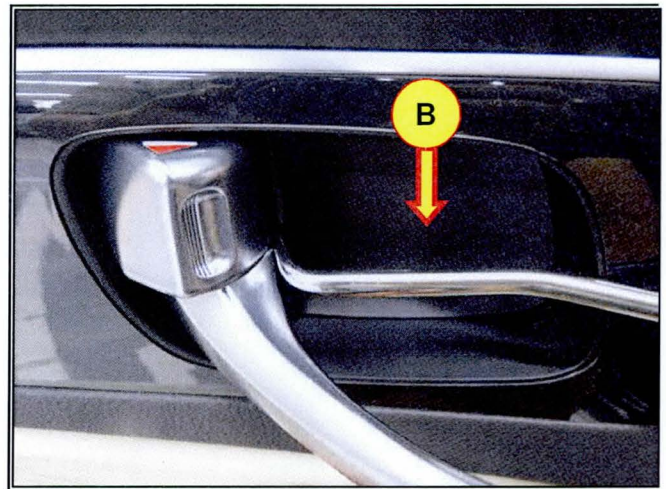
2. Remove the rear door inside handle cover (B), and then remove the screw.

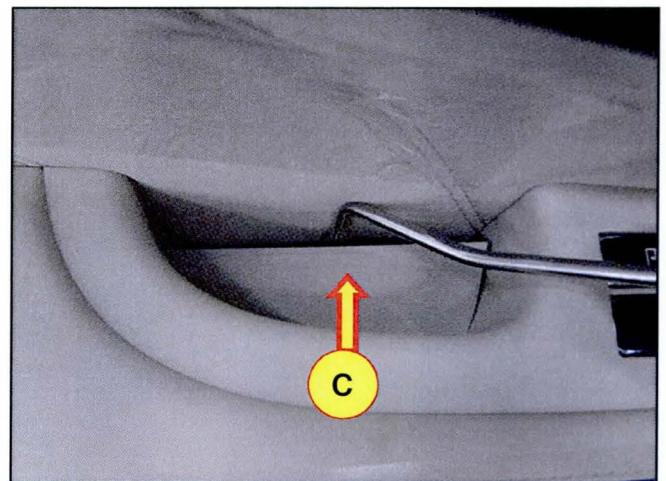
3. Remove the rear door pull-handle cap (C), and then remove the screw.

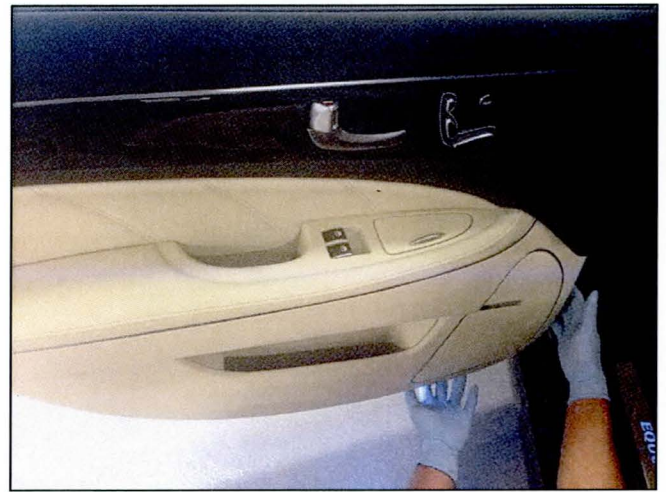
4. Separate the rear door trim from the door by pulling the lower part of the trim.

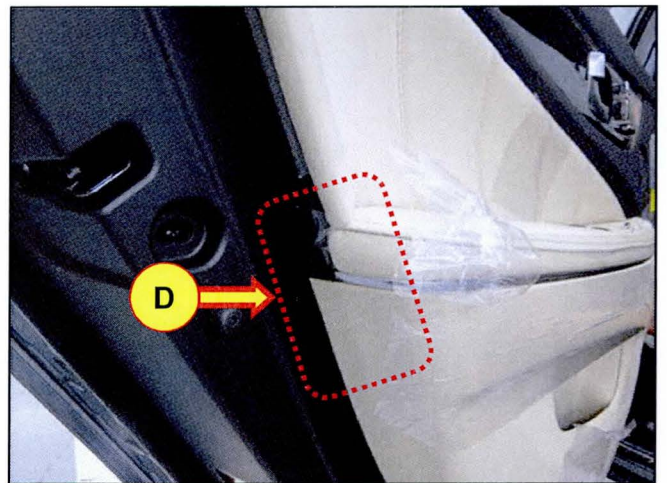
When separating the trim (D), pull the upper part and lower part simultaneously. Otherwise, the trim may be broken.

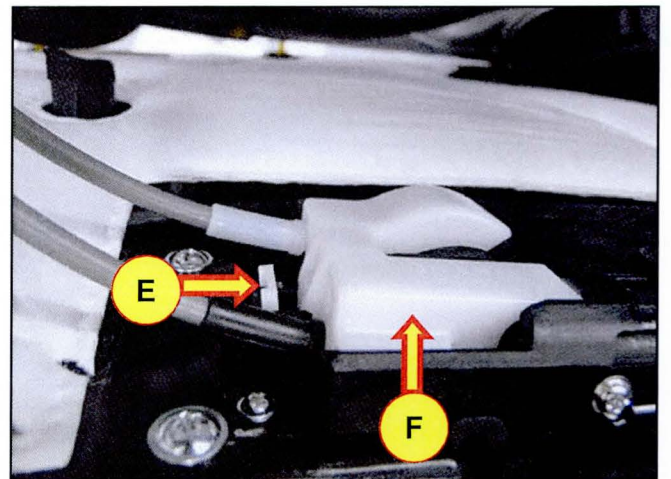
6. Separate the door inside handle cage (F) by pushing the hook (E).

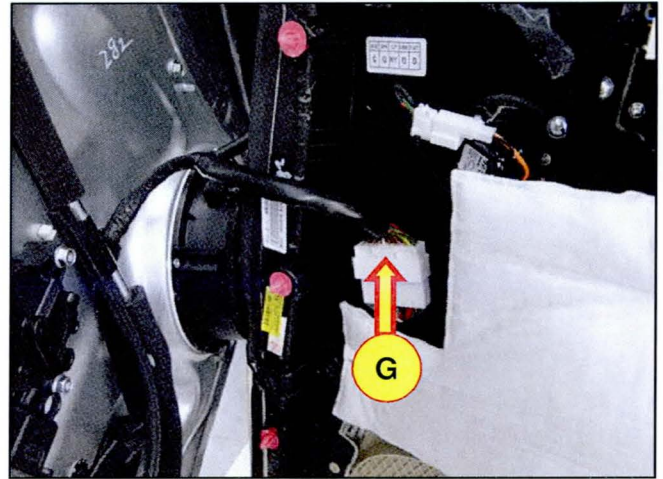
7. Disconnect the power connector (G), and then remove the rear door trim.

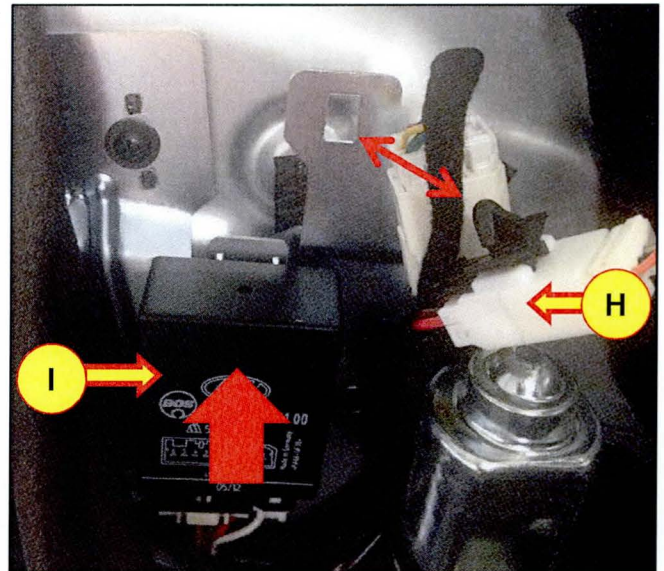
8. Using a needle nose plier remove the connector (H) from the metal bracket.

Remove the rear door curtain ECU (I) by sliding it upward as shown in the directional arrow.

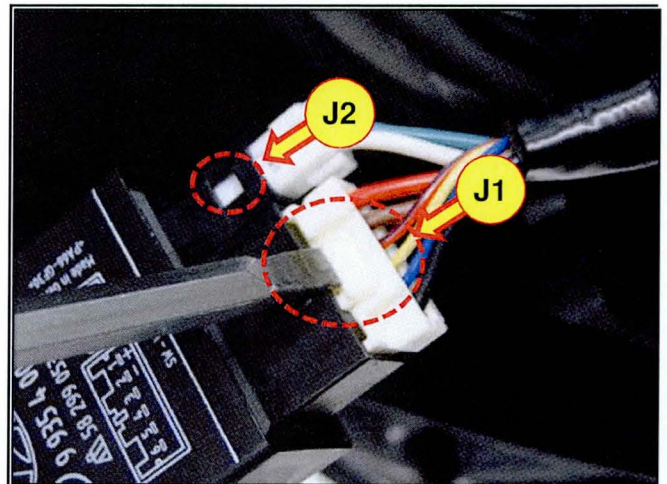
9. Disconnect the connector (J1) by pressing the hook.

Disconnect the connector (J2) by pressing the locking tab.

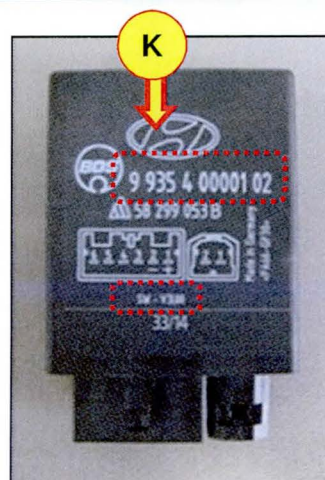
Rear Driver/Passenger Side

10. Install the new ECU (K) in reverse of removal.

Confirm the part number and S/W version of the new ECU.

PART ID	S/W VER.
PREVIOUS	9 935 4 00001 <u>01</u> (Rear Driver and Passenger Side)	V <u>2.00</u>
NEW	9 935 4 00001 <u>02</u> (Rear Driver and Passenger Side)	V <u>3.00</u>

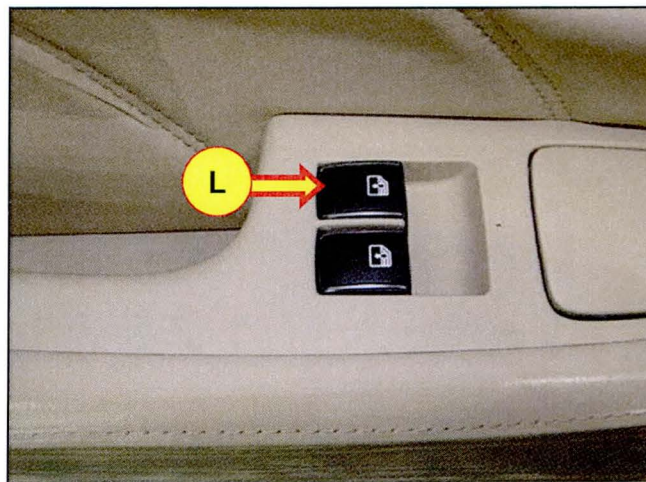
11. Initiate the rear driver side door curtain ECU as follows:

- 1) Lift the switch (L) to partially expand it.
- 2) Press the switch (L) to completely fold it.
- 3) Lift the switch (L) to fully expand it.

12. Repeat same procedure above for the rear passenger side door.
