Technical Service Bulletin

14-01-055

ELANTRA (MD)

SUBJECT: SUNROOF DEFLECTOR REPLACEMENT
(SERVICE CAMPAIGN TV6)

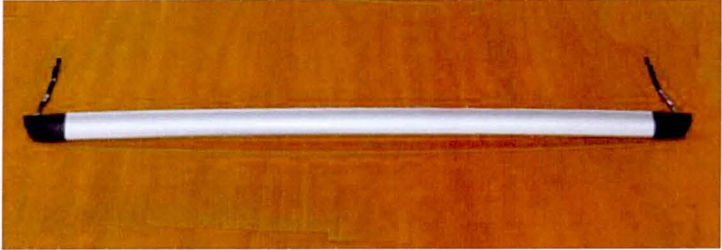
A photograph of a long, white, cylindrical sunroof deflector assembly with black end caps and small metal tabs at each end, resting on a wooden surface.
Sunroof Deflector Assembly	81641-3X000QQH
