Technical Service Bulletin

GROUP	NUMBER
CAMPAIGN	14-01-057
DATE	MODEL
DECEMBER 2014	GENESIS SEDAN(DH)

SUBJECT: FOAM PAD ADDITION TO THE REAR COMBINATION LAMP (SERVICE CAMPAIGN TV7)

Description: This bulletin provides the procedure to add a foam pad to the rear combination lamp to improve sealing and prevent water intrusion/condensation.

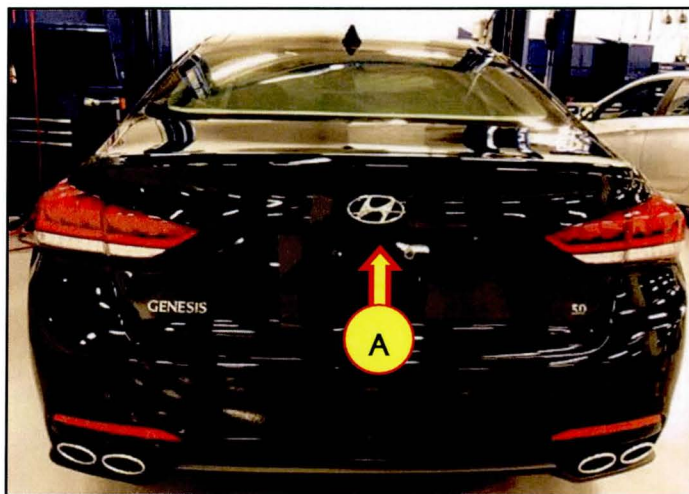
1. Open the trunk (A).

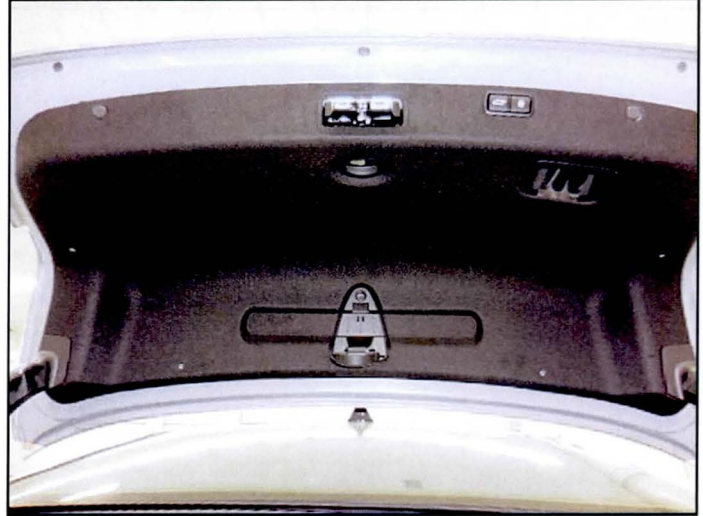
2. Remove the trunk lid latch cover (B).

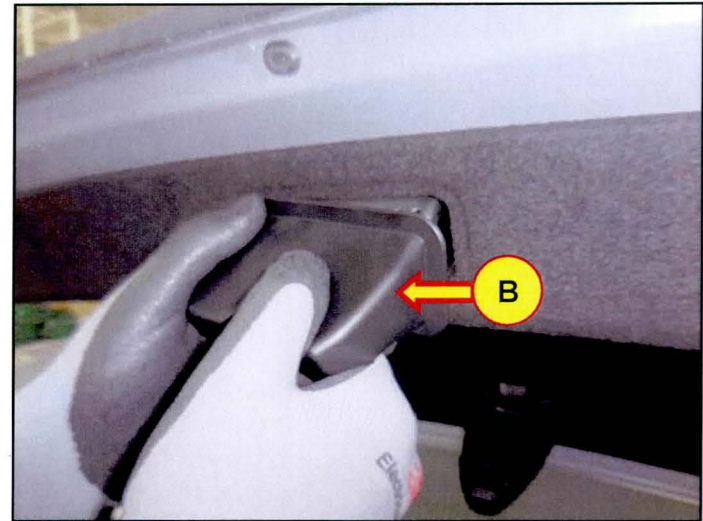
3. Using a flat blade screwdriver carefully separate the trunk lid switch (C) from the trunk lid trim.

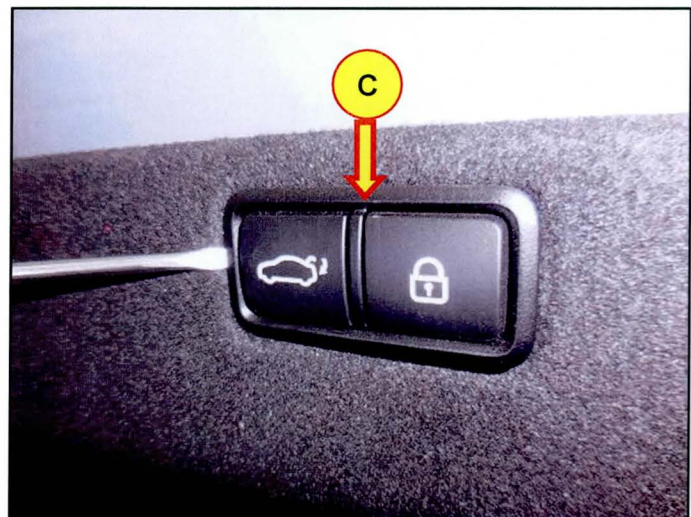
4. Disconnect the switch connector (D) and then remove the trunk lid switch.

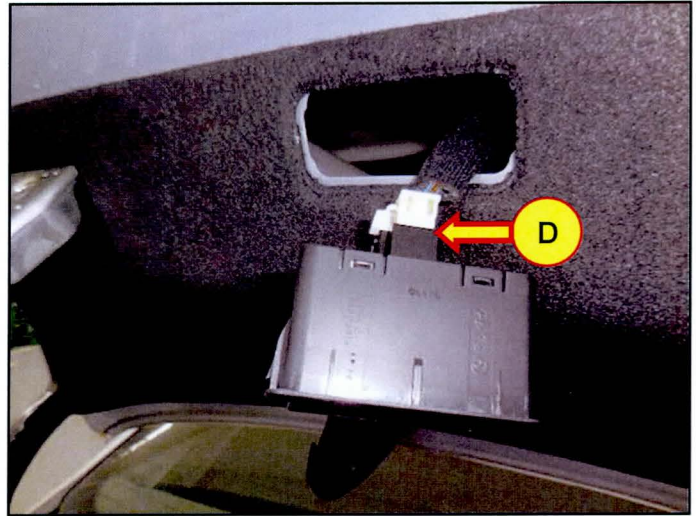
5. Remove the inside handle mounting screw (E).

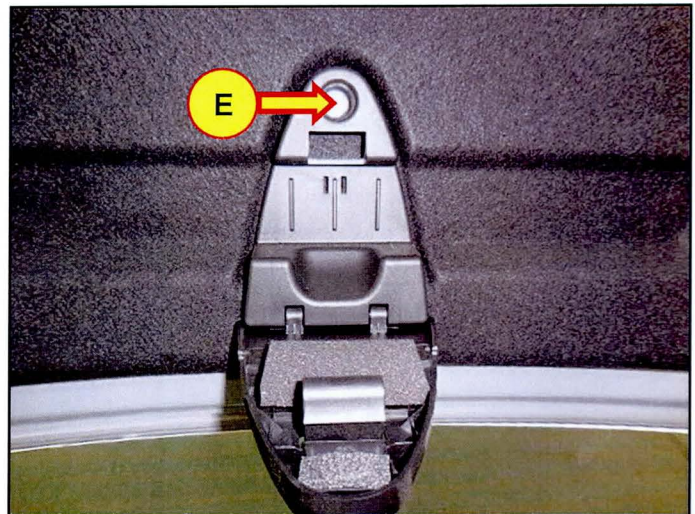
6. Remove the 4 trunk lid trim retainers (F) using a flat headed screwdriver.

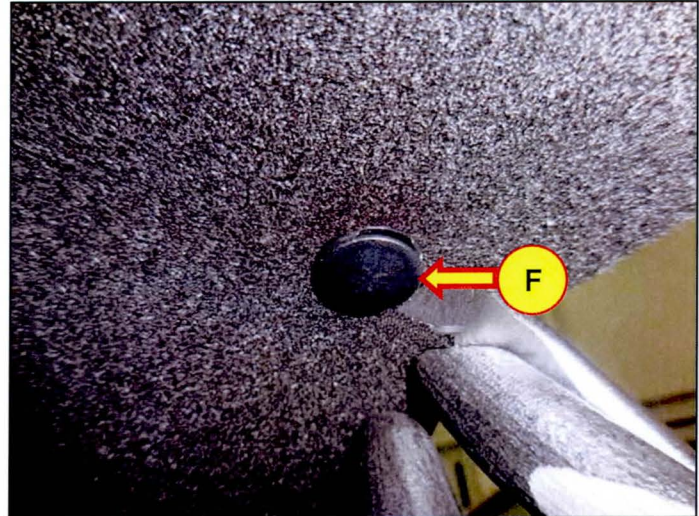
Red rectangle area on the below picture shows the position of 4 retainers to be removed.

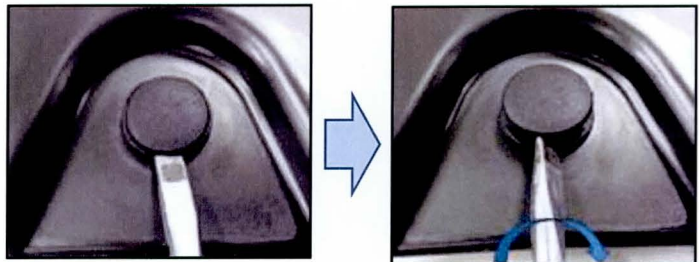
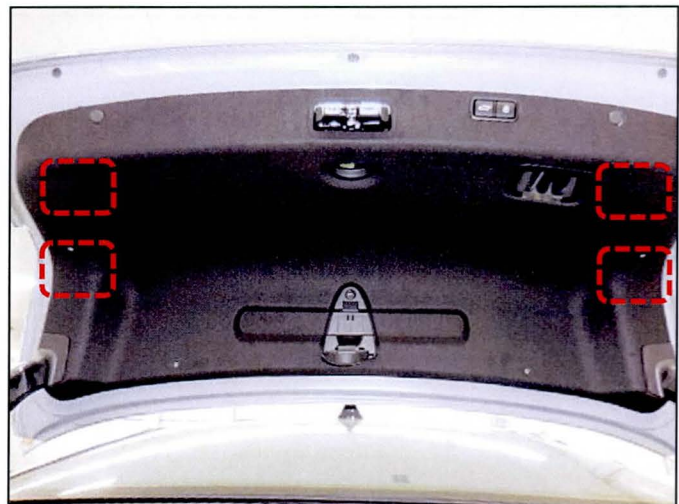
When removing the retainer, insert a flat headed screwdriver into the slot and then pry up the pin by turning the screw driver.

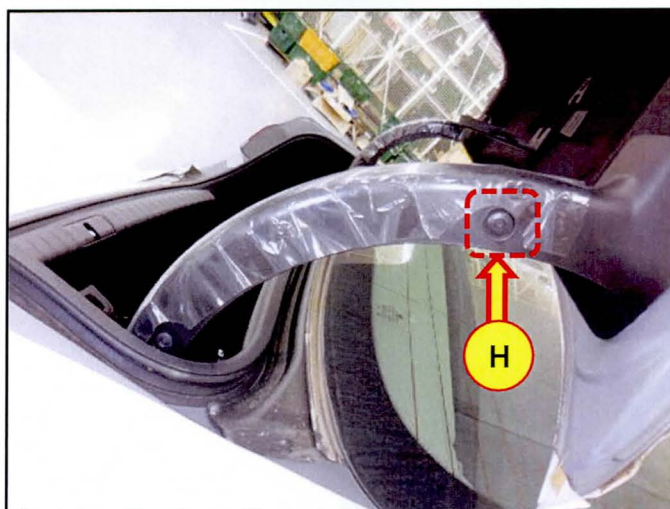
8. Remove the side cover mounting clips (H) on both sides.

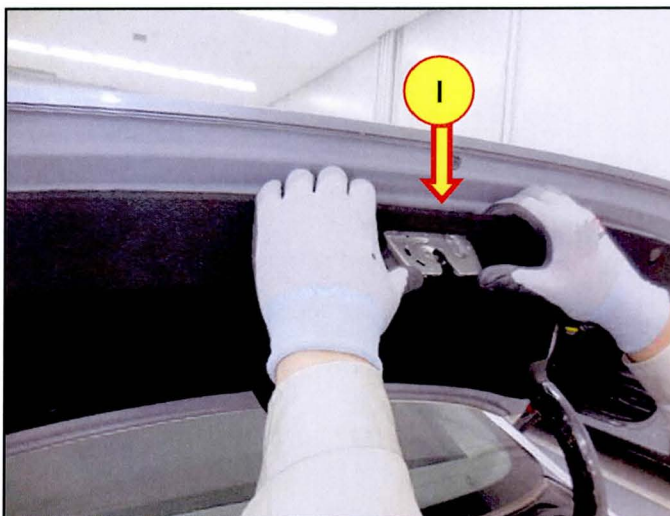
9. Separate the trunk lid trim (I) from the trunk by pulling it down.

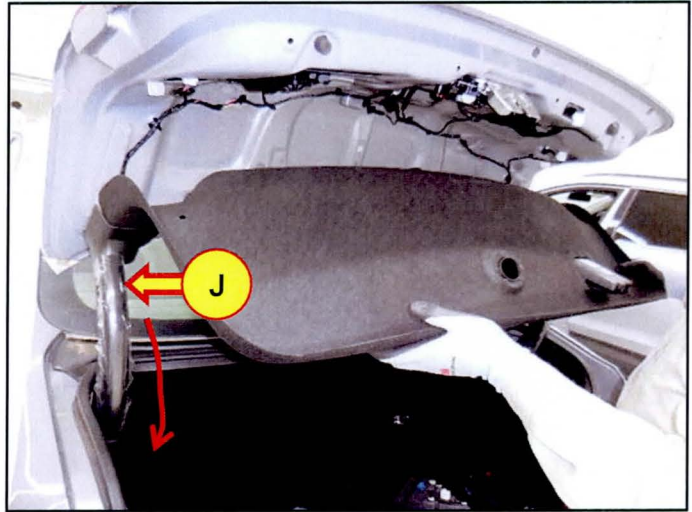
*Pull down the side cover (J) to the red arrow direction to secure the work space.
Be careful not to damage the trunk lid trim.*

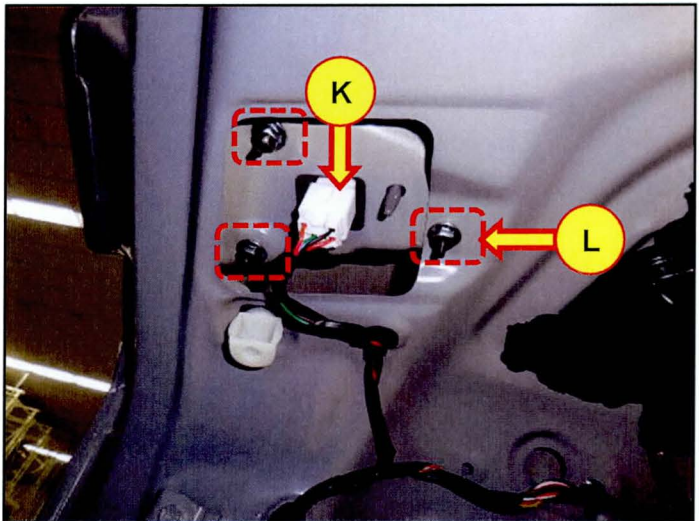
10. Disconnect the rear combination lamp connector (K) on both sides. Then remove the rear combination lamp mounting nuts (L) on both sides using a 10mm socket.

**Nut : 2.0 ~ 4.9Nm (0.2 ~ 0.5 kgf.m,
1.5 ~ 3.6 lb-ft)**

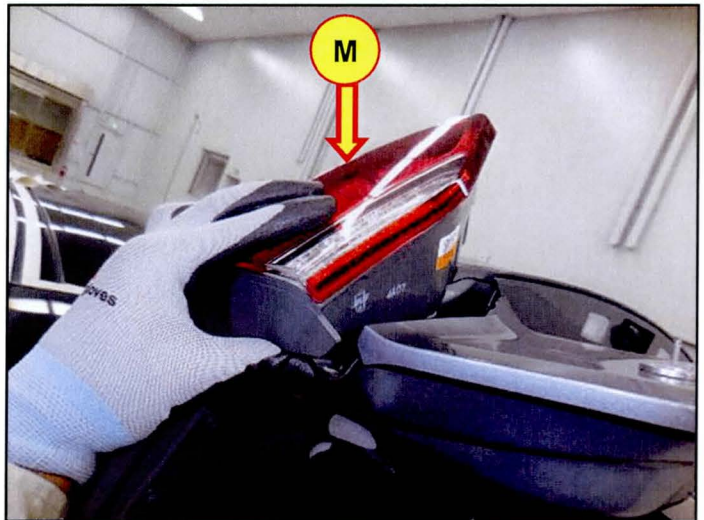
11. Remove the rear combination lamp (M) on both sides.

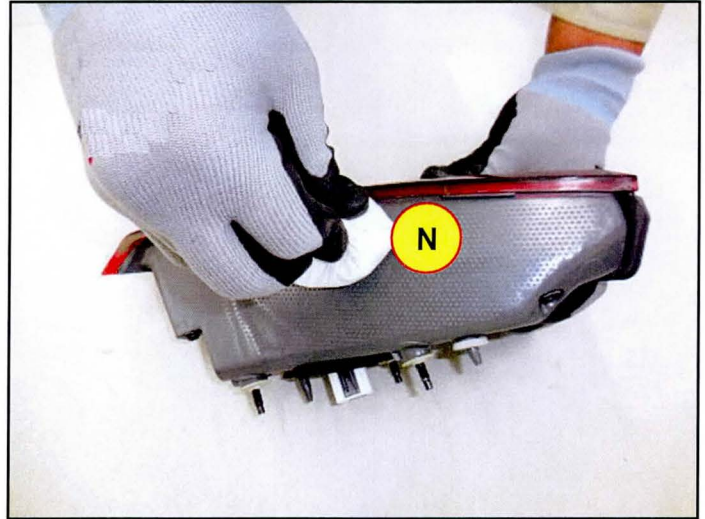
12. Clean the pad addition area (N) with a clean fabric.

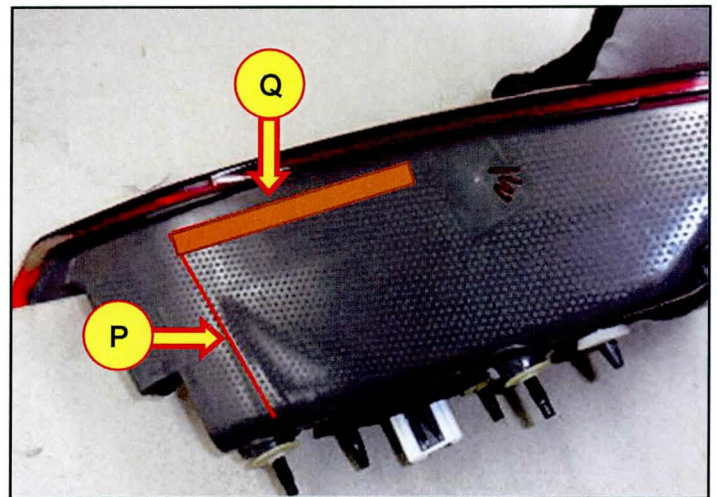
13. - P : Vertical end slope line
- Q : Horizontal end line of the embossment
- Orange rectangle area : Pad addition area

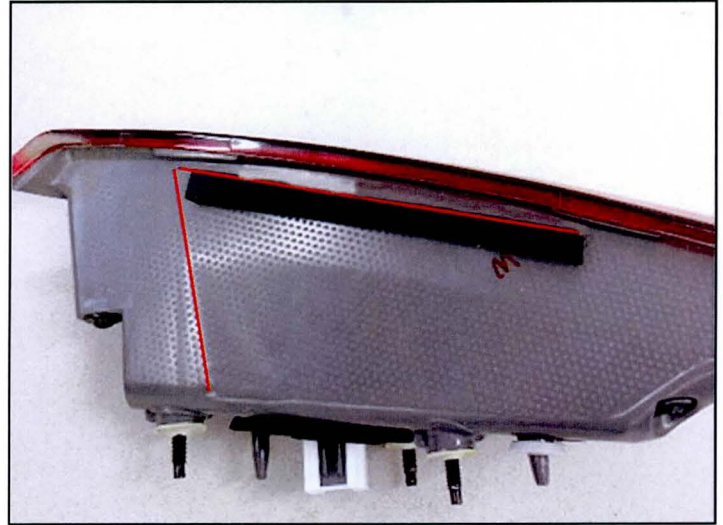
14. Attach the pad to the rear combination lamp for LH & RH and then reinstall all the removed parts in reverse order of removal.
