HYUNDAI

Technical Service Bulletin

NUMBER
14-01-061

**MOOD LAMP INSPECTION AND REPLACEMENT
(SERVICE CAMPAIGN TW1)**

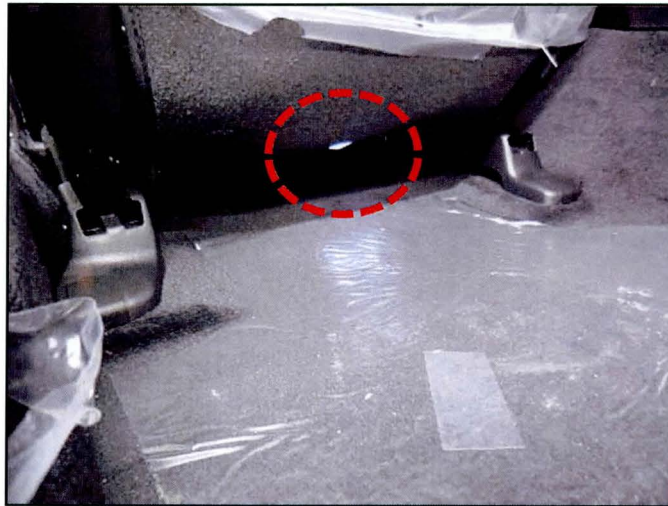
Description: This bulletin provides a service procedure to inspect and replace the front seats mood lamps if one of the lamps is dimmer than the other or does not illuminate.

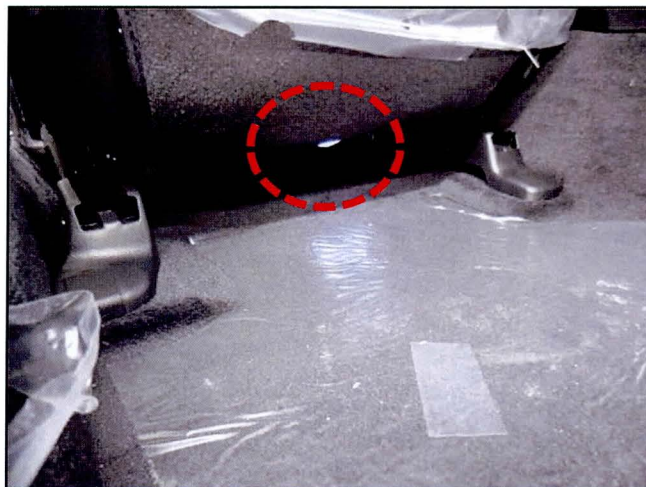
Check underneath the driver and passenger front seat to confirm the mood lights are operating normally.

If one of the mood lamps is darker than the other or does not illuminate, replace it with a new one.

When checking the mood lamp, place your eyes as level to the lamp as possible.

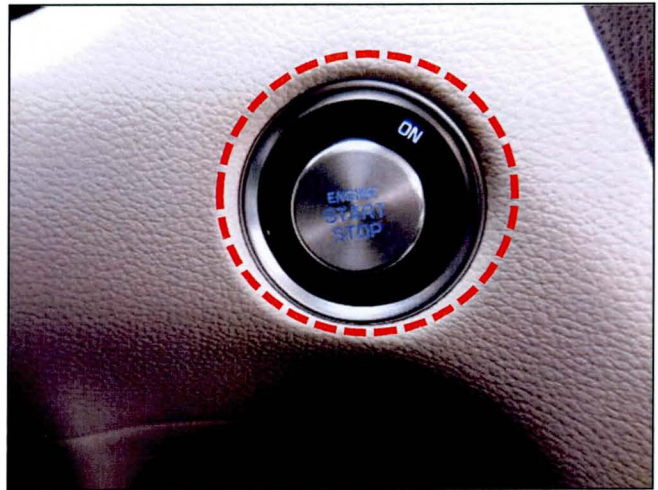
1. Turn the ignition **ON** (Press the Start-Stop button 2 times without depressing the brake pedal).

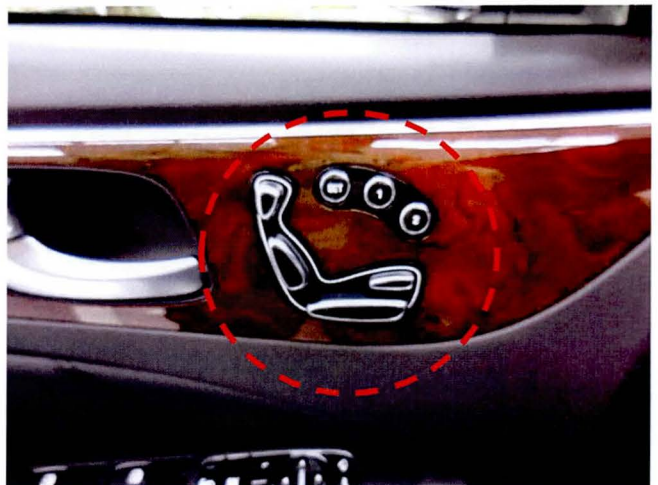
2. Using the seat control switches, move the seat to its maximum forward, and upward position.

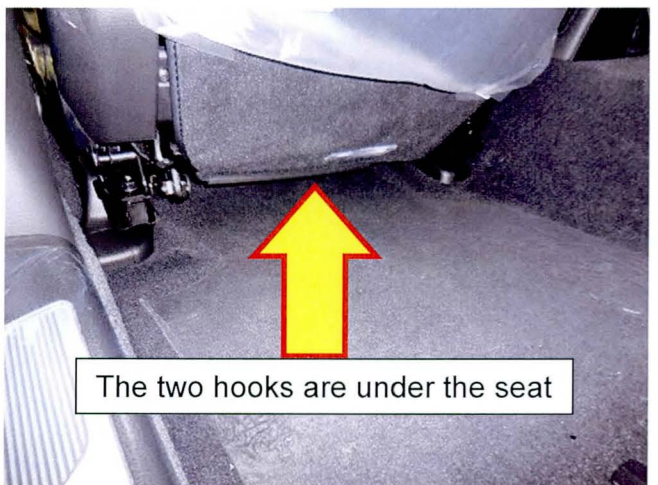
3. Remove the seat back cover hooks located at the bottom of the seat.

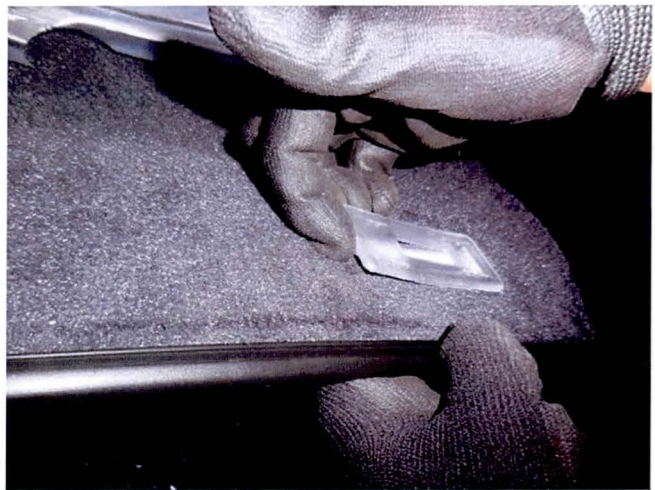
4. Remove the mood lamp lens cover.

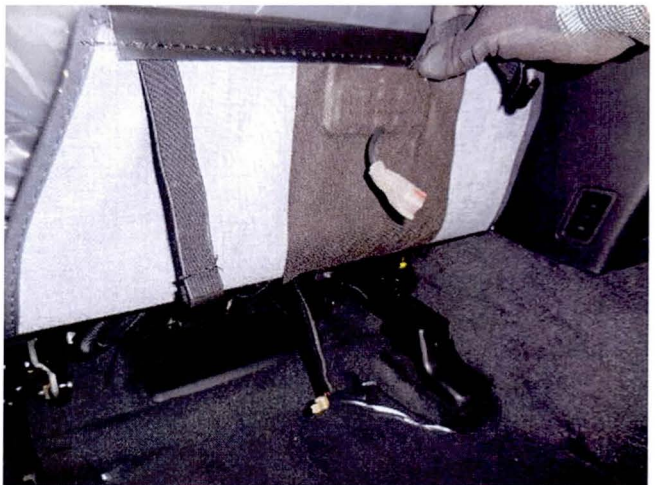
5. Disconnect the mood lamp connector

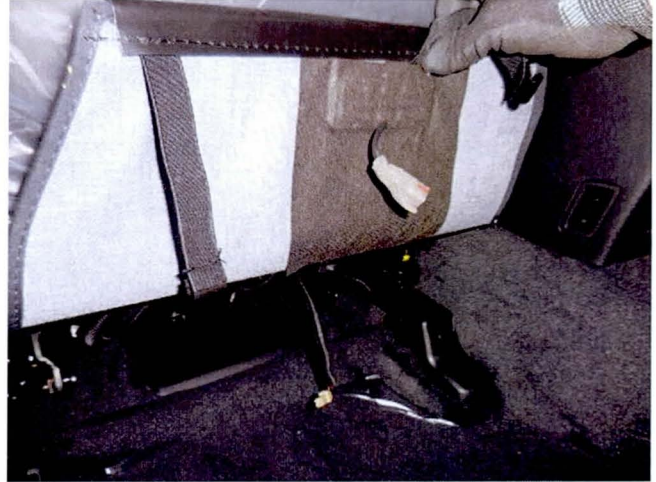
6. Remove the pad

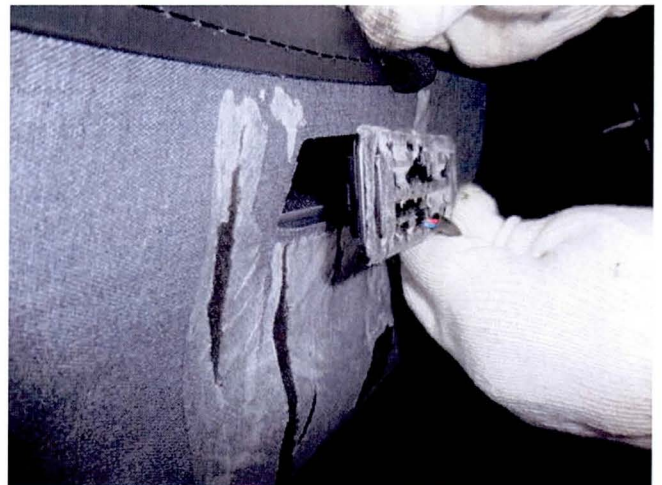
7. Remove the mood lamp

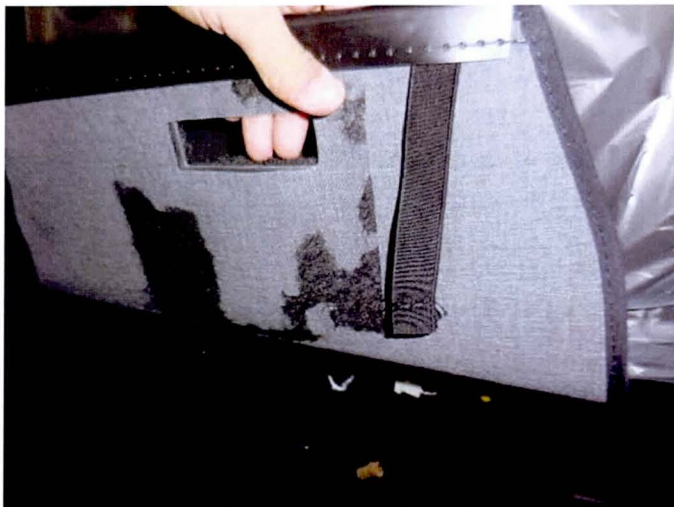
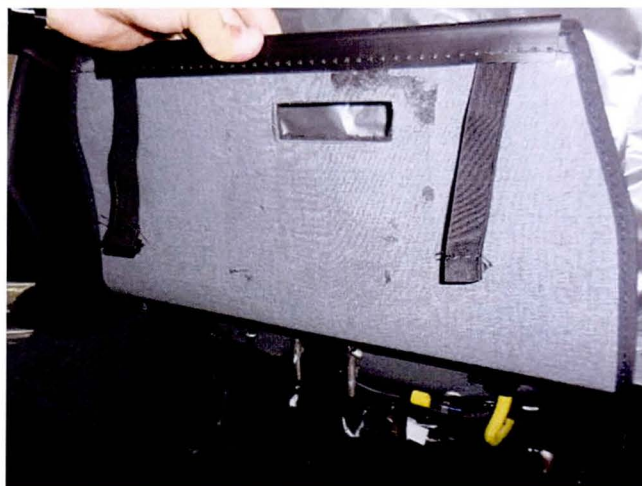
8. Remove the remaining pad residue on the seat back cover.

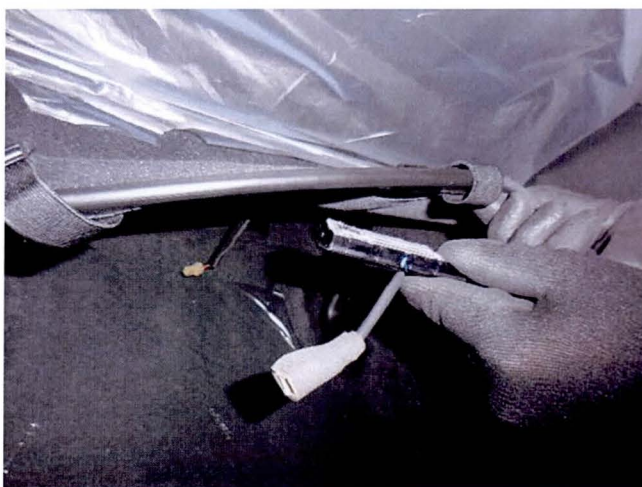
9. Install the new mood lamp.

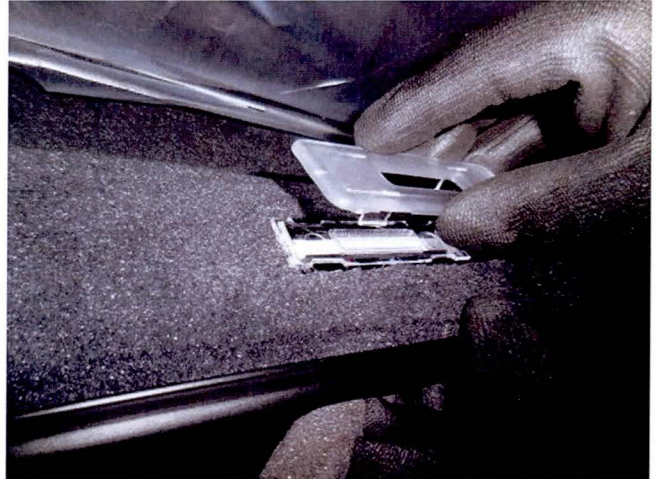
10. Install the new mood lamp lens cover.

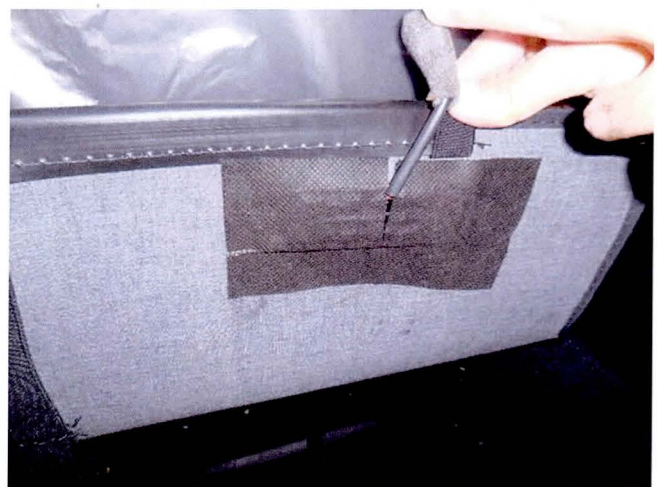
11. Confirm the correct pad for the seat (driver or passenger) is being used.

Attach the new pad.

- The mood lamp connector should be located at the center cut area of the pad.

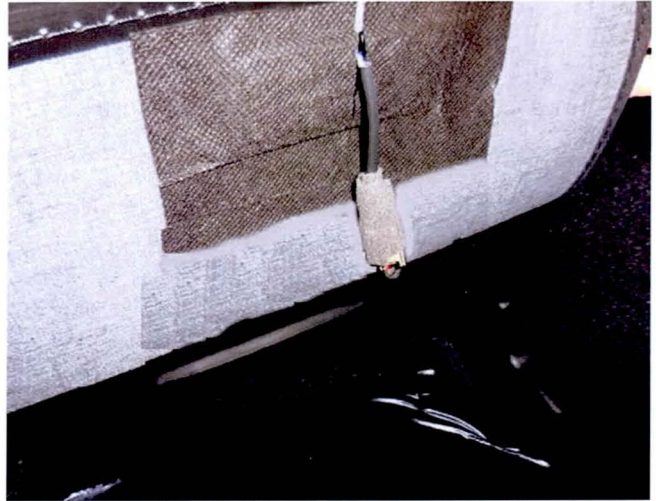
12. Reconnect the mood lamp connector.

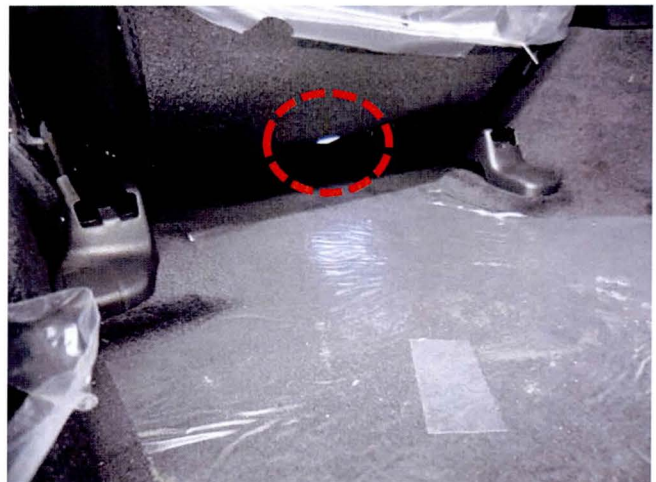
14. Turn the ignition switch **ON** and check underneath the driver and passenger front seat to confirm the mood lights are operating normally.
