HYUNDAI | NEW THINKING.
NEW POSSIBILITIES.
Technical Service Bulletin

GROUP CAMPAIGN	NUMBER 14-01-062
DATE DECEMBER 2014	MODEL(S) EQUUS (VI)

**SUBJECT: REAR CENTER CONSOLE ARMREST LID REPLACEMENT
(SERVICE CAMPAIGN TW2)**

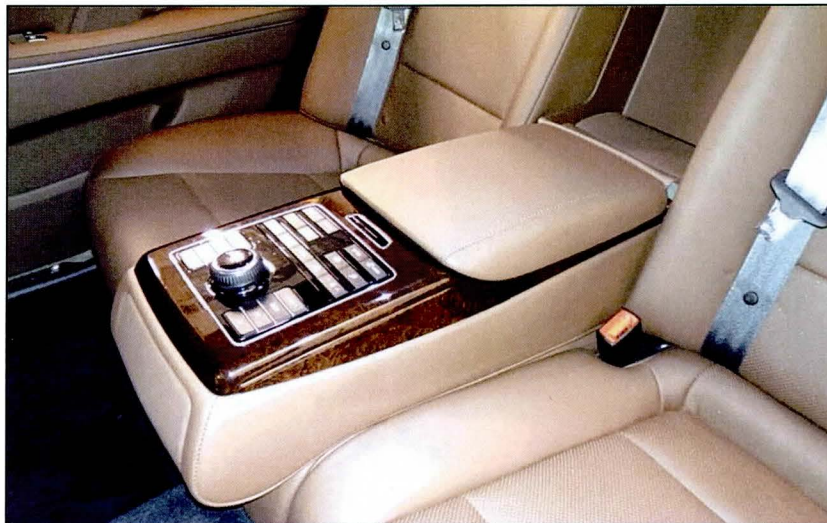
Description: On certain 2014MY- 2015MY Equus (VI) vehicles, the hinge on the rear center console armrest may split. This bulletin describes the procedure to replace the rear center console armrest lid.
