# Power Steering Rack Leak from Right Side: Overhaul Procedure

YEAR(S)	MODEL(S)	ADDITIONAL INFORMATION
2004 – 2009	RX330, RX350	WMI(s): 2T2

A new repair procedure and overhaul kit have been developed for repairing the power steering rack to improve the overall serviceability and reduce ownership cost. This repair procedure only applies to vehicles where the steering rack leak is originating from the right (passenger) side **and** is the OEM steering rack assembly.

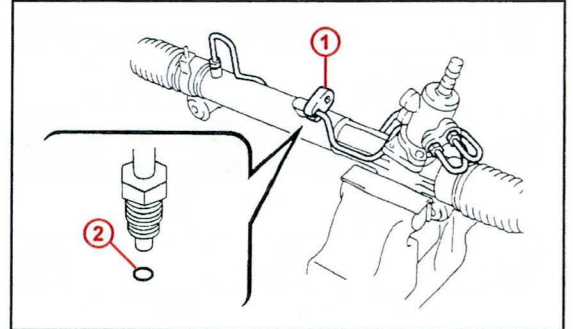
Figure 1.

1. Prepare the steering rack by steering the rack to the left-hand lock (clockwise).
2. Remove the steering left turn pressure tube.
  - A. Remove the tube clamp from the turn pressure tubes.
  - B. Using a 12 mm Union Nut Wrench (or equivalent), disconnect the left turn pressure tube.
  - C. Remove the 2 O-rings from the left turn pressure tube and discard.

<b>1</b>	Union Nut Wrench, 12 mm (or equivalent)
<b>2</b>	O-ring

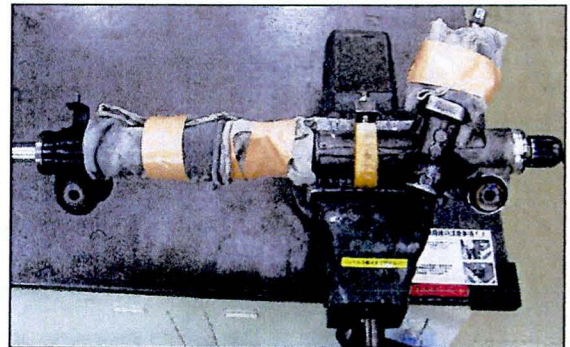
Figure 2.

3. Remove the steering right turn pressure tube.
  - A. Disconnect the right turn pressure tube using the procedure above.
  - B. Remove the 2 O-rings from the right turn pressure tube and discard.

Wrap the steering rack in cloth or shop rags to capture any excess power steering oil that will leak during the repair.

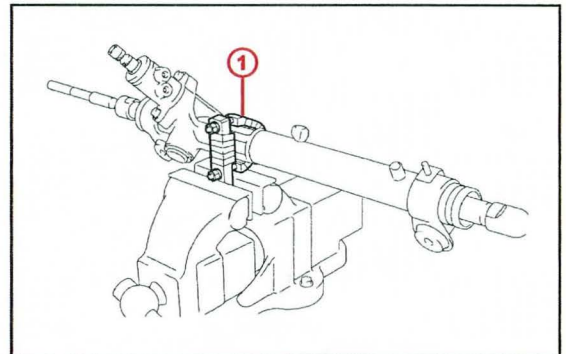
Figure 3.

- Using the Rack & Pinion Holding Tool, secure the steering link assembly to prevent damaging the steering link assembly.

SST: 09612-00012-01, Rack & Pinion Holding Tool

Wrap the SST with tape before use, in order to prevent damaging the steering link assembly.

1 Rack & Pinion Holding Tool

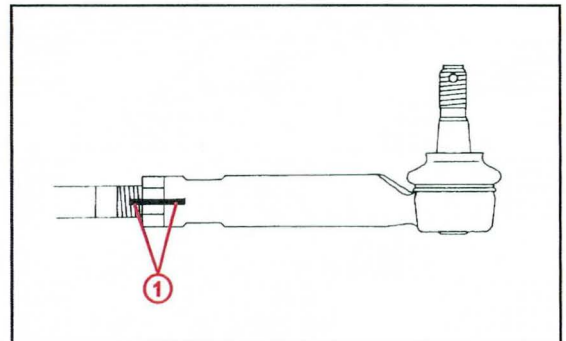
Figure 4.

- Put matchmarks on the tie rod assembly and the rack end.

1 Matchmarks

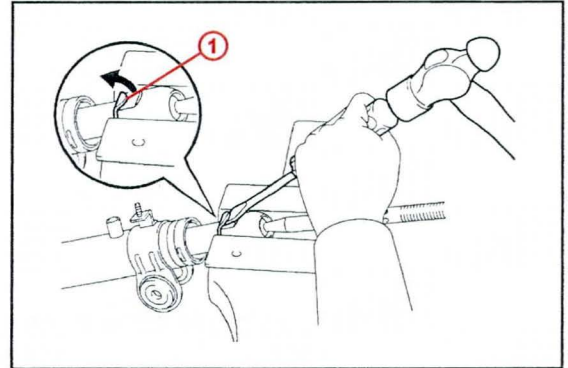
- A. Using soft jaws, clamp the steering rack end as shown in Figure 5.

This step is necessary to avoid transmitting impact to the steering rack gear and steering pinion gear which may cause damage.

1 Claw Washer

- B. Using a screwdriver and a hammer, unstake the claw washer.

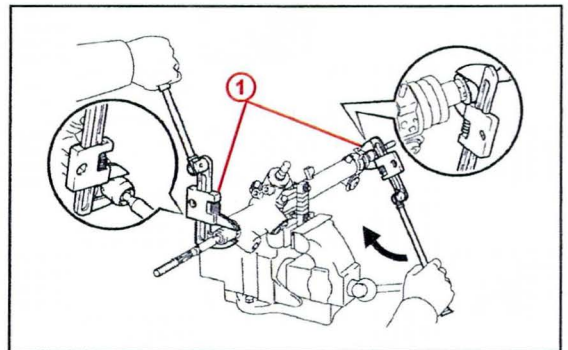
Figure 6.

- C. Using the Variable Open Wrench, remove the right-hand rack end and the claw washer.

SST: 09922-10010-01, Variable Open Wrench

1 Variable Open Wrench

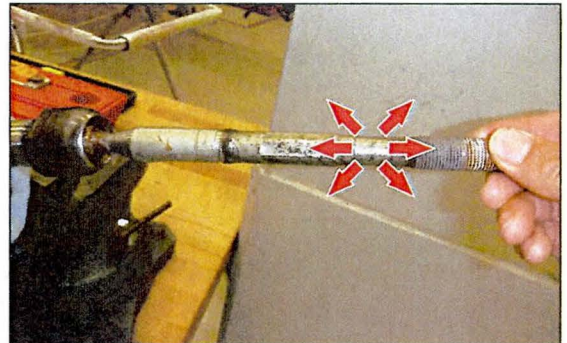
Figure 7.

14. Inspect the left-hand and right-hand tie rod ends for excessive wear and play. Push and pull the tie rod to confirm condition. Replace as necessary.

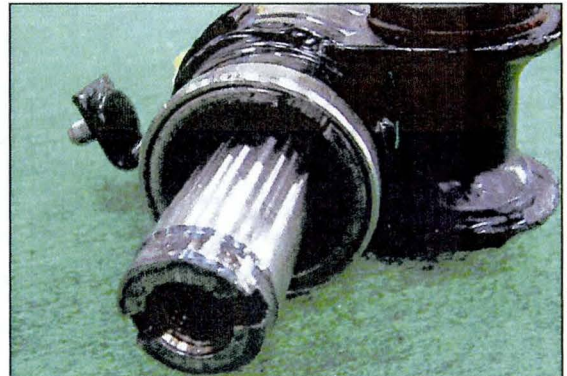
Figure 8.

15. Thoroughly clean the steering rack assembly.

Be sure to clean the inside of the rack assembly to prevent foreign material from damaging the rack surface (for example, when boot has torn and allowed debris to collect around the inside of the rack).

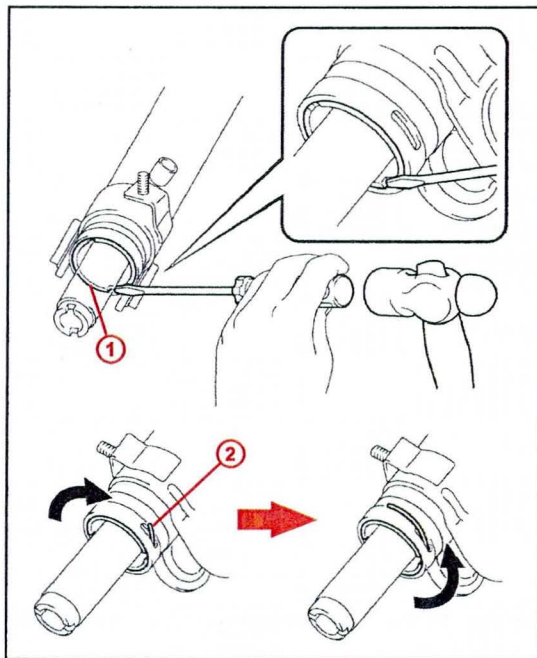
Figure 9.

- A. Using a screwdriver and a hammer, turn the cylinder end stopper clockwise until the wire end is visible through the service hole.
- B. Using a screwdriver and a hammer, turn the cylinder end stopper counterclockwise, and remove the wire and the cylinder end stopper.

Use the hooked wire end or a 90 degree angle hooked pick to pull the end stopper out.

1	Cylinder End Stopper
2	Wire

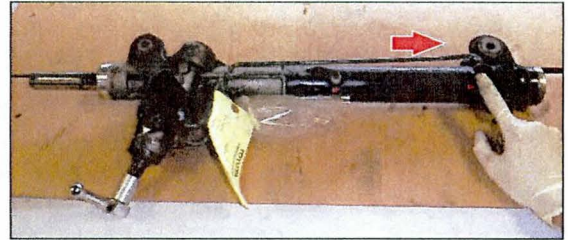
Figure 11.

17. Remove the power steering rack bushing.

Plug the port while simultaneously turning the input shaft counterclockwise.

The internal air pressure will cause the rack bushing to get pushed out.

Do NOT turn the input shaft clockwise. May cause damage to the center seal on the rack bar if it goes beyond its normal travel.

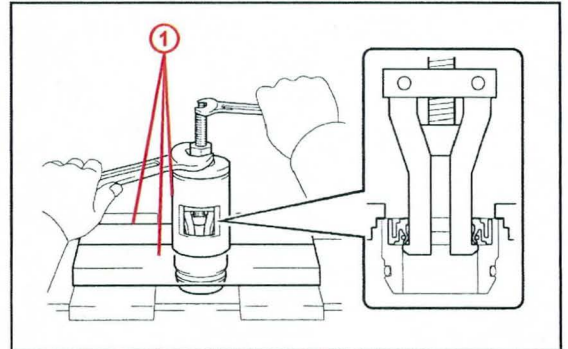
Figure 12.

- A. Using the SSTs listed below, remove the rack bushing oil seal from the rack bushing.

SST: 09527-21011, Rear Axle Shaft Bearing Remover (or equivalent)

SST: 09612-24014, Steering Housing Overhaul Tool Set (09613-22011, Puller)

- B. Using a screwdriver or pick, remove the O-ring from the rack bushing.

- 1 Rear Axle Shaft Bearing Remover (or equivalent), Puller

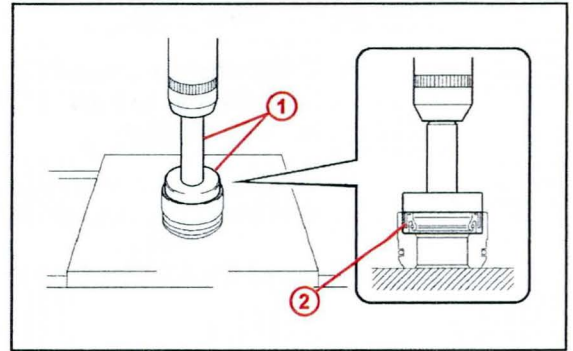
Figure 13.

- A. Coat a new rack bushing oil seal lip and outside diameter with power steering oil.
- B. Using the SSTs listed below and a press, install the rack bushing oil seal to the rack bushing.

**SST: 09950-60010-02, Replacer Set #1 (09951-00400-01, Replacer 40)**

**SST: 09950-70010-02, Handle Set (09951-07100-01, Handle Assembly 100 - 4.25")**

- C. Coat a new O-ring with power steering oil and install it to the rack bushing.

<b>1</b>	Replacer 40, Handle Assembly 100 - 4.25"
<b>2</b>	Oil Seal

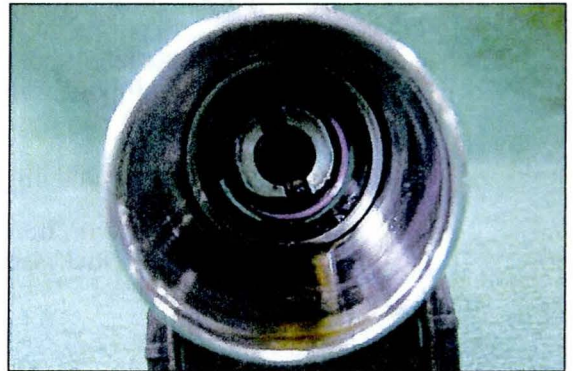
Figure 14.

21. Inspect and clean the inside of the rack housing.

Look down inside the rack housing to confirm it is clean before reinstalling the rack bushing.

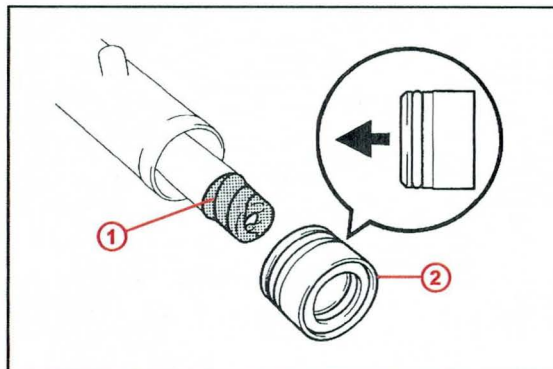
Figure 15.

22. Install the power steering rack bushing to the rack housing.
  - A. Wrap vinyl tape around the end of the steering rack in order to prevent damaging the rack bushing oil seal.
  - B. Coat the rack bushing oil seal lip, vinyl tape, and the O-ring with power steering oil.
  - C. Install the rack bushing to the rack housing.

1	Vinyl Tape
2	Rack Bushing

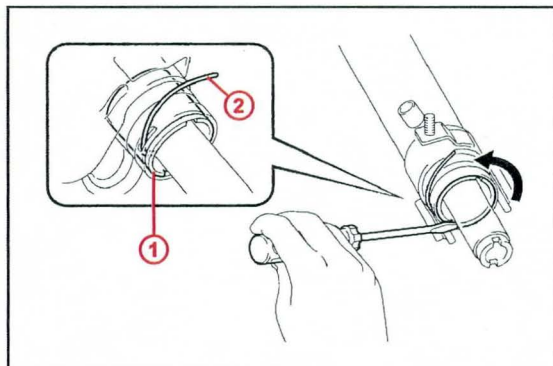
Figure 16.

23. Install the cylinder end stopper.
  - A. Align the installation hole for the wire of the cylinder end stopper with the slot of the rack housing.
  - B. Install a new wire into the cylinder end stopper.
  - C. Using a screwdriver, turn the cylinder end stopper counterclockwise by  $450^{\circ} \pm 50^{\circ}$ .

1	Cylinder End Stopper
2	Wire

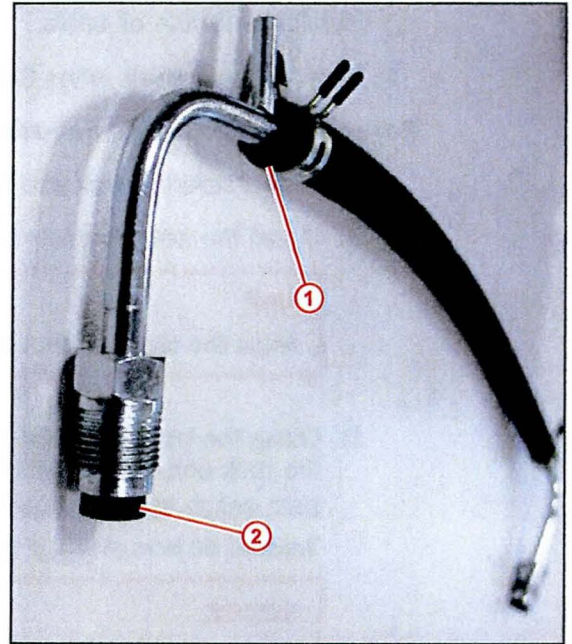
Figure 17. Vacuum Pressure Tester Seal

1. Remove the old O-ring and install 2 Vacuum Pressure Tester Seals to ensure proper sealing during testing.

SST: 09633-00010-01, Vacuum Pressure Tester Seal

1	Vacuum Pressure Tester
2	Tester Seal

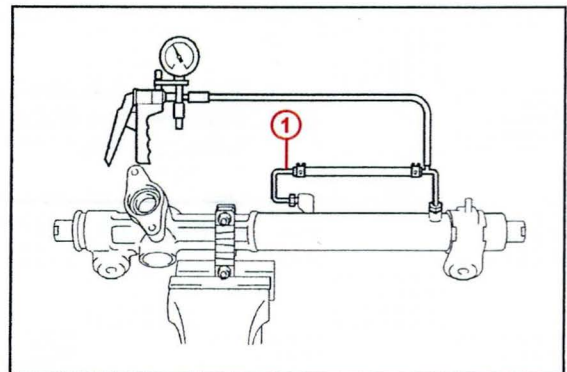
Figure 18.

2. Install the SSTs to the rack housing.  
SST: 09631-12071, Steering Rack Oil Seal Test Tool  
SST: 09633-00010-01, Tester Seal (2)

**NOTE**  
Be sure not to over-torque the SST as it can crush the opening of the seal shut and cause inaccurate reading.

1	Steering Rack Oil Seal Test Tool, Tester Seal
---	---

3. Apply a vacuum of 53 kPa for about 30 seconds.  
Vacuum Pressure: 53 kPa (400 mmHg, 15.75 in.Hg)

4. Check that there is no change in the vacuum. If there is a change in the vacuum, check the installation of the oil seals.
5. Remove the 2 seals when SST is removed from the steering rack housing.

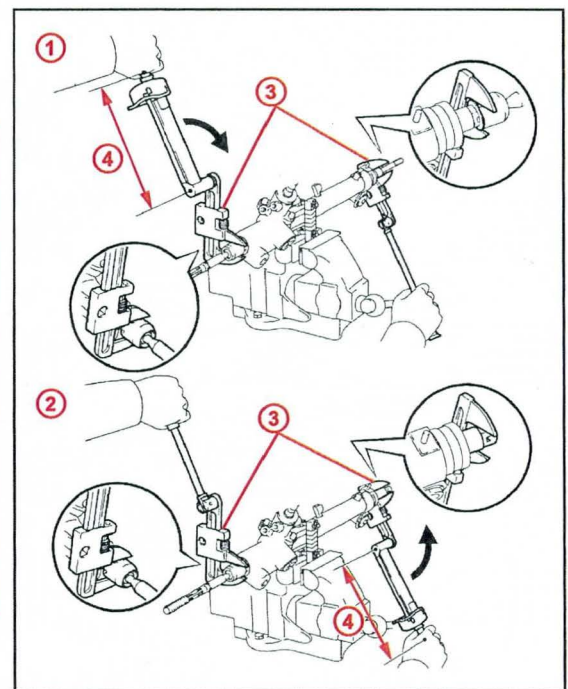
Figure 19.

1. Install the steering rack end sub-assembly.
  - A. Install the new claw washers, and temporarily install the rack end sub-assembly.

Align the claws of the claw washer with the steering rack grooves.

- B. Using the Variable Open Wrench SST, install the rack end sub-assembly.

Torque: 50 N\*m (505 kgf\*cm, 37 ft\*lbf)

Use the Variable Open Wrench following the direction shown in the illustration. Failure to follow this procedure will result in the tie rod not being tightened to the proper torque.

- Using the Variable Open Wrench, hold the rack and install the rack end sub-assembly.
- Use a torque wrench with a fulcrum length of 345 mm (13.58 in.).

1	LH
2	RH
3	Variable Open Wrench
4	Fulcrum Length

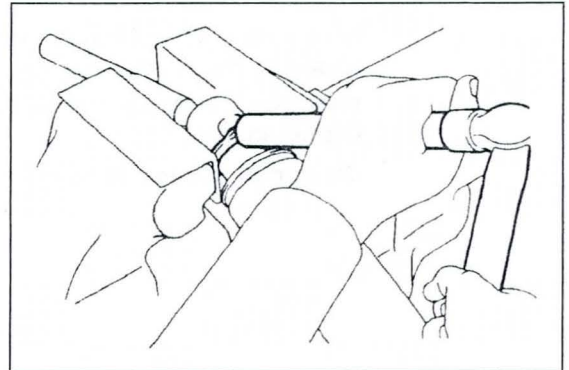
Figure 20.

2. Use a brass bar and a hammer to stake the claw washer.

Clamp the tie rod as shown to help avoid any impact to the steering rack.

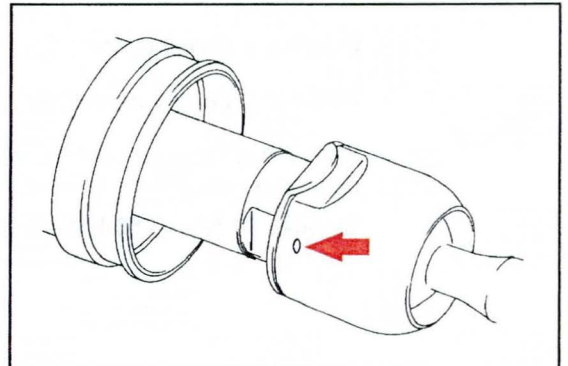
Figure 21.

3. Inspect the power steering rack end. Ensure that the holes of the rack ends are NOT clogged with grease.

If the hole is clogged, the pressure inside the boot will change after it is assembled and steering wheel is turned.

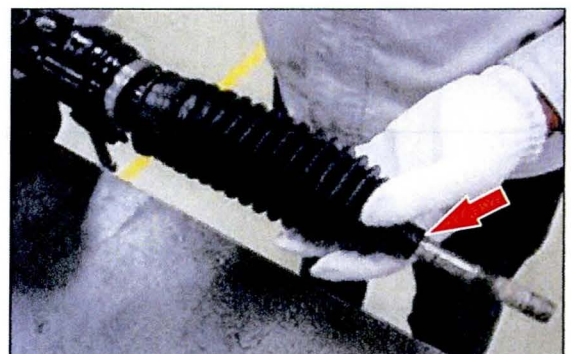
Figure 22.

4. Install the steering rack boot.
  - A. Apply a small coat of silicone grease to the inside clamping surface of the small end of the boot as shown.
  - B. Install the steering rack boot.
  - C. Install the steering rack boot clip using pliers.

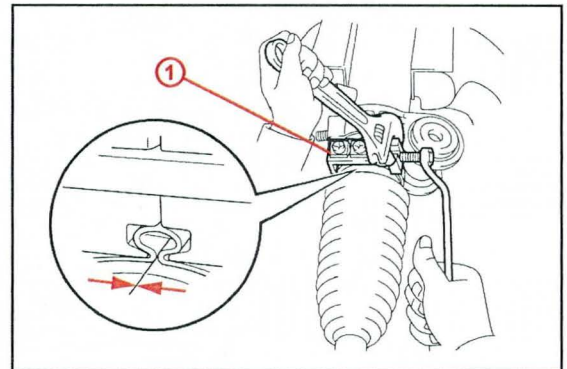
**Figure 23.**

Using the SST, tighten the rack boot clamp as shown in the illustration.

**SST: 09521-24010-02, Drive Shaft Boot Clamping Tool**

**Clearance: 3.0 mm (0.18 in.) or less**

<b>1</b>	<b>Drive Shaft Boot Clamping Tool</b>
----------	---------------------------------------

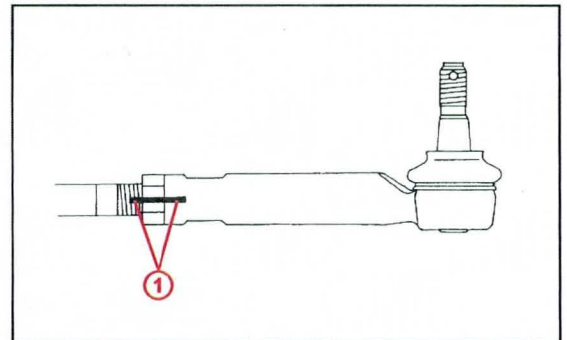
**Figure 24.**

Screw the lock nut and tie rod assembly on the rack end until the matchmarks are aligned.

**Torque: 74 N\*m (750 kgf\*cm, 54 ft\*lbf)**

<b>1</b>	<b>Matchmarks</b>
----------	-------------------

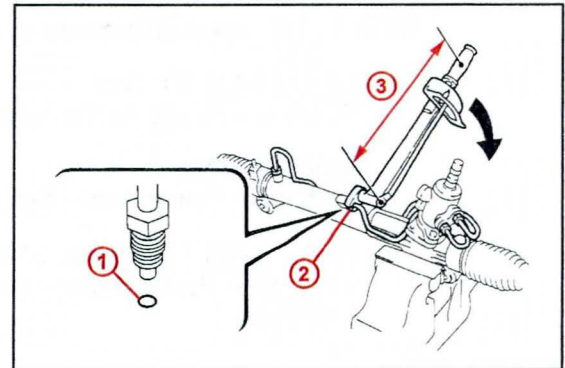
Figure 25.

9. Install the steering left turn pressure tube.
  - A. Coat 2 NEW O-rings with power steering oil and install them to the left turn pressure tube.
  - B. Using a 12 mm union nut wrench (or equivalent), install the left turn pressure tube to the steering link assembly.  
Torque: 12 N\*m (122 kgf\*cm, 9 ft\*lbf)

Use a torque wrench with a fulcrum length of 250 mm (9.84 in.).

1	O-ring
2	Union Nut Wrench, 12 mm (or equivalent)
3	Fulcrum Length

10. Install the steering right turn pressure tube.
  - A. Coat 2 NEW O-rings with power steering oil and install them to the right turn pressure tube.
  - B. Using a 12 mm union nut wrench (or equivalent), install the right turn pressure tube to the steering link assembly.  
Torque: 12 N\*m (122 kgf\*cm, 9 ft\*lbf)
