HYUNDAI NEW THINKING. NEW POSSIBILITIES. Technical Service Bulletin	GROUP CAMPAIGN	NUMBER 14-01-003
	DATE JANUARY 2014	MODEL(S) Entourage (EP)
SUBJECT: HEATER PIPE AND HOSE ASSEMBLY REPLACEMENT (SERVICE CAMPAIGN TR9)

Description: This bulletin describes the procedure to replace the heater pipe and hose assembly on certain Entourage (EP) vehicles with an updated part (shown below).

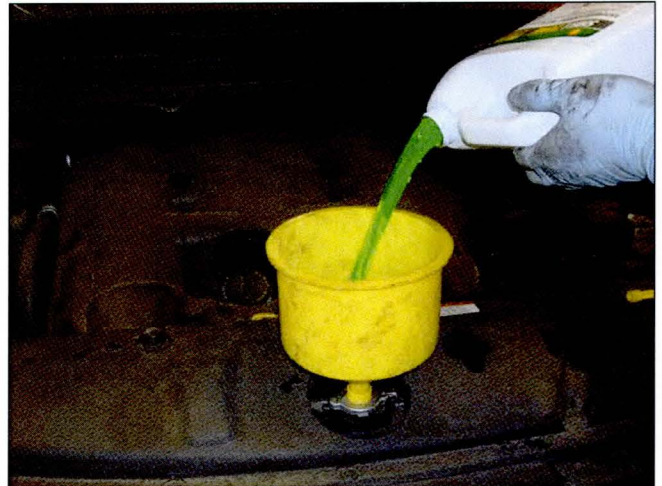
Use an elevated funnel to the radiator filler neck with a cap adapter (as shown on the right picture) to facilitate the coolant filling and air bleeding process.

9. Replace the heater pipe and hose assembly with an updated part and install in reverse order of removal.
10. Refill the engine cooling system with coolant mixture of anti-freeze and water by referring to the applicable Shop Manual.

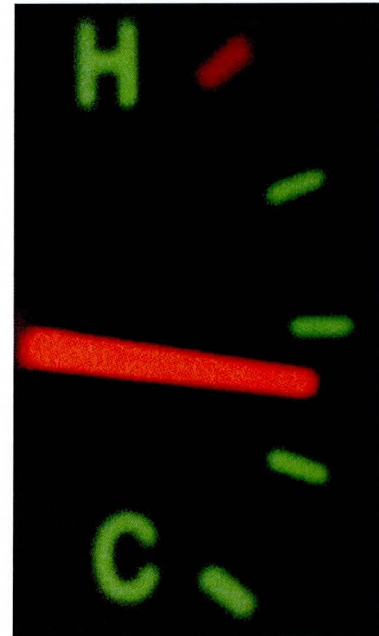
12. After the cooling system has reached normal operating temperature and all the trapped air is bled out of the system:
 - Close the radiator cap.
 - Wipe any residual coolant that may have been spilled.
 - Check for any leaks.
