**NUMBER:** 08-003-14 REV. A

Integrated Center Stack Missing Buttons

This bulletin involves replacing the integrated center stack (ICS) bezel.

2014 (WK) Jeep Grand Cherokee

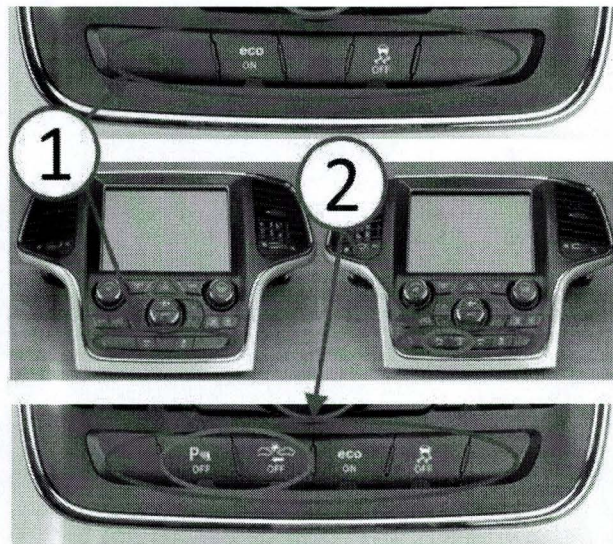
**Fig. 1 ICS Button Content Inspection**

1 - Buttons Missing - Replace ICS

2 - Buttons Present - Correct ICS

1. Inspect the ICS button content for the Front & Rear Park Assist and Forward Collision Warning buttons (Fig. 1).
  - a. Buttons missing, only two buttons in lower row (1) >>> Proceed with Repair Procedure.
  - b. Buttons present, four buttons in lower row (2) >>> Repair Procedure does not apply, return vehicle to customer.

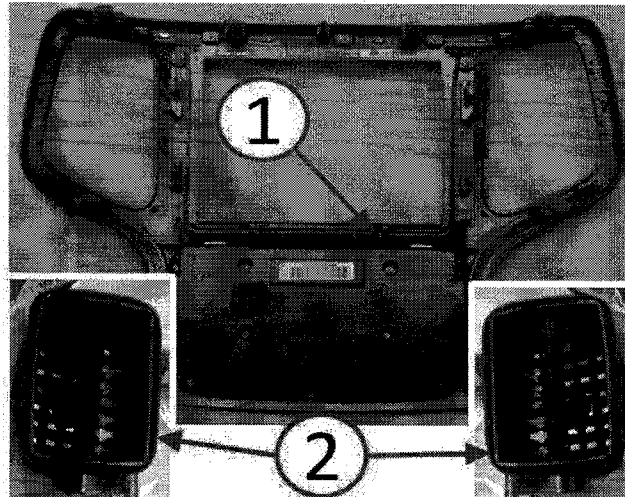
**Fig. 2 New ICS Components**

- 1 - ICS Bezel
- 2 - HVAC outlets

- 
2. Unpack the NEW ICS bezel (1) and HVAC outlets (2). Place ICS bezel face down on a clean padded surface. Determine the proper location of the HVAC outlets. HVAC outlets are labeled LH and RH (Fig. 2).

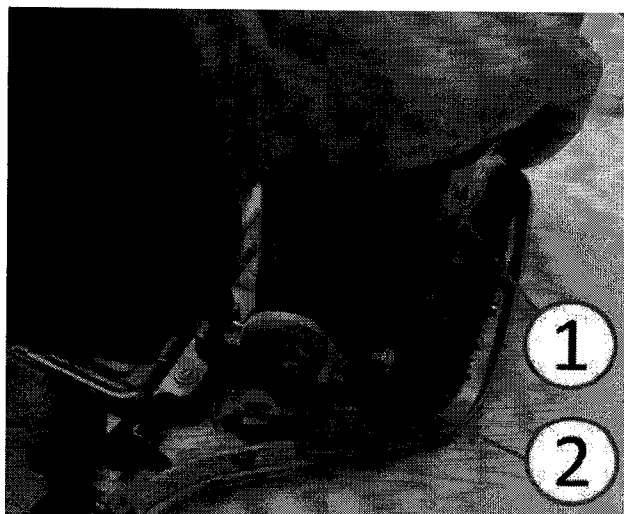
***Fig. 4 HVAC Outlet Lower Attachment***

- 1 - HVAC outlet
- 2 - ICS Bezel

4. Apply equal pressure with palm of hand to the bottom portion of the HVAC outlet (1) to engage the remaining HVAC outlet to ICS bezel (2) attachment features (Fig. 4).

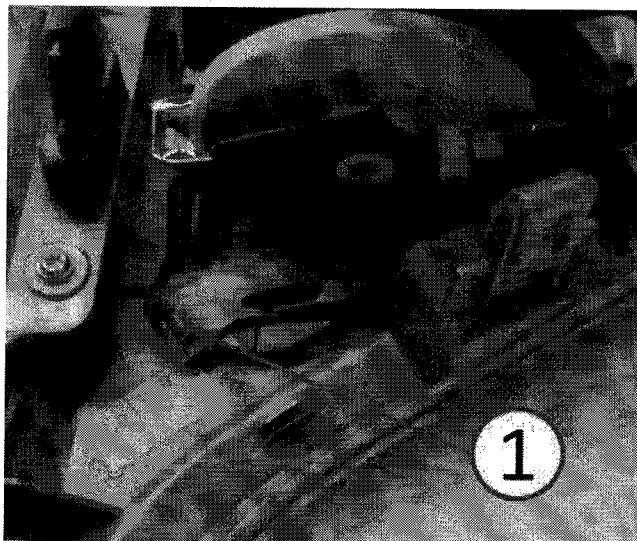
***Fig. 5 HVAC Outlet Lower Inner Corner Attachment***

- 1 - Attachment Feature
-

- 
5. Ensure the lower inner corner of the HVAC outlet is properly attached (Fig. 5).

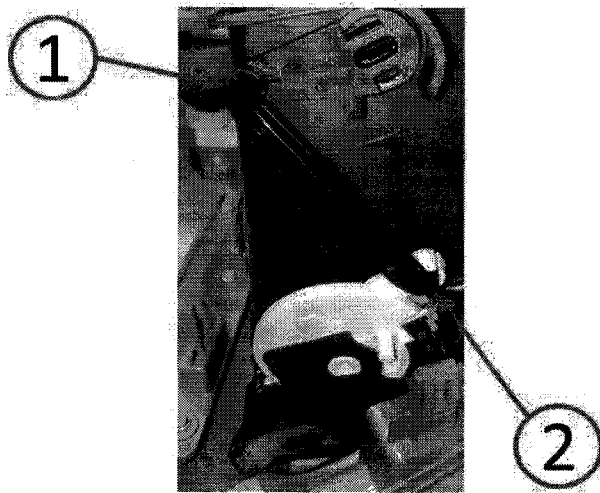
**Fig. 8 HVAC Outlet Linkage Attachment**

- 1 - Damper Door Lever  
2 - Control-Wheel
-

8. Ensure that the linkage arm is attached to the damper door lever (1) and the control-wheel (2) (Fig. 8).

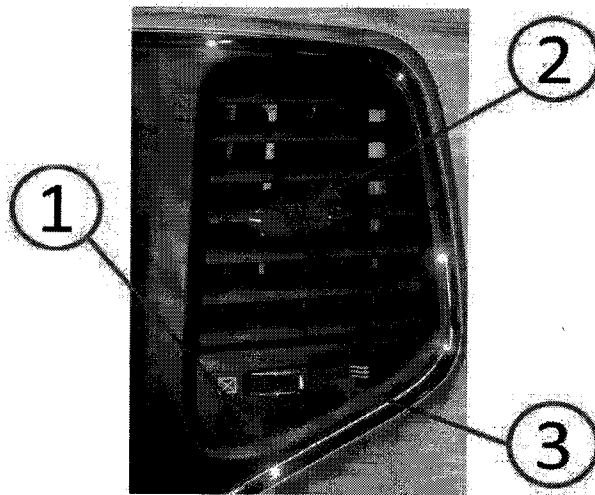
***Fig. 9 HVAC Outlet Installation And Function***

- 1 - HVAC Outlet Mating Surface
- 2 - Center-Knob
- 3 - Control-Wheel

9. Ensure there are no gaps between the ICS bezel and the HVAC outlet perimeter mating surface (1) (Fig. 9).
10. Using the center-knob (2), cycle the air vanes up, down, and side to side to ensure they move freely (Fig. 9).
11. Cycle the control-wheel (3) side to side while inspecting the damper door is functioning properly in open and closed positions (Fig. 9).

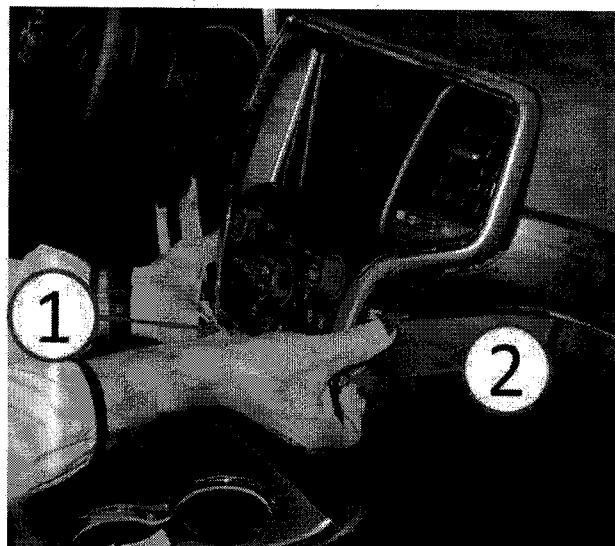
***Fig. 10 ICS Bezel Removal Lower***

1 - ICS Bezel

2 - HVAC Outlets

- 
- 12. Repeat steps 3 through 11 for opposite side HVAC outlet installation to ICS bezel.
  - 13. Open console bin door and grasp bottom edge of ICS bezel (1) (Fig. 10).
  - 14. Pull firmly rearward to disengage the lower attachment clips (2) (Fig. 10).

**NOTE: Do not use a trim stick to remove the center stack as damage to instrument panel surface is possible.**

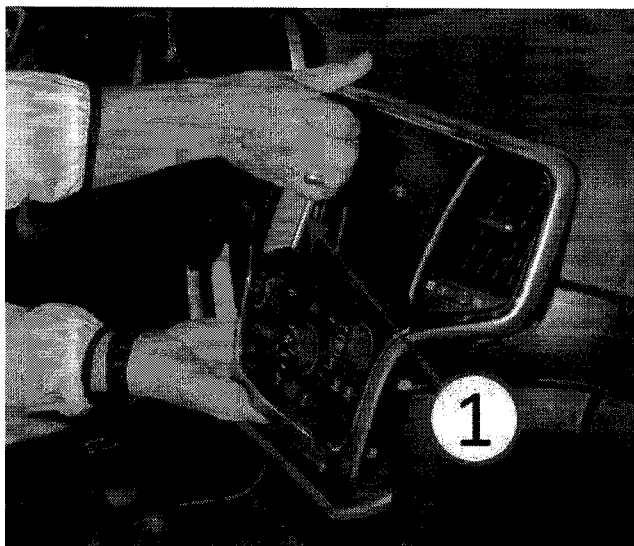
***Fig. 11 ICS Bezel Removal Upper***

1 - ICS Bezel

- 
15. Continue working around the ICS Bezel to disengage the remaining attachment clips on the right side and left side grasping inside the display screen opening (Fig. 11).

**NOTE: Verify that no damage has been done to wood appliques.**

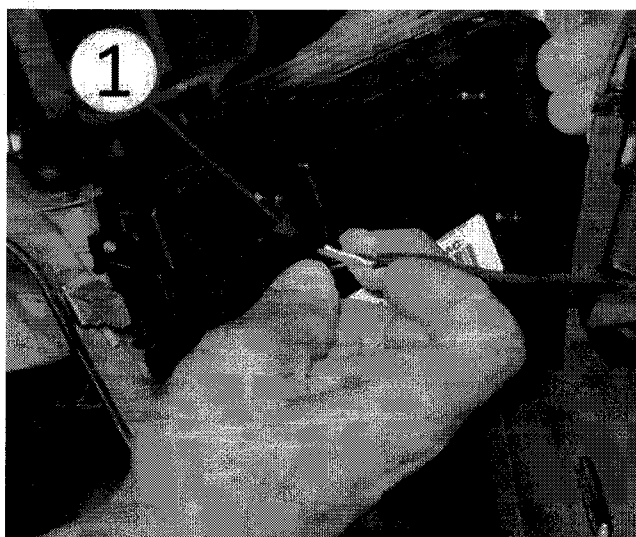
***Fig. 12 ICS Electrical Connector***

1 - Electrical Connector

16. Disconnect the electrical connector from the ICS (Fig. 12).
17. Connect the electrical connector to the NEW ICS (Fig. 12).

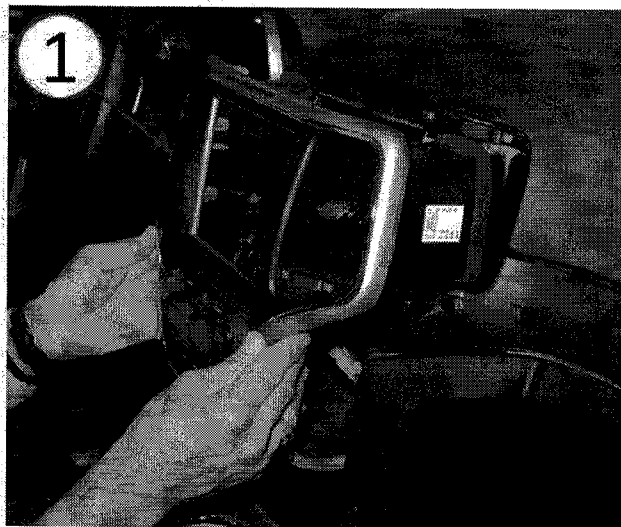
***Fig. 13 ICS Bezel Installation***

1 - ICS Bezel

18. Gently wiggle the ICS bezel into place ensuring the HVAC outlets properly engage the HVAC ducts (Fig. 13).

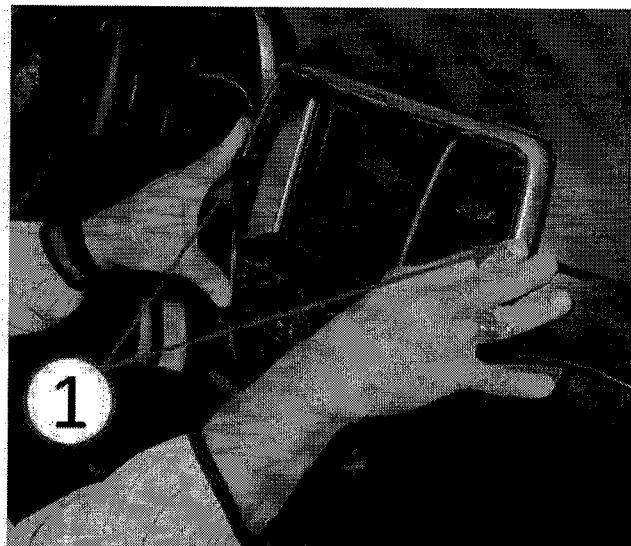
***Fig. 14 ICS Bezel Installation***

1 - Plastic Injection Molding Flash Bump

- 
19. Using both hands firmly push on the perimeter of the ICS bezel to fully engage the attachment clips (Fig. 14).

**NOTE:** Verify that no damage has been done to wood appliques.

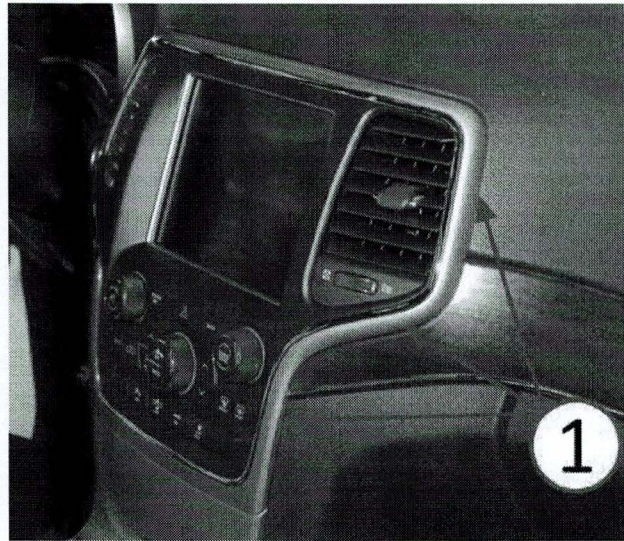
**Fig. 15 ICS Bezel Installation Inspection**

1 - ICS Bezel Perimeter

20. After seating the ICS bezel check for gaps around the perimeter to insure the ICS bezel is flush and properly installed to the instrument panel (Fig. 15).
