# Abnormal Noise from Front Strut Mount

Service Category Suspension

Section Front Suspension

YEAR(S)	MODEL(S)	ADDITIONAL INFORMATION
2011 – 2015	CT200H

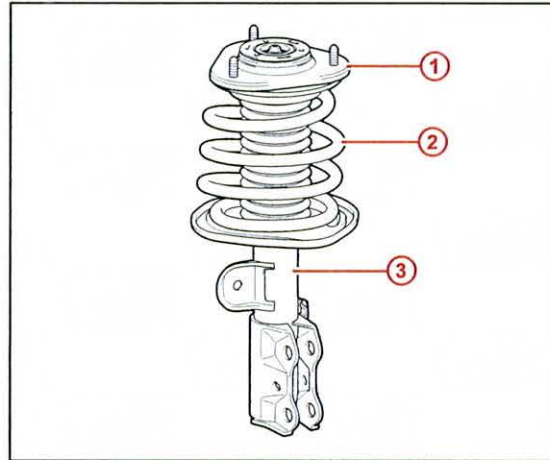
Figure 1.

Some 2011 – 2015 model year CT 200h vehicles may exhibit a metallic clicking noise from the front of the vehicle when driving over a washboard-type road surface, or a creak when turning left or right. A new Front Suspension Support Sub-assembly (front strut cap support) is now available to address this condition.

1	Front Suspension Support Sub-assembly
2	Coil Spring
3	Strut

4. Install front strut assembly with the NEW front strut cap support.
