NUMBER: 23-027-14

Zinc Coating Missing From Left Rear Close Out Panel

This bulletin involves inspecting the Julian date on the left rear close out panel.

Wrangler

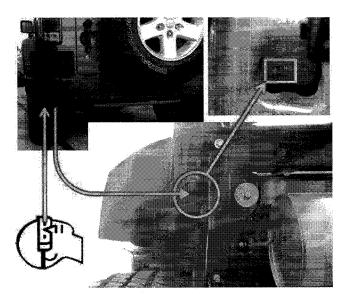
Fig. 1 Left Rear Close Out Panel Inspection

Zinc coating missing from left rear close out panel, no corrosion protection.

- 1. On the left rear corner of the vehicle, behind the wheel, next to the frame, using a flash light, look in the hole identified in (Fig. 1).
- 2. Inspect the Julian date on the left rear close out panel (Fig. 1) and (Fig. 2).
- 3. Was the Julian date 205 ? (Fig. 2)
 - a. YES>>> Contact your Area Manager or Business Center Customer Relations/Warranty Manager for buy back instructions.
 - b. NO>>> This bulletin does not apply. Return vehicle to stock or customer.
