Technical Service Bulletin

01 MIL on, rough running, no start (DTC P0087, P0088, and/or P0191) (TDI only)

01 14 75 2036668/2 March 20, 2014. Supersedes Technical Service Bulletin Group 01 number 14-69 dated March 6, 2014 for reasons listed below.

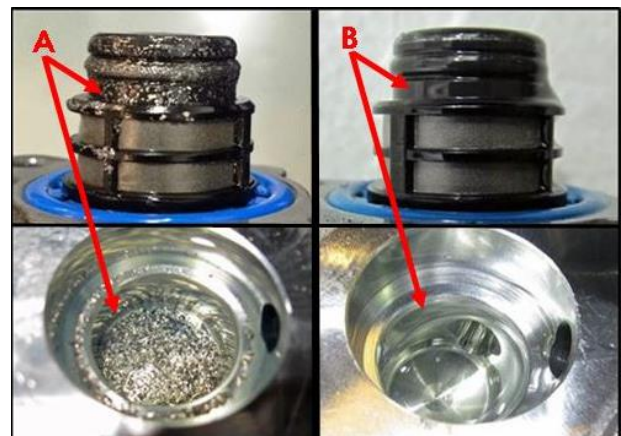
1. Remove the N290 fuel metering valve and inspect the valve and valve bore for the presence of metallic particles (Figure 2). Proceed with the appropriate section below.

Figure 2. Fuel metering valve and valve bore with metallic particles (A), and without metallic particles (B).

If metallic particles *are* found on the N290 fuel metering valve or in the valve bore:

If metallic particles *are not* found on the N290 fuel metering valve or in the valve bore:

1. Do NOT replace the high pressure fuel pump.

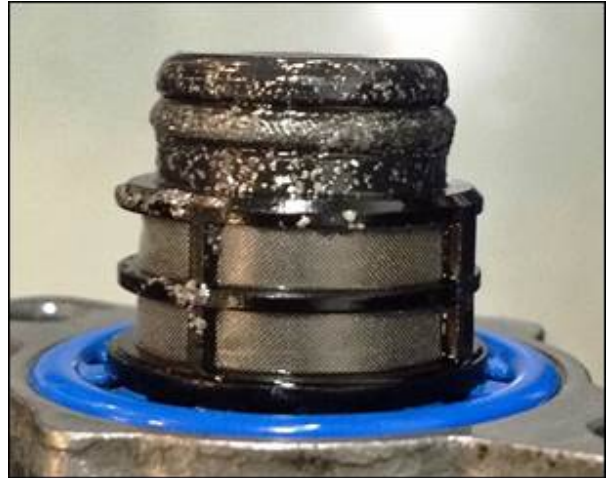
Figure 3. Example of a clear picture showing the metallic particles in the N290 fuel metering valve.

1. Contact the Audi Technical Assistance Center (TAC) and open a TAC ticket before continuing with the repair. Before contacting TAC, attach the following to the TAC ticket:
 - GFF diagnostic log
 - Clear pictures showing the metallic particles in the N290 fuel metering valve and bore (Figure 3 and Figure 4).

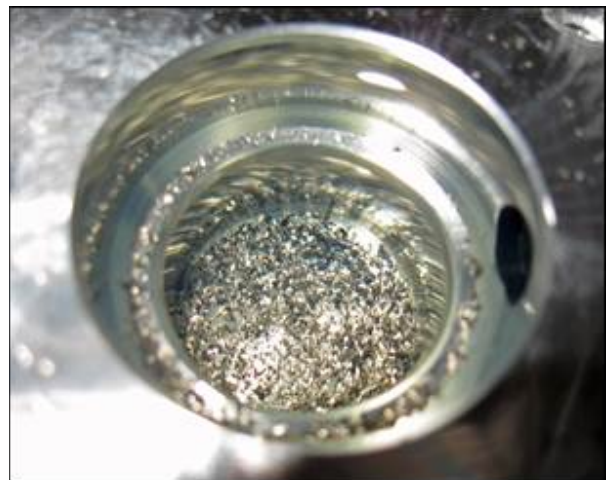
Figure 4. Example of a clear picture showing the metallic particles in the valve bore.
