# Service Bulletin

**SUBJECT:** Service Update for Inventory and Customer Vehicles  
Black Door Tape Cleaning / Replacement  
Expires with Base Warranty

**MODELS:** 2013 Chevrolet Spark

This bulletin provides a service procedure to clean or replace the black door tape at the A and B pillars on certain 2013 model year Chevrolet Spark vehicles. These vehicles may have an appearance issue related to the black door tape wrinkling or shrinking.

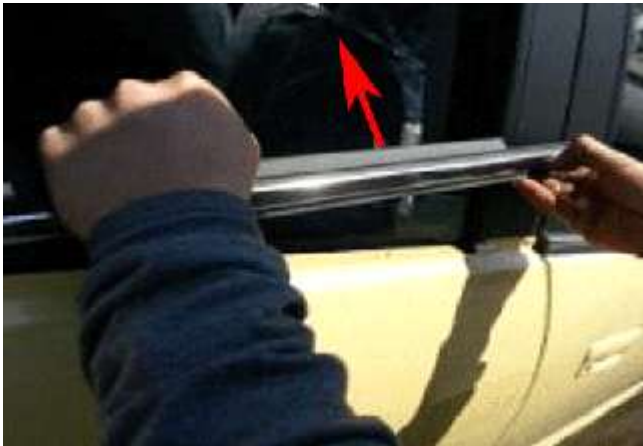
3512221

2. Detach the outer door glass molding.

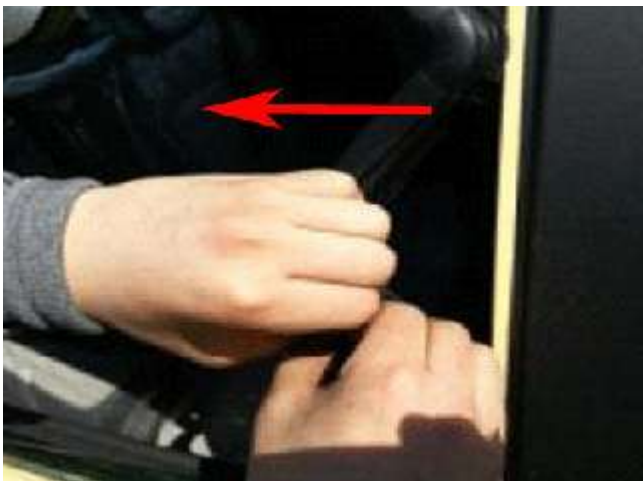
3512222

3. Pull the door weather strip to rework position.

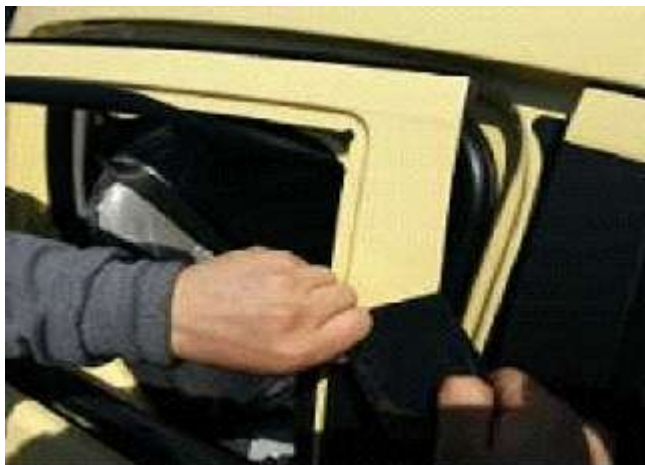
3512223

4. Remove the black tape from the door.

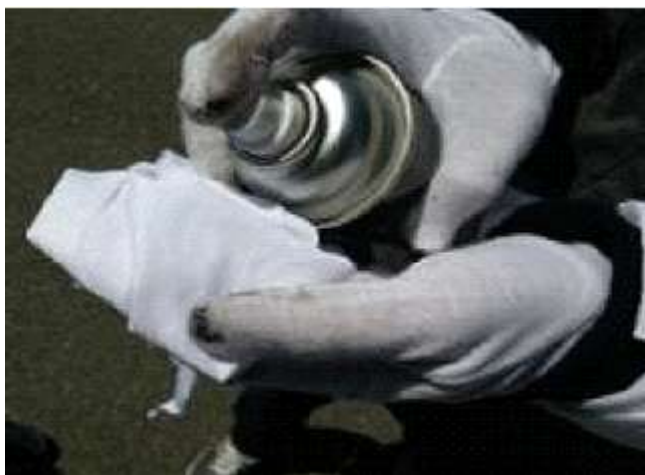
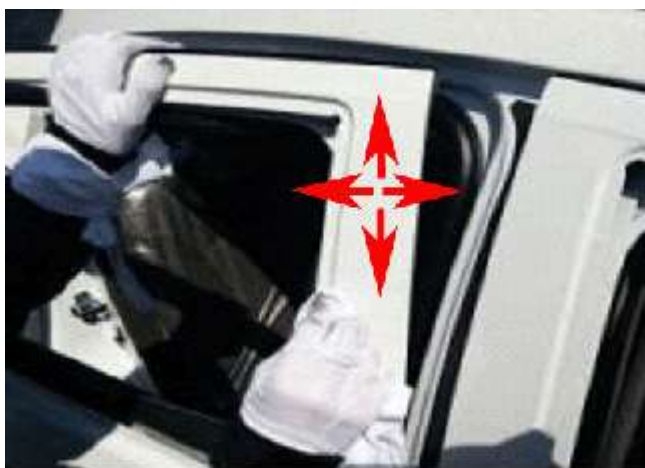
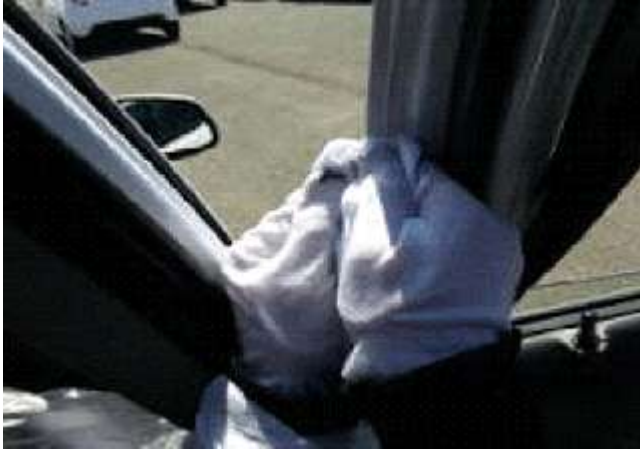
3512224

5. Wipe to remove adhesive residue using 3M Woodgrain and Stripe Adhesive Remover #8908, or equivalent if available.

**Note:** Do not spray the adhesive remover on the body directly.

**Note:** Clean the stained remover on the body parts if required (OSRVM cover/Glass run/Door molding / Fixed glass molding.)

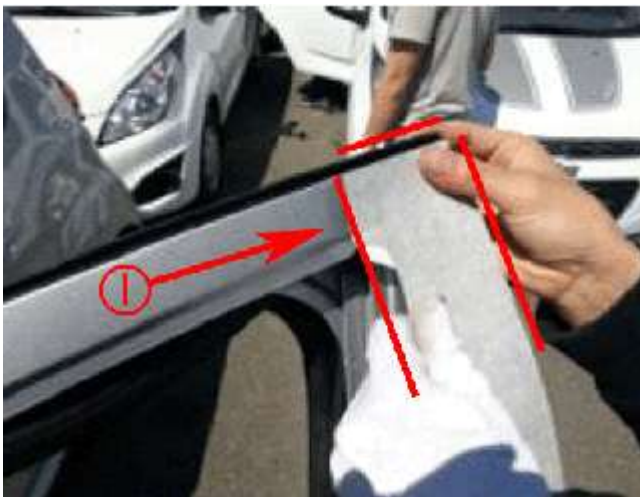
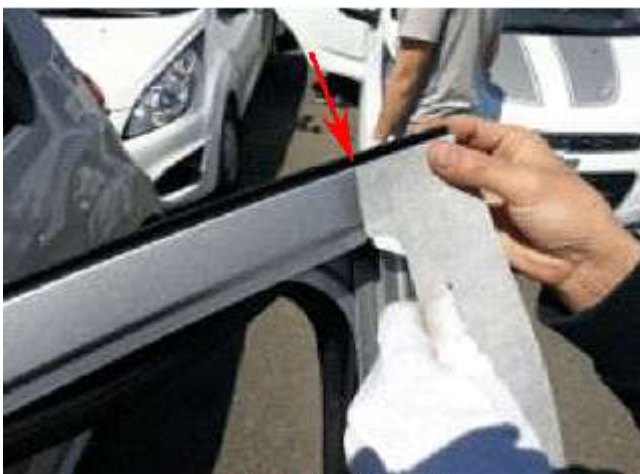
3512233

6. Align door top and the new black tape to the upper door edge and attach the black tape.

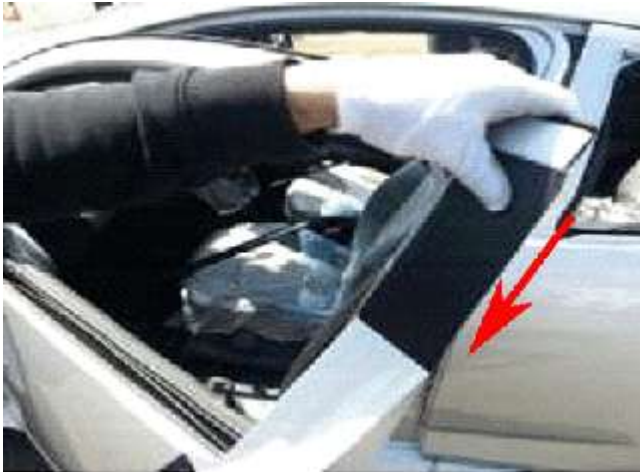
3512242

7. Remove release-liner and squeeze with squeegee from top to bottom.

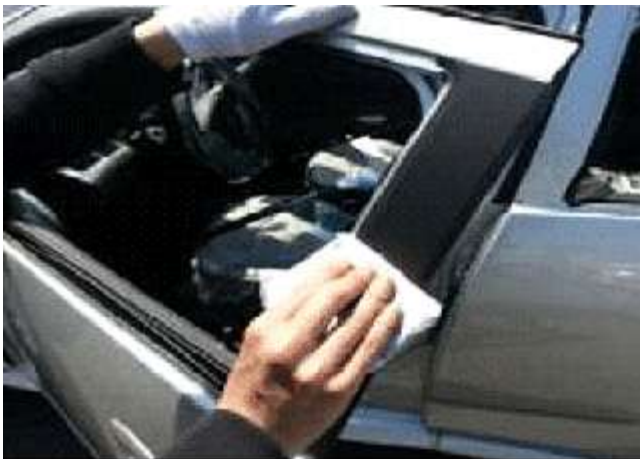
3512243

8. Remove the Pre-Mask Tape.

9. Remove bubbles with a squeegee.
10. Assemble the weather strip and door glass molding in reverse order. (Steps 3, 2,1)
11. Check for noise while operating glass window.
12. If noise is present, confirm and relocate the weather strip and door glass molding.

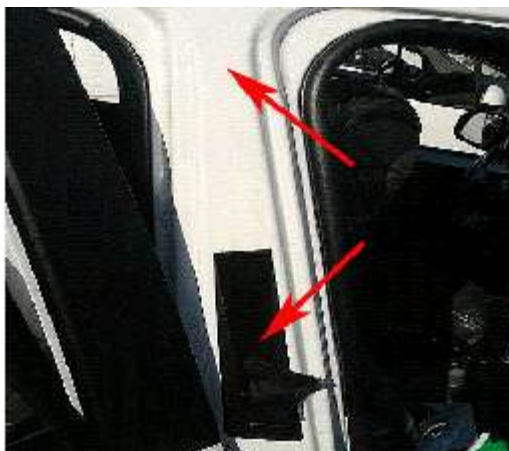
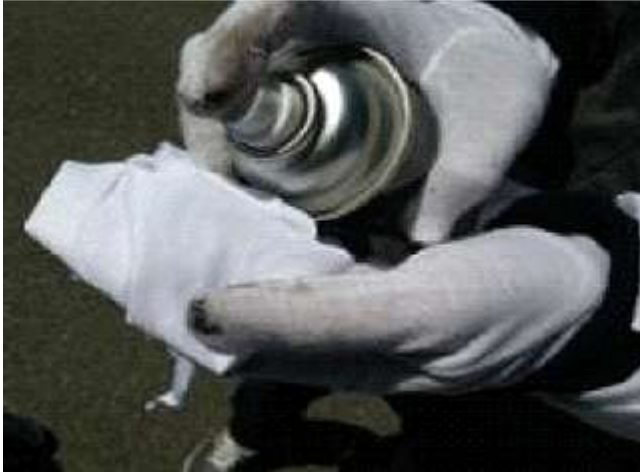
3512244

1. Remove the black tape from door body

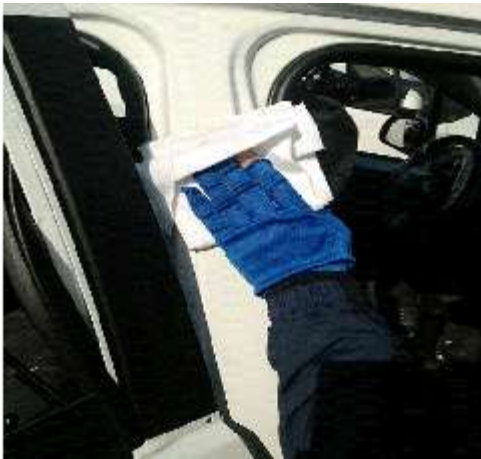
3512247

2. Wipe to remove adhesive residue using 3M Woodgrain and Stripe Adhesive Remover #8908, or equivalent if available.

**Note:** Do not spray the adhesive remover on the body directly.

**Note:** Clean the stained remover on the body parts if required (OSRVM cover/Glass run/Door molding / Fixed glass molding.)

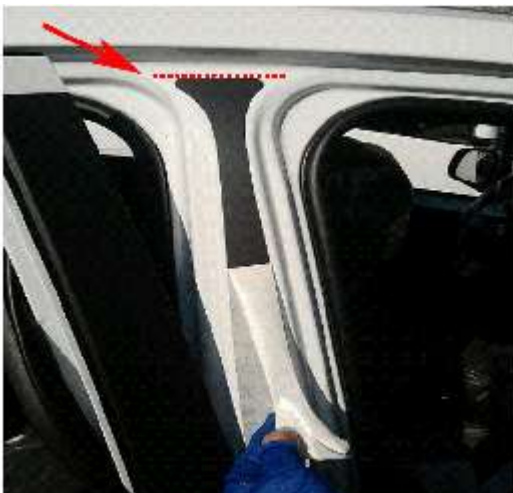
3512255

3. Align door top and the new black tape to the upper door edge and attach the black tape.
  - 3.1. Remove release-liner and squeeze with a squeegee.

- 3.2. After film is attached, remove the Pre-Mask Tape.
- 3.3. Remove any bubbles by wiping the stripe out with a squeegee.

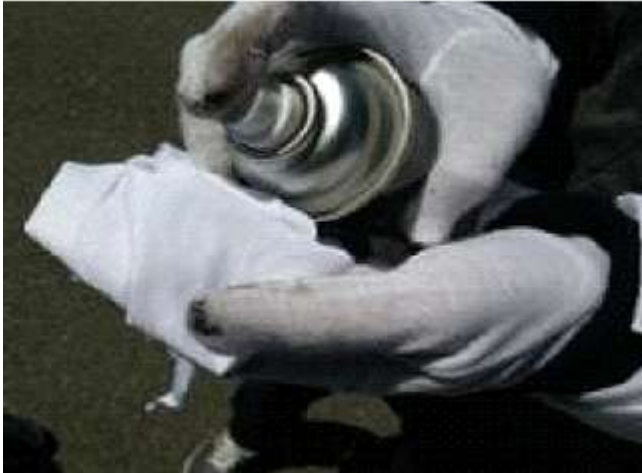
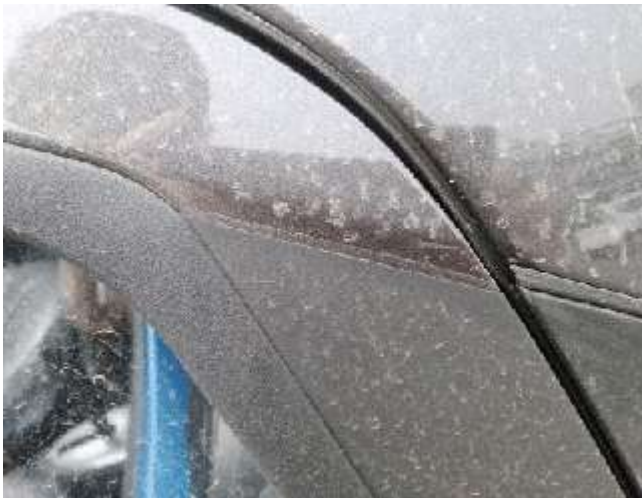
3512259

1. Wipe to remove adhesive residue using 3M Woodgrain and Stripe Adhesive Remover #8908, or equivalent if available.

**Important:** Do not inject the remover on the body directly

**Notice:** Clean the stained remover on the body parts if required (OSRVM cover/Glass run/Door molding / Fixed glass molding.)
