# Technical Service Bulletin

## 87 Cleaning of the air conditioning refrigerant circuit

87 14 55 2018162/4 August 28, 2014. Supersedes Technical Service Bulletin Group 87 number 11-23 dated September 20, 2011 for reasons listed below.

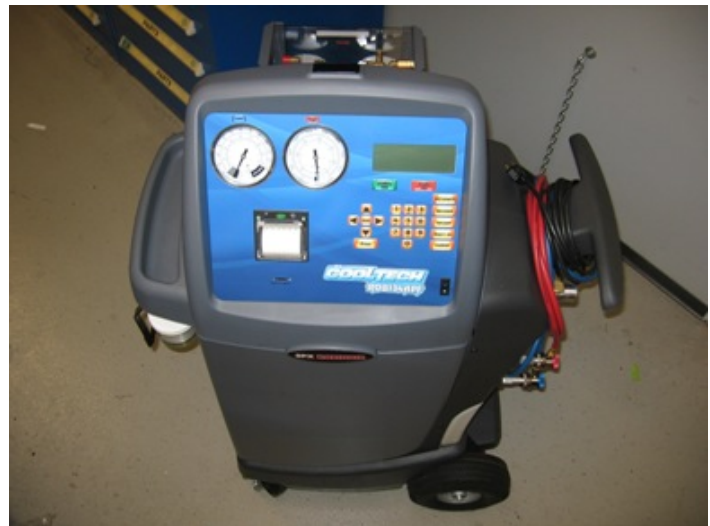
**ROB134APF Air Conditioning Service System with VAS 6337/1A Air Conditioning System Flushing Device** (Figure 1). Used for effective refrigerant handling and air conditioning circuit flushing after air conditioning component failure.

Now air conditioning system refrigerant recovery, evacuation, recharge, *and* refrigerant circuit cleaning after component failure can be performed with a single servicing station.

**Figure 1.** The ROB134APF Air Conditioning Service System with VAS 6337/1A Air Conditioning System Flushing Device.

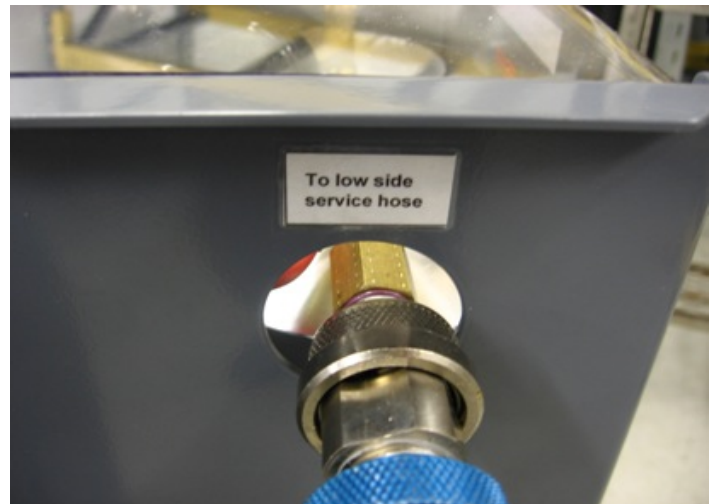
4. Once the appropriate adapters are in place, connect the service station to the vehicle through the air conditioning compressor hoses. The flushing attachment ports are labeled on the flusher (Figure 2 and Figure 3).

**Figure 2.** A flushing attachment port.

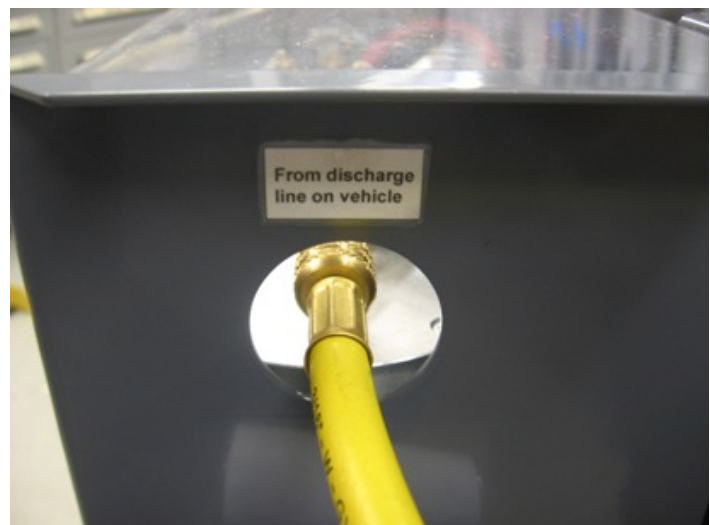
**Figure 3.** A flushing attachment port.

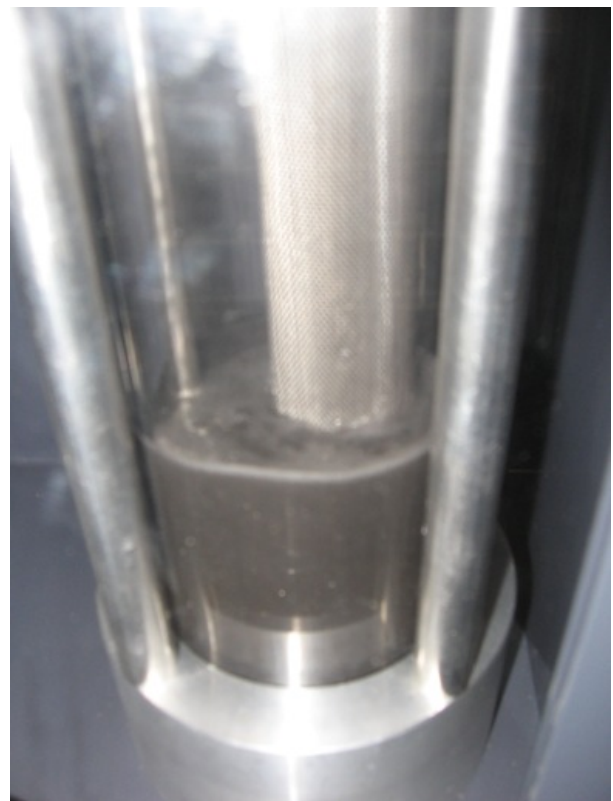
The flush program will begin with an evacuation of the system and a rate of rise test. This is necessary to test the integrity of the connections before the flush cycles begin. If the rate of rise test passes, the program will proceed into the flush cycles (Figure 5, Figure 6, and Figure 7). These cycles will occur automatically in succession.

**Figure 5.** The first cycle.

The debris is then rinsed from the circuit and contained within the filtration in the flusher. After the flush program, the system will be evacuated.

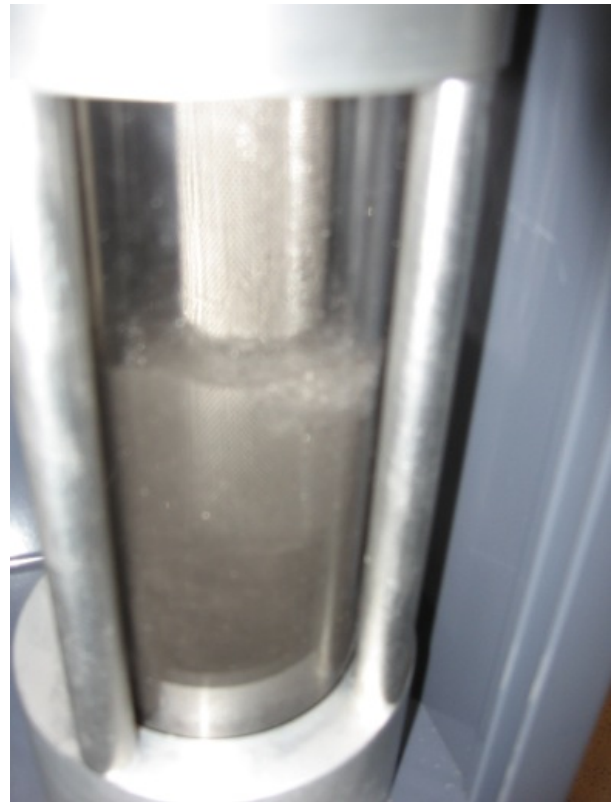
*Figure 6. The second cycle.*

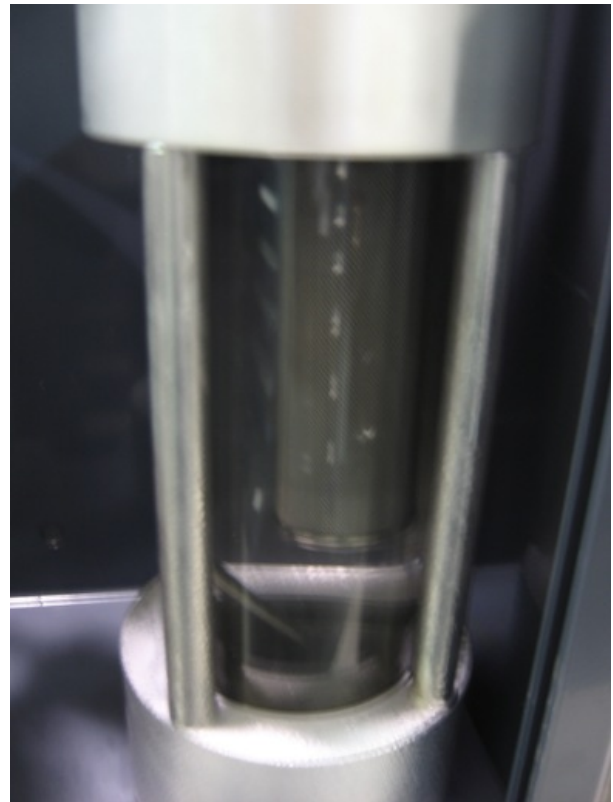
*Figure 7. The third cycle.*

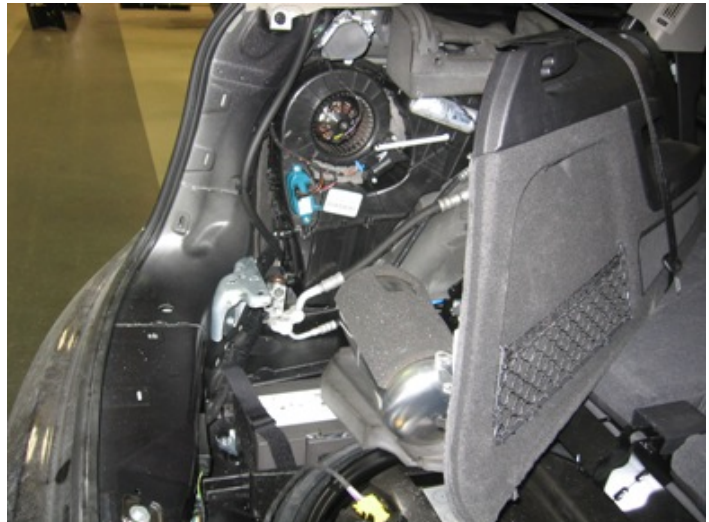
2. Bypass the rear expansion valve with an adapter (Figure 9).

**Figure 9.** Location of rear air conditioning unit and expansion valve.
