Technical Service Bulletin

87 Air conditioning does not cool and / or compressor is noisy

87 14 56 2038023/1 September 12, 2014.

Model(s)	Year	VIN Range	Vehicle-Specific Equipment
A3 Sedan	2015	All	Not Applicable

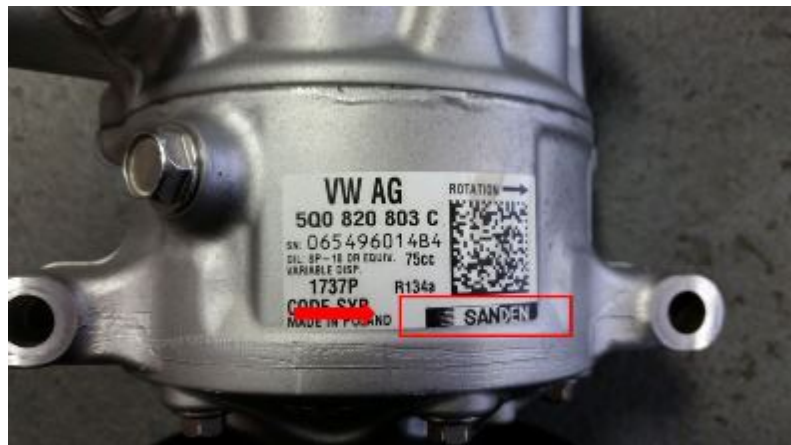
Figure 1: Sanden compressor identification tag.

The originally installed compressor on the MY 2015 A3 is manufactured by Sanden (Figure 1). The replacement compressor is manufactured by Denso (Figure 2).

When replacing the original Sanden compressor with a Denso compressor, be aware that while the refrigerant volume is the same regardless of the compressor installed, the PAG oil type and volume is not. Sanden and Denso compressors have specific PAG oils that must be used. The original PAG oil that will be in the refrigerant circuit must be flushed out completely with the air conditioning service station with flushing equipment, as specified in the repair manual.

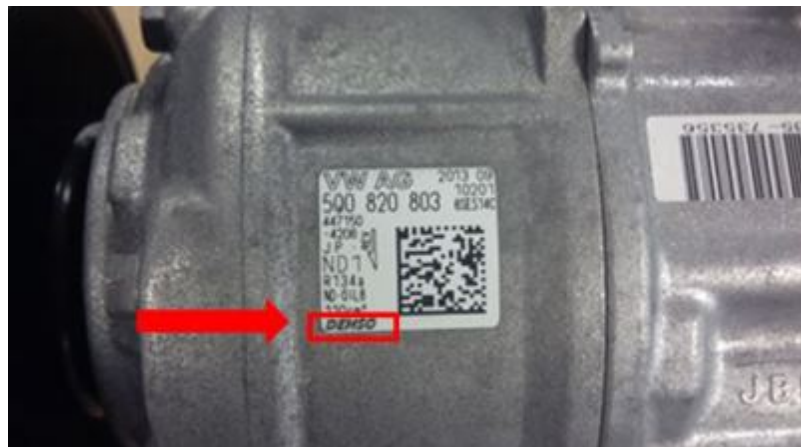
Figure 2: Denso compressor identification tag.

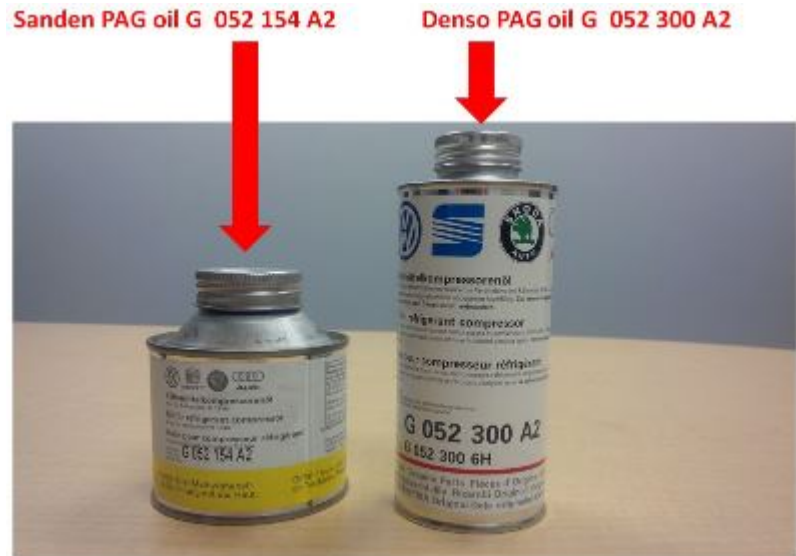
Figure 3: Compressor manufacturer specific PAG oils.

The replacement compressor will come with the specified type of PAG oil for the compressor (Figure 3). The amount of PAG oil supplied with the replacement compressor may not be the exact amount required to replenish the refrigerant circuit. Drain and measure the PAG oil in the replacement compressor to determine the required amount. If the amount needs to be adjusted, do so using the correct type of PAG oil specified in ETKA. Refer to Elsa for the correct oil capacity for the compressor being installed.

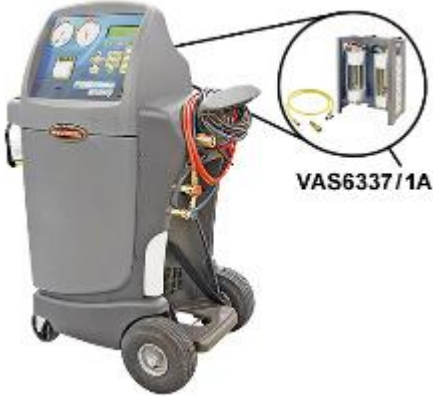
<p data-bbox="396 915 699 945">Robinair A/C Service Unit</p>	1
VAS 6337/1A

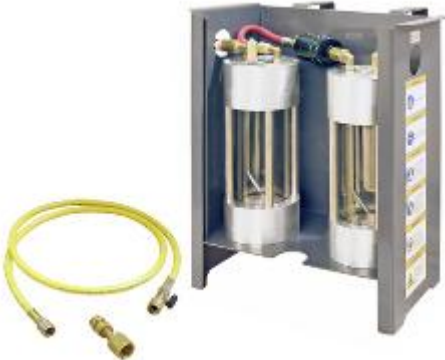
<p data-bbox="396 1392 716 1421">Air Conditioning Flush Tool</p>	1
VAS 6338/3
