## PRODUCT SAFETY RECALL

**SUBJECT:** Diesel Fuel Transfer Pump Tube Nut Torque

**MODELS:** 2015 Chevrolet Silverado HD  
2015 GMC Sierra HD  
Equipped with Diesel Engine (LML) and Dual Fuel Tanks (N2N)

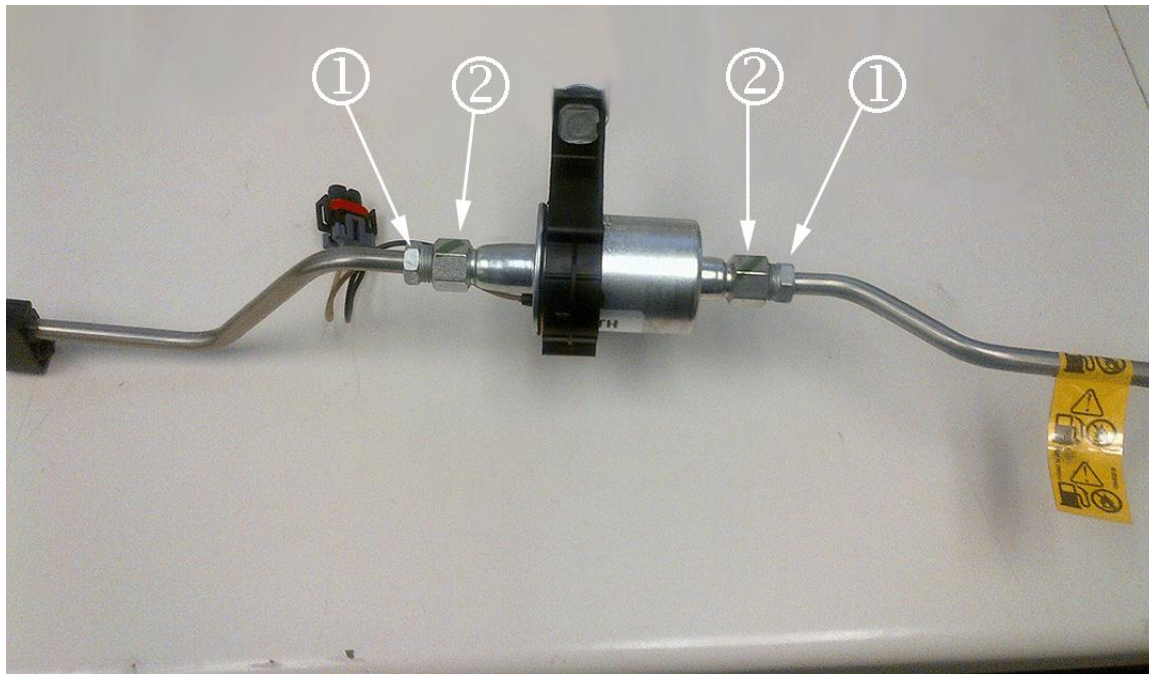
3749706

1. Raise and suitably support the vehicle. Refer to *Lifting and Jacking the Vehicle* in SI.
2. Locate the fuel transfer pump. The fuel transfer pump is on the frame cross member, inside left-hand frame channel and above the rear axle.

**Note:** Use a backup wrench to prevent the fuel transfer pump from turning. Hold the larger nut (2) in place while tightening the smaller tube nut (1).

3. Tighten the tube nuts (1) on both sides of fuel transfer pump to **30 Nm (22 lb-ft)**.
