# Recall Bulletin

**SUBJECT:** Front Axle Right Half Shaft Fracture

**MODELS:** 2013-2014 Chevrolet Cruze  
Equipped with 1.4L Turbo Engine (LUV)

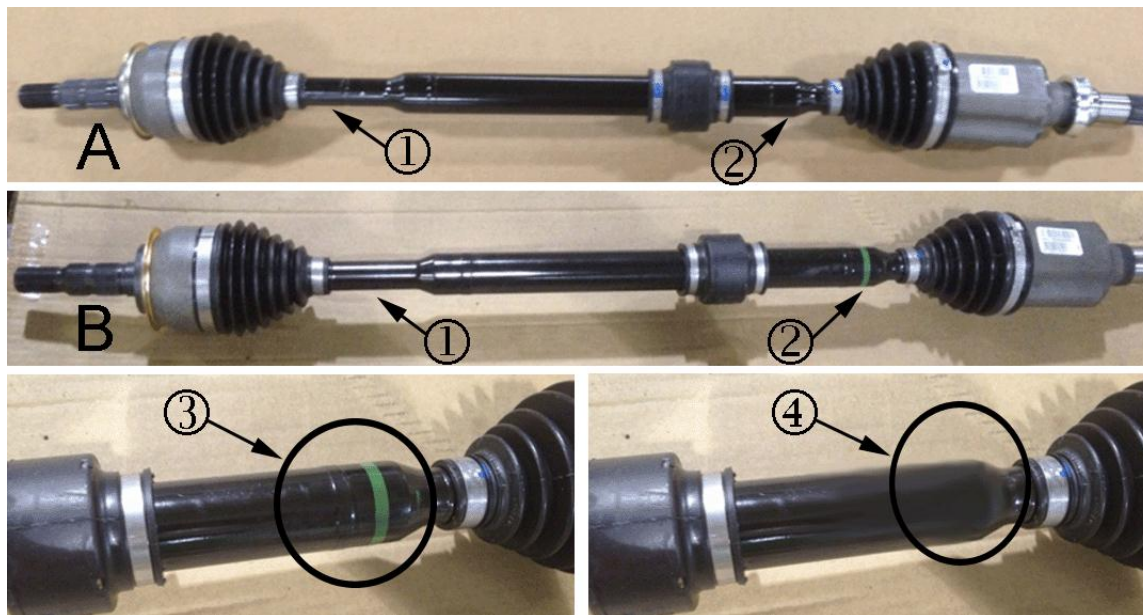
3773595

(1) Wheel Side of Half Shaft (2) Transmission Side of Half Shaft (A) Automatic Transmission (B) Manual Transmission (3) Green Stripe (4) No Stripe

- If a green stripe is present (3) on the half shaft, no further action is required. Lower the vehicle.

**Note:** Replace the half shaft if a blue stripe or no stripe (4) is present.

- If a green stripe is NOT present on the half shaft, replace the half shaft. Refer to *Front Wheel Drive Shaft Replacement ---Right Side* in this bulletin.
