# Recall Bulletin

## PRODUCT SAFETY RECALL

**SUBJECT:** Inspect Power Steering Hose Clamps

**MODELS:** 2015 Chevrolet Silverado 2500/3500 HD  
2015 GMC Sierra 2500/3500 HD

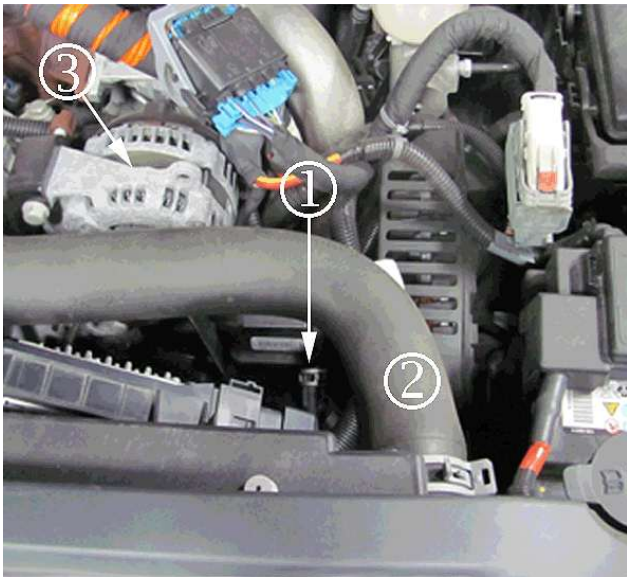
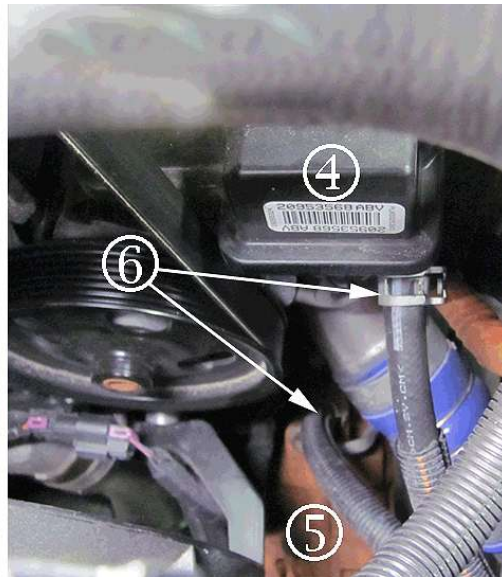
3940428

**Diesel engine shown in the photograph.**

**Note:** A stool is required to view and gain access to the power steering hose clamps at the power steering pump and power steering gear locations. The power steering pump and power steering gear are located (1) below the upper radiator hose (2) and alternator (3) on vehicles equipped with a diesel engine. Power steering pump (4), power steering gear (5) and power steering hose clamp locations (6) shown in diesel and gasoline engine photographs.

2. Locate the power steering hose clamps (6) at the power steering gear (5) and power steering pump (4) locations.

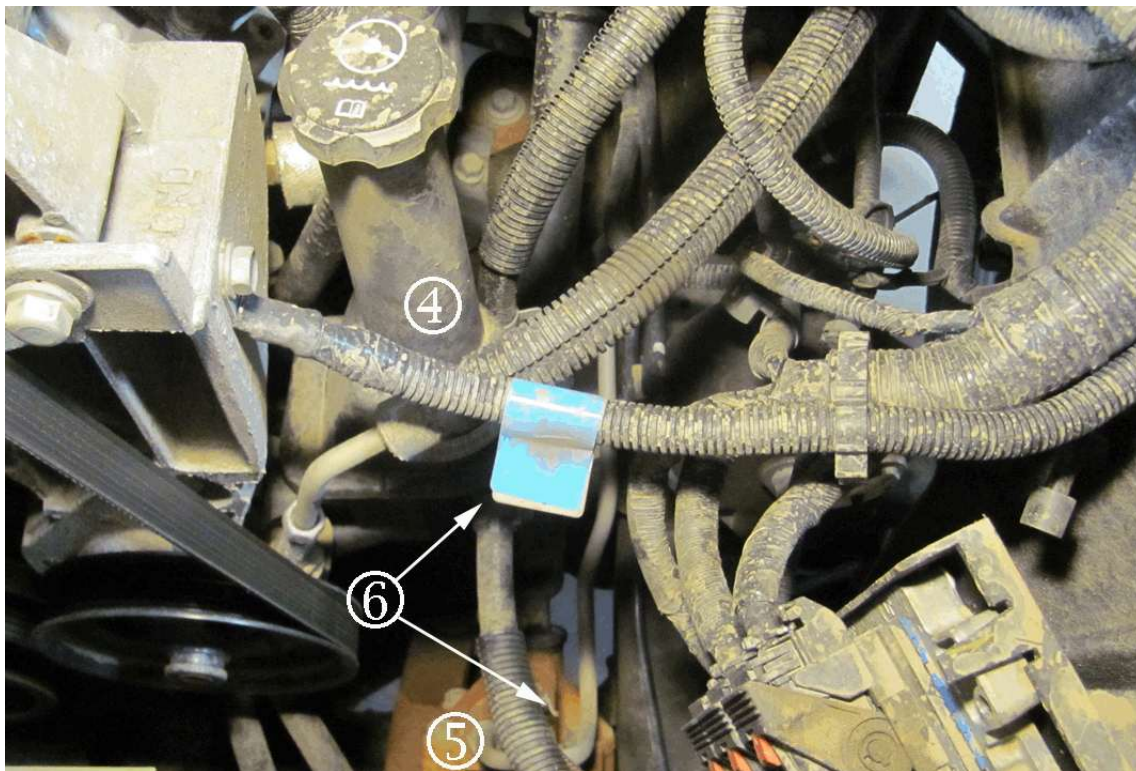
3940429

Gasoline engine shown in photograph.

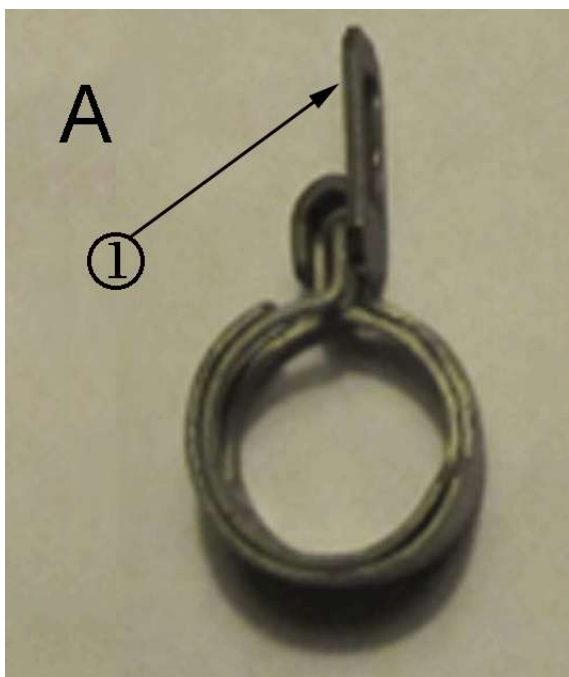
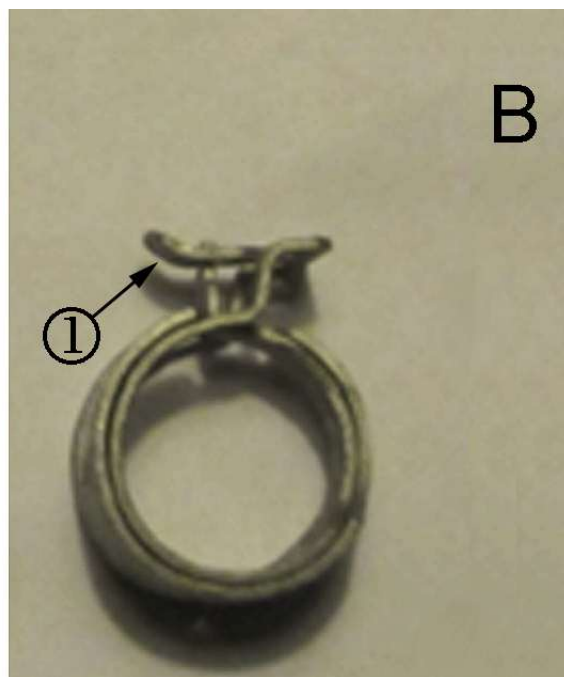
3940430

**Note:** There are two designs for the power steering hose clamp. The first design clamp (A) has an upright tab (1). Pull up on the tab (1) to release the pin and engage the clamp. The second design clamp (B) has a horizontal tab (1). Push up on the tab (1) to release the pin and engage the clamp. Refer to photograph. The power steering hose connection at the power steering gear and pump will be secure (tight) if the clamp is engaged. A long telescope-style mirror and light may be required to inspect the power steering hose clamps. Power steering fluid may be present on the power steering hose, pump or gear if a clamp is NOT engaged.

3. Determine if the power steering hose clamps are engaged. Inspect the power steering hose clamps connections at the power steering gear and power steering pump. **Pull lightly on the end of the power steering hose at the power steering pump and power steering gear locations to ensure the hose is secure at the two locations.**

- If the power steering hose clamps are engaged at both the power steering gear and pump locations, no further action is required.
  - If the power steering hose clamps are NOT engaged at the power steering gear and/or pump locations, engage the clamp to secure (tighten) the hose connection. Proceed to step 4.

4. Engage (tighten) the power steering hose connection at the power steering gear and/or power steering pump locations.
5. Lightly pull on the end of the power steering hose at the power steering pump and/or power steering gear locations to ensure the hose is secure at the two locations.
