SERVICE BULLETIN

APPLICABILITY: 2010-2014MY Legacy and Outback Models

NUMBER: 12-166-14

SUBJECT: Revised L/Front Dash Speaker Grille

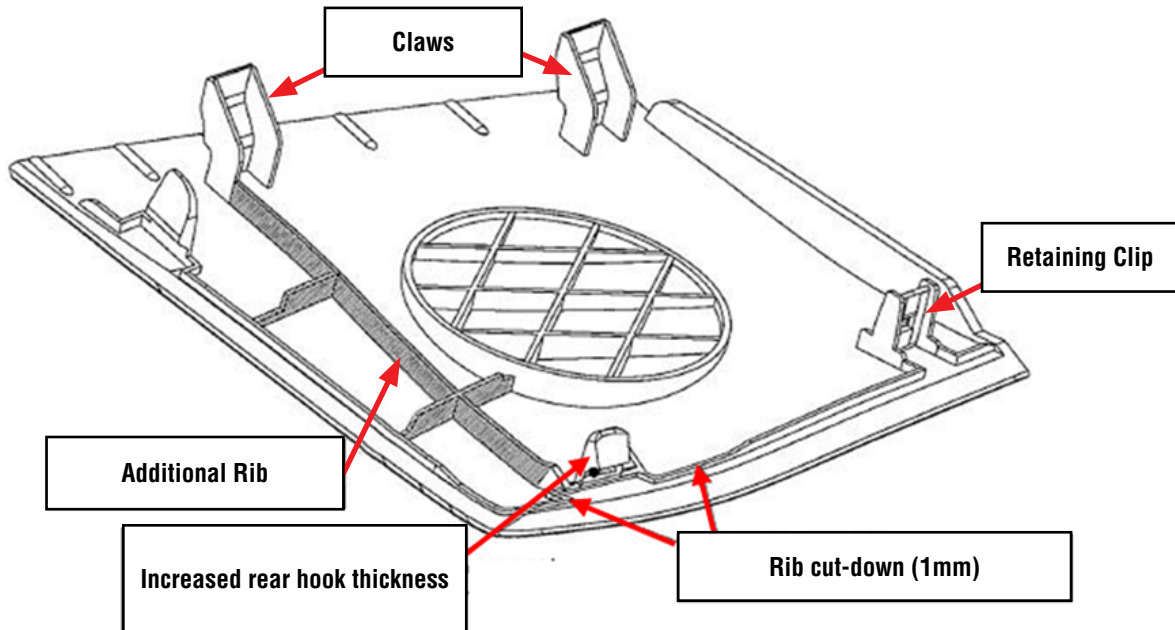
A design change has been made to the retaining hook and reinforcement rib portions of the left front dash speaker grille to increase retention and maintain proper fit to the dashboard trim.

PART NAME	NEW PART NUMBER
GRILLE-SPEAKER, SIDE	66119AJ06A
