APPLICABILITY: 2015MY WRX and STI Models

SUBJECT: Fuel (Gasoline) Filler Door (Flap) Does Not Open **NUMBER:** 09-57-14R **DATE:** 06/11/14 **REVISED:** 08/22/14

INTRODUCTION

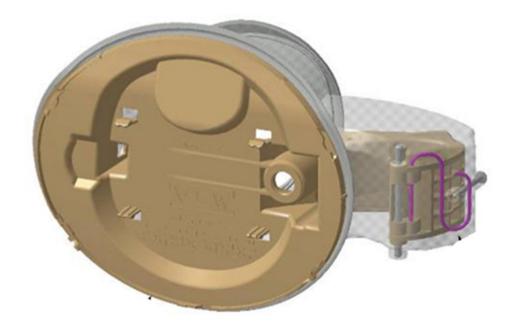
NOTE: Installation of this new assembly replaces the previous repair procedure which involved installation of a revised spring and a new ring clip. A change was made to the plastic material used in addition to incorporating the new style opener spring.

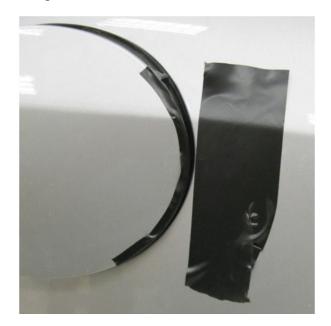
• Apply protective tape to the edge of the fuel filler door and the vehicle body to protect the finish as shown in the photo below.

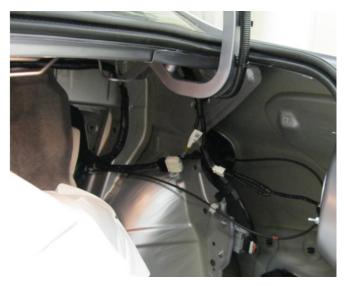
• CAREFULLY remove the retaining clips as necessary from the trunk threshold trim and the inner liner as shown in the illustrations below to provide access to the back side of the fuel filler area.

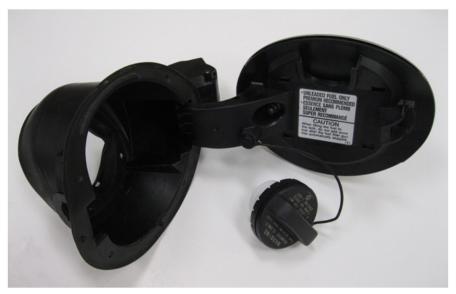
• Once the ring clip is removed, the fuel filler door assembly is ready to remove. Using a finger in the latch hole, pull the rear part of the assembly toward you to disloge it from the body. Once loose from the body, use another finger or a plastic trim tool to "unhook" the rubber insert portion from the front of the filler neck then remove completely as shown below.

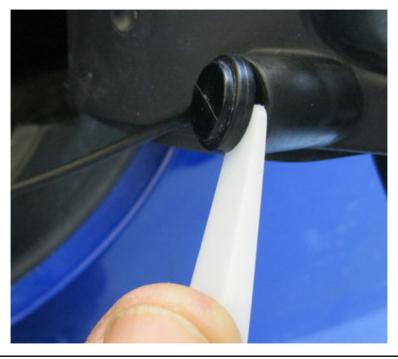
• Swap over the fuel cap / tether to the new saucer assembly. Release the tether retaining clip using a plastic trim tool as shown below.

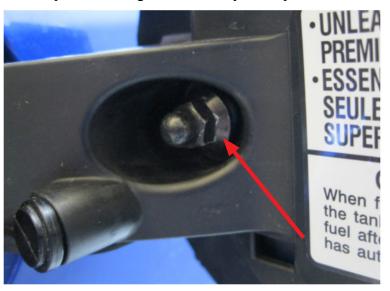
• Remove the hex cap nut securing the outer body-color panel to the outside of the filler door.

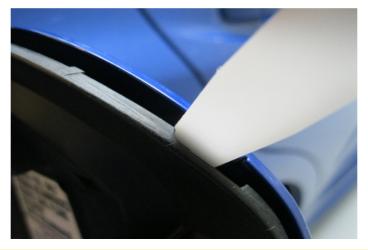
• Using a plastic trim tool, CAREFULLY work the trim tool in between the inner plastic filler door and the metal outer panel to release the 2 upper retaining clips. Once the upper 2 clips are released, the outer panel will be easy to remove from the door. A photo of the inner door with the outer panel removed showing the 4 clip locations is provided below to use as a reference.

NOTE: Be careful not to drop or damage the outer panel while releasing the retaining clips.

Adding a piece of masking tape to secure the outer panel to the plastic door is a good extra safety measure to prevent damage.

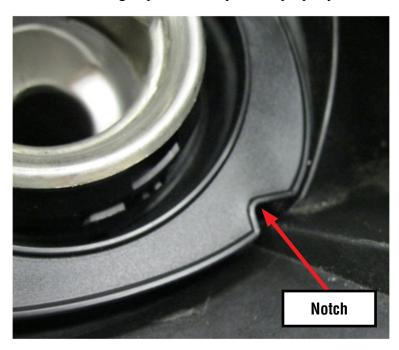
- Transfer the outer panel to the new saucer's filler door making sure all 4 retaining clips are reengaged. Reinstall the cap nut onto the outer panel's mounting stud and torque to 5.5 ft. lbs.
- Reinstall the new saucer assembly into the vehicle in the reverse order of removal. The new saucer assembly includes a new plastic ring clip.
- Once the assembly is back in position, secure it in place using the new plastic ring clip. The ring clip can only be installed one way. Make sure the notch is positioned as shown below then make sure all 4 retaining clips lock into position properly.

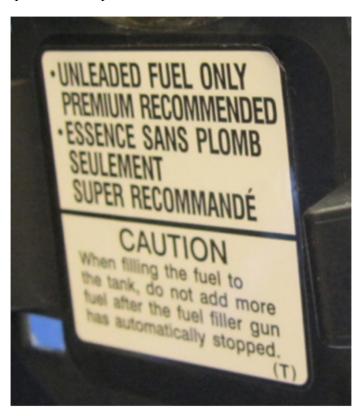
- The remainder of the reassembly is in the opposite order of disassembly.
- Affix the appropriate fuel requirement label to the inside of the filler door.
