NUMBER: 19-002-14 REV. A

GROUP: Steering

Steering Column Squeak / Moan While Turning Wheel

This bulletin involves removing/installing the steering column, removing/installing the bulkhead pass through boot, removing the wiper seal, and applying lubricant to the intermediate shaft bearing sleeve.

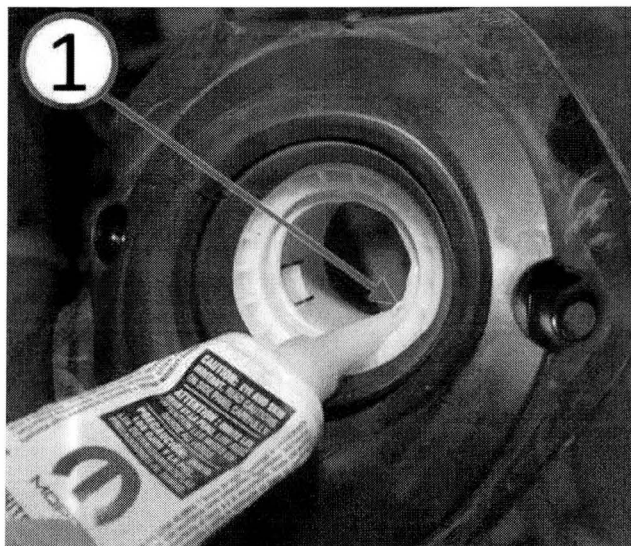
Fig. 7 Apply White Lithium To Outer Bearing Sleeve

1 - White Lithium Grease

7. Apply white lithium grease to the contact surface at each end of the outer bearing sleeve (Fig. 7).
